COFFEE FILTER – AL ALLOY – MODERN TIMES – FRANCE

Artefact name Coffee filter

Authors Christian. Degriigny (HE-Arc CR, Neuchâtel, Neuchâtel, Switzerland)

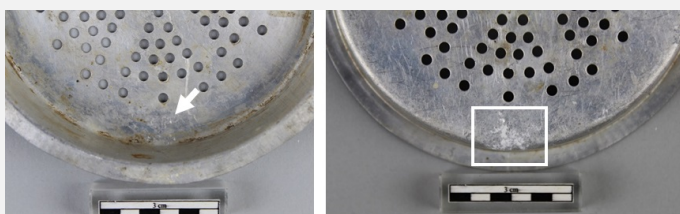
Fig. 2: Detail of the front and back sides of the coffee filter showing the location of Fig. 3,

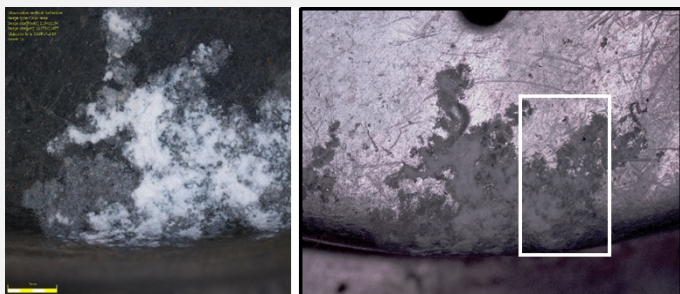
Fig. 3: Detail of the back side of the coffee filter showing the location of the sampling area,

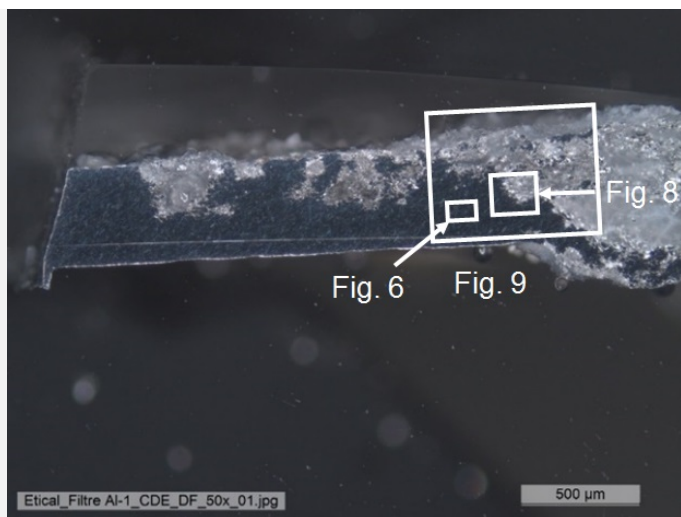
Fig. 4: Micrograph of the cross-section showing the location of Figs. 6, 8 and 9, dark field,

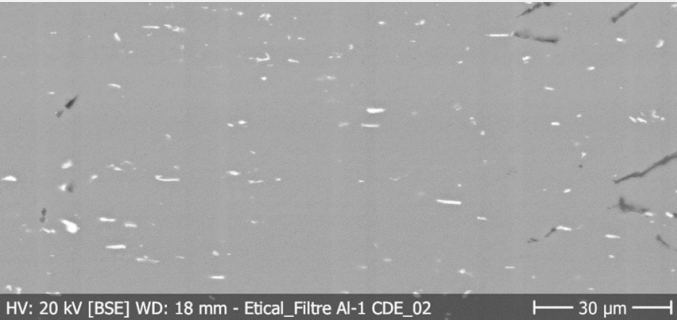
The metal is a relatively pure aluminium alloy with numerous elongated inclusions (Fig. 6). From their chemical composition they can be interpreted as Al₃Fe intermetallic compounds (Fig. 7). Inter- and transgranular corrosion has

Fig. 6: SEM image of the metal sample from Fig. 4 (detail), BSE-mode. We observe the presence of numerous elongated inclusions,

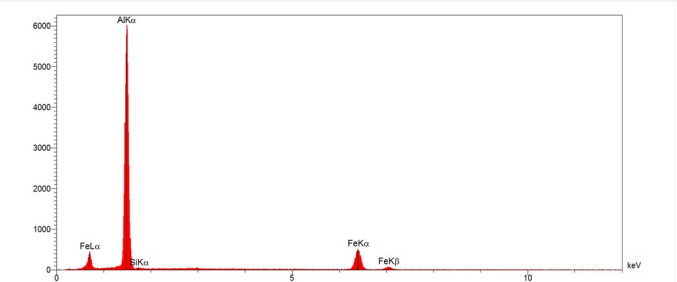
Fig. 7: EDS spectrum of the elongated inclusions of Fig. 6,

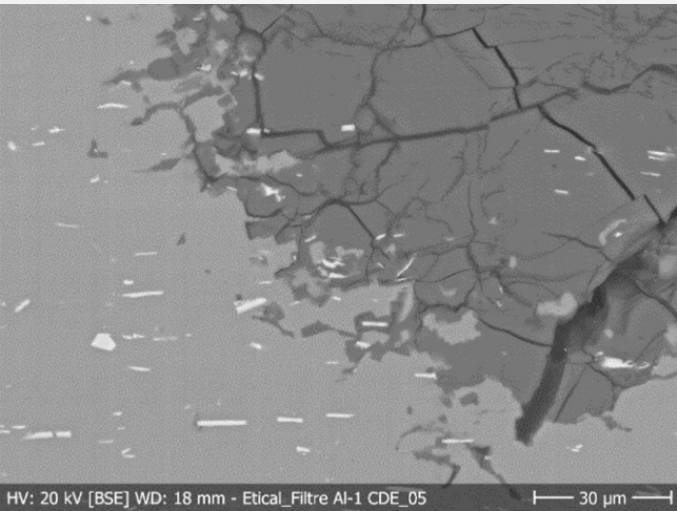
developed so extensively that some grains (not elongated) are outlined (Fig. 8).

Fig. 8: SEM image of the metal sample from Fig. 4 (detail), BSE-mode. Extensive inter- and transgranular corrosion has developed within the metal,

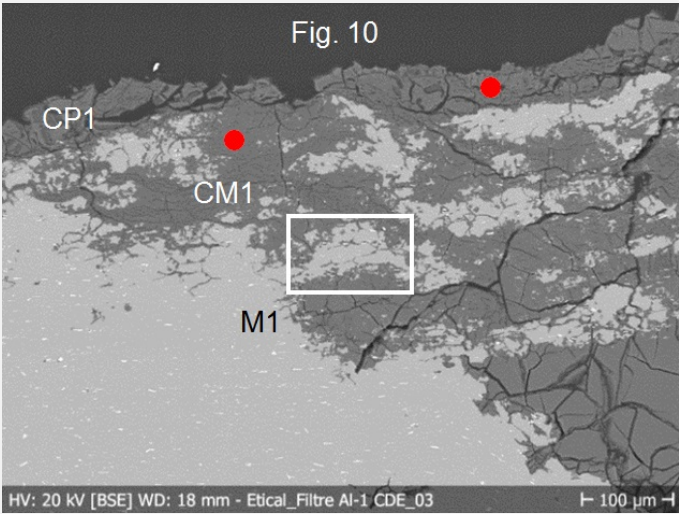
The average thickness of the corrosion layer (CP1) is about 50mm, but may be thinner or thicker depending on the area. Intergranular corrosion has developed locally to extend the whole thickness of the metal. Analysis by SEM-EDS

Fig. 9: SEM picture (detail of Fig. 4 with location (red spots) of EDS analyses of Fig. 10), BSE-mode. From bottom to top left: the metal (M1) in light grey, the corroded metal (CM1) and CP1. The mapped area of Fig. 11 is marked by a rectangle,

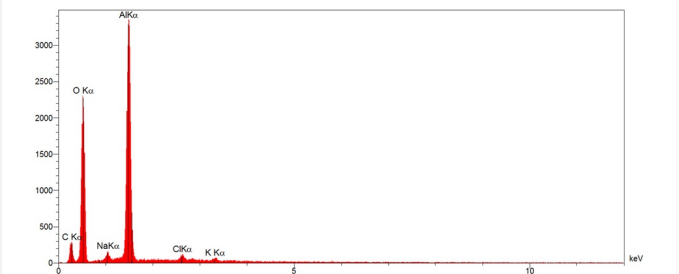
indicates that the metal is, as expected, covered by an Al and O-rich layer containing chlorides (red spots on Fig. 9) and surprisingly Na (Figs. 10 and 11). Chlorides do not seem to form active corrosion. A new examination carried out after 4 months (Fig. 12) shows new forms of alteration with a local enrichment of Na, C and O (Na₂CO₃?).

Fig. 10: EDS spectrum of red spots in Fig. 9,

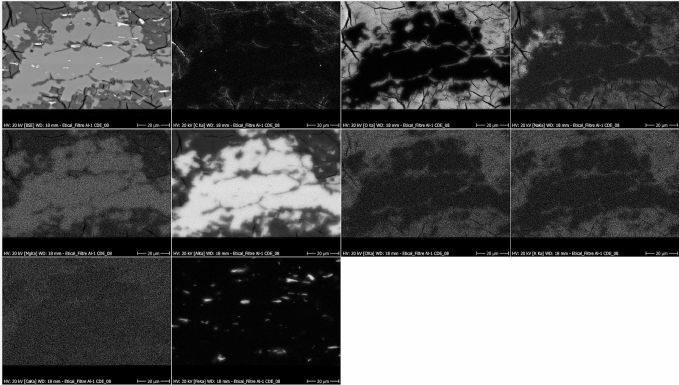
Fig. 11: SEM image, BSE-mode, and elemental chemical distribution of the selected area of Fig. 9. Method of examination: SEM-EDS, Lab of Electronic Microscopy and Microanalysis, IMA (Néode), HEI Arc,

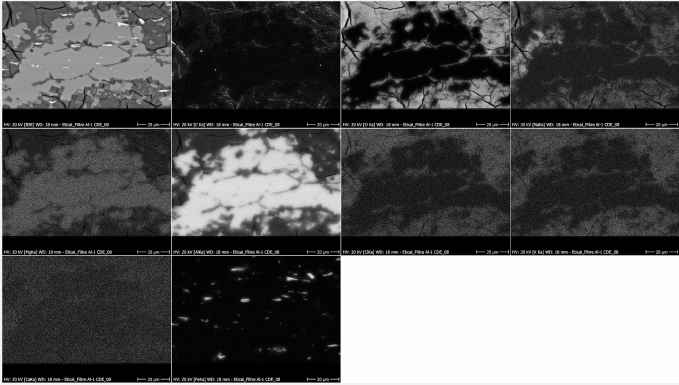
Fig. 12: SEM image, BSE-mode, and elemental chemical distribution of the selected area of Fig. 9 after 4 months. Method of examination: SEM-EDS, Lab of Electronic Microscopy and Microanalysis, IMA (Néode), HEI Arc,

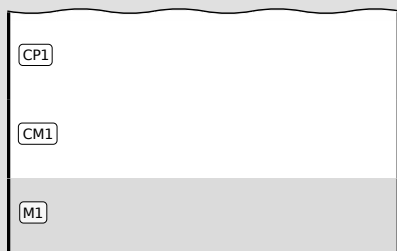
Fig. 5: Stratigraphic representation of the object in cross-section using the MiCorr application. The characteristics of the strata are only accessible by clicking on the drawing that redirects you to the search tool by stratigraphy representation. This representation can be compared to Fig. 9, Credit HE-Arc CR, C.Degrigny.
