SHINGLE OF A ROOF – CU ALLOY – MODERN TIMES – SWITZERLAND

Artefact name	Shingle of a roof
Authors	Marianne. Senn (EMPA, Dübendorf, Zurich, Switzerland) & Christian. Degryny (HE-Arc CR, Neuchâtel, Neuchâtel, Switzerland)
Url	/artefacts/446/

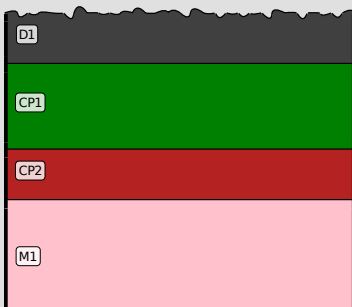
Fig. 4: Stratigraphic representation of the object in cross-section using the MiCorr application. The characteristics of the strata are only accessible by clicking on the drawing that redirects you to the search tool by stratigraphy representation. This representation can be compared to Fig. 7, Credit HE-Arc CR.
