SHINGLE OF A ROOF – CU ALLOY – MODERN TIMES – SWITZERLAND

Artefact name	Shingle of a roof
Authors	Marianne. Senn (EMPA, Dübendorf, Zurich, Switzerland) & Christian. Degriigny (HE-Arc CR, Neuchâtel, Neuchâtel, Switzerland)
Url	/artefacts/446/

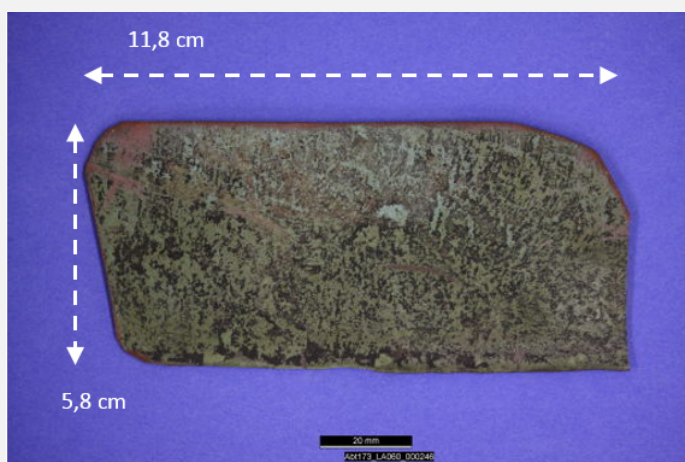
Fig. 1: Copper alloy shingle, internal side,

Description of the artefact	Shingle, slightly curved, the internal side is covered with heterogeneously distributed green and black corrosion products (Fig. 1). The external side shows a regular dark green corrosion crust. Dimensions: L = 11.8cm; W = 5.8cm.
Type of artefact	Architectural element
Origin	Roof of the Abbey of St Gallen, Sankt Gallen, Saint Gallen, Switzerland
Recovering date	None
Chronology category	Modern Times
chronology tpq	<input type="text" value="1780"/> A.D. ▾
chronology taq	<input type="text" value=""/> ---- ▾
Chronology comment	1780
Burial conditions / environment	Outdoor atmosphere
Artefact location	Conservation Department of the Musées d'art et d'histoire, Genève, Geneva
Owner	Abbey of St Gallen, Sankt Gallen, Saint Gallen

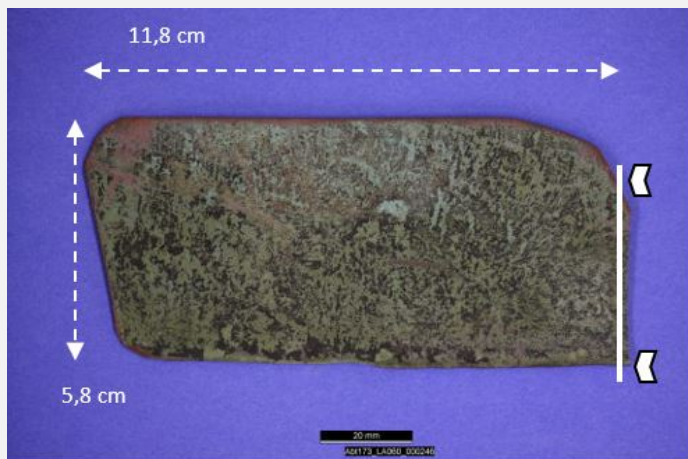
Fig. 2: showing the location of sampling area,

Description of sample	Two samples were taken (Fig. 2). The polished samples show a well-preserved metal surface with a thin corrosion crust (Fig. 3). T = 0.5mm.
Alloy	Cu Alloy
Technology	Rolled (probably hot rolling) and annealed
Lab number of sample	MAH-98-257
Sample location	Empa (Marianne Senn)
Responsible institution	Conservation Department of the Musées d'art et d'histoire, Genève, Geneva
Date and aim of sampling	2009, integration of sample to the MIFAC-Métal project

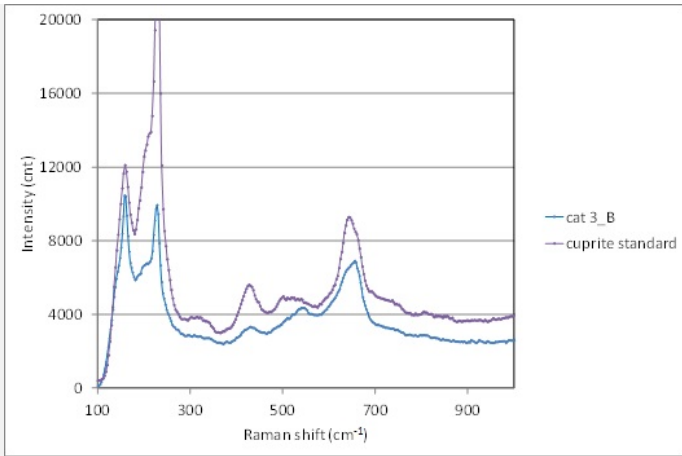
Fig. 9: Raman spectrum of the red-orange inner corrosion layer (CP2) of the external side (cat3_B) compared to a cuprite standard spectrum. Settings: laser wavelength 532nm, acquisition time 100s,

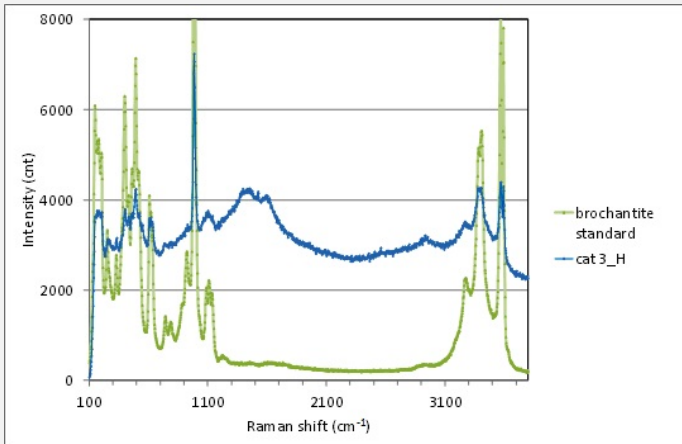
Fig. 10: Raman spectrum of the green outer corrosion layer (CP1) of the external side (cat3_H) compared to a brochantite standard spectrum. Settings: laser wavelength 532nm, acquisition time 100s, one accumulation, filter D2 (0.75-0.8 mW), hole 500, slit 80, grating 600. The peak indicated with an arrow on the cat3_H spectrum is due to fluorescence. Method of analysis: Raman spectroscopy, Lab Swiss National Museum, Affoltern a. Albis ZH,

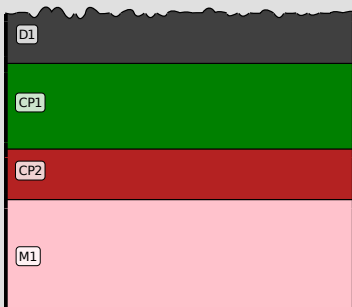
Fig. 4: Stratigraphic representation of the object in cross-section using the MiCorr application. The characteristics of the strata are only accessible by clicking on the drawing that redirects you to the search tool by stratigraphy representation. This representation can be compared to Fig. 7, Credit HE-Arc CR.
