CORRODED METAL SHEET FN 655.13.01 – FE ALLOY – MODERN TIMES – SWITZERLAND

Artefact name	Corroded metal sheet FN 655.13.01
Authors	Marianne. Senn (EMPA, Dübendorf, Zurich, Switzerland) & Christian. Degrigny (HE-Arc CR, Neuchâtel, Neuchâtel, Switzerland)
Url	/artefacts/448/

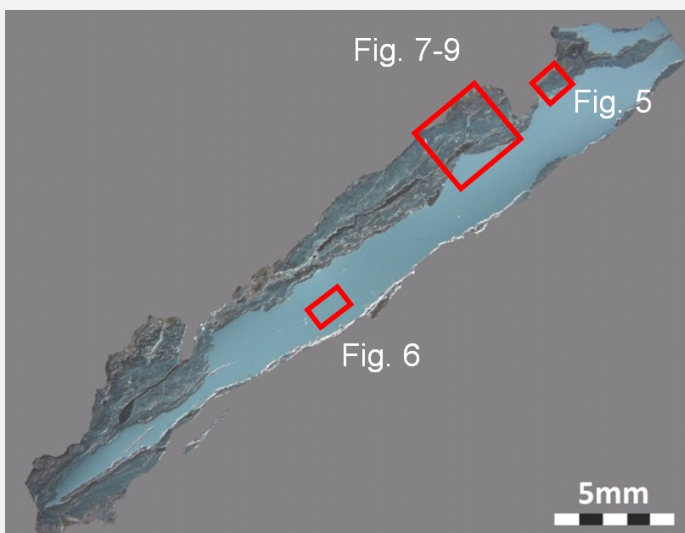
Fig. 3: Micrograph of the cross-section showing the location of Figs. 5 to 9,

The corrosion is massive and large parts of the outer corrosion layers have been lost during the sample preparation. The heavily cracked corrosion crust represents about one third of the thickness of the sample (Fig. 3) and is located on one side of the metal (the rest having been lost during the cutting process). It does not show well defined layers. Despite this, three areas can be distinguished (Figs. 7 and 8). Adhering to the metal (area 1), we find an orange-red-brown layer enriched in Cl (CP3 in Fig. 4, Fig. 9 and Table 3). The dark or violet middle area 2 is richer in Fe (CP2 in Fig. 4). The outer area 3 is red-brown (CP1 in Fig. 4) and strongly contaminated by soil material (rock fragment inclusion and elements like Si, Al, P etc.). This layer is enriched in O (Fig. 9).

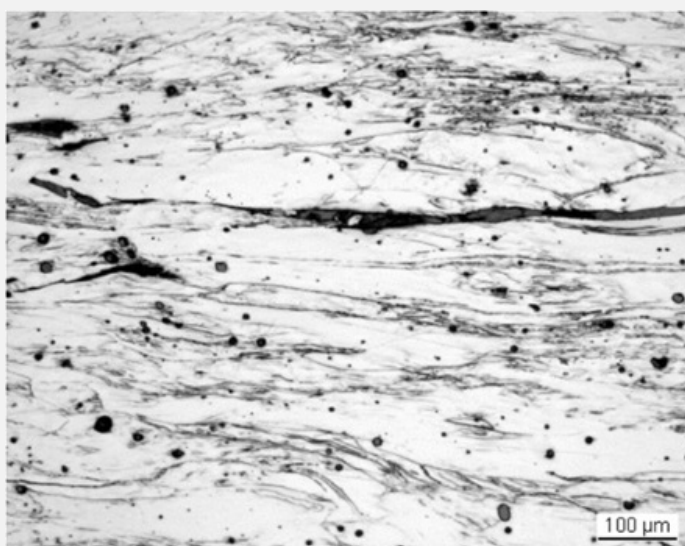
Fig. 6: Micrograph of metal sample from Fig. 3 (detail), etched, bright field. The heavily cold worked metal shows elongated grains with nearly invisible grain boundaries and cracks parallel to the grains,

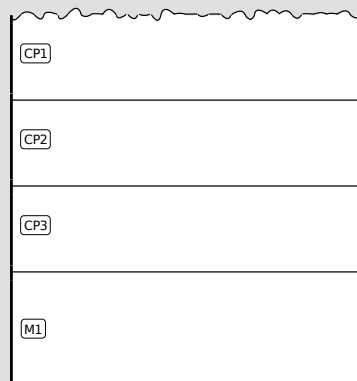
Fig. 4: Stratigraphic representation of the object in cross-section using the MiCorr application. The characteristics of the strata are only accessible by clicking on the drawing that redirects you to the search tool by stratigraphy representation. This representation can be compared to Figs. 7 and 8, Credit HE-Arc CR.

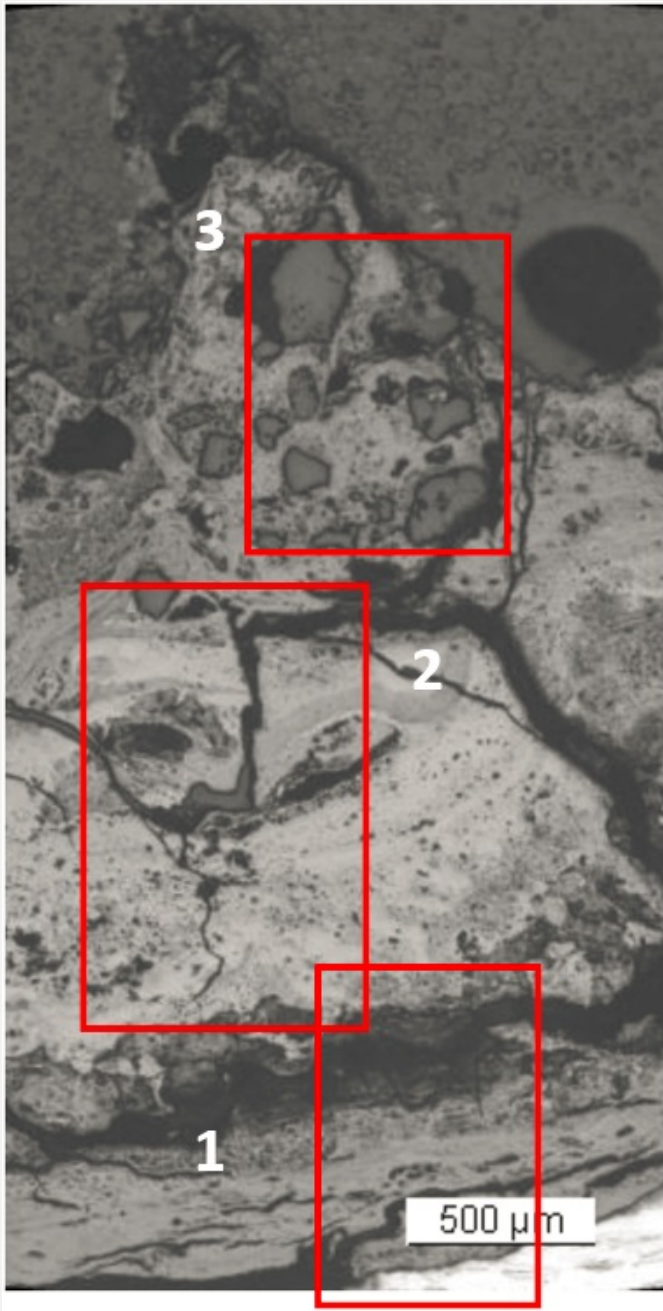
Fig. 7: Micrograph of the corrosion layer from Fig. 3 showing the metal - corrosion crust interface (detail, rotated by 45°) and corresponding to the stratigraphy of Fig. 4, unetched, bright field. Areas 1 (inner layer, CP3) to 3 (outer layer, CP1) are indicated,
