# CORRODED METAL SHEET FN 655.13.01 – FE ALLOY – MODERN TIMES – SWITZERLAND

<b>Artefact name</b>	Corroded metal sheet FN 655.13.01
<b>Authors</b>	Marianne. Senn (EMPA, Dübendorf, Zurich, Switzerland) & Christian. Degriigny (HE-Arc CR, Neuchâtel, Neuchâtel, Switzerland)
<b>Url</b>	/artefacts/448/

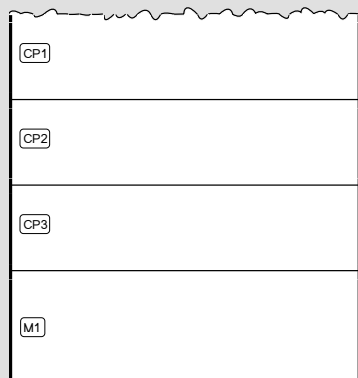
Fig. 4: Stratigraphic representation of the object in cross-section using the MiCorr application. The characteristics of the strata are only accessible by clicking on the drawing that redirects you to the search tool by stratigraphy representation. This representation can be compared to Figs. 7 and 8, Credit HE-Arc CR.

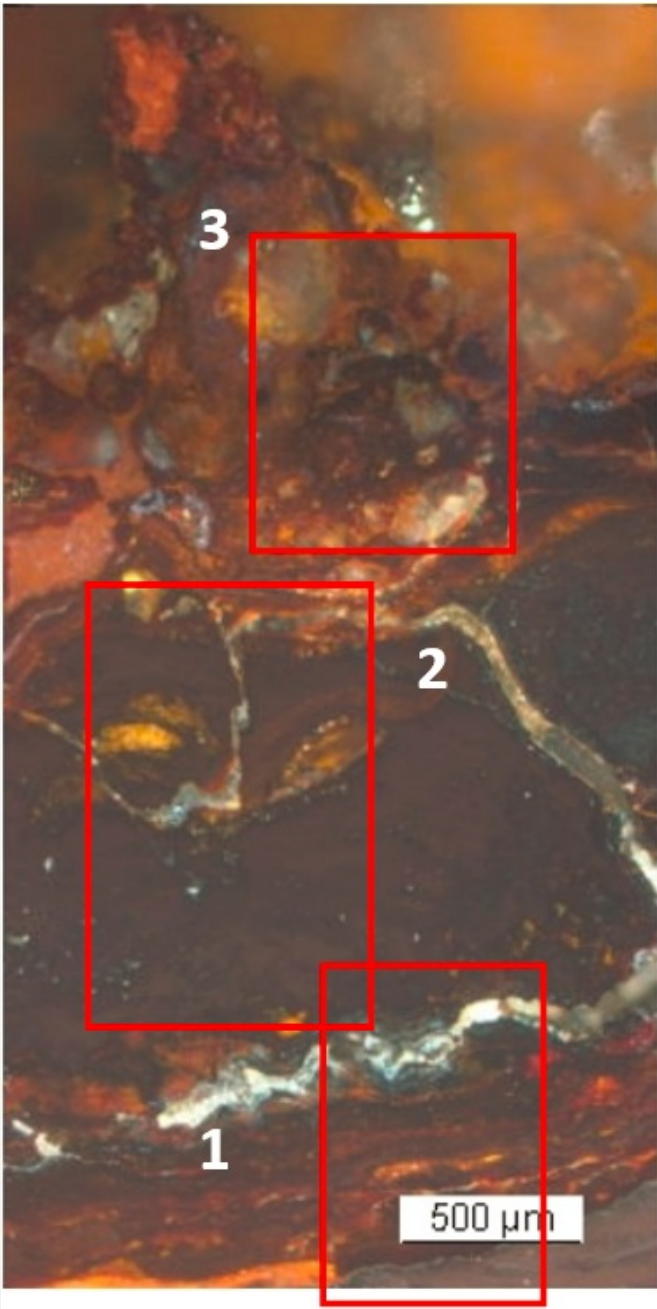
Fig. 8: Micrograph (same as Fig.7) and corresponding to the stratigraphy of Fig. 4, polarised light. The inner layer (CP3) is red-brown, area 2 is brown-violet (CP2) and the outer pale brown area contains rock fragment inclusions (CP1),
