# CORRODED METAL SHEET FN 655.13.01 – FE ALLOY – MODERN TIMES – SWITZERLAND

**Artefact name** Corroded metal sheet FN 655.13.01

**Authors** Marianne. Senn (EMPA, Dübendorf, Zurich, Switzerland) & Christian. Degriigny (HE-Arc CR, Neuchâtel, Neuchâtel, Switzerland)

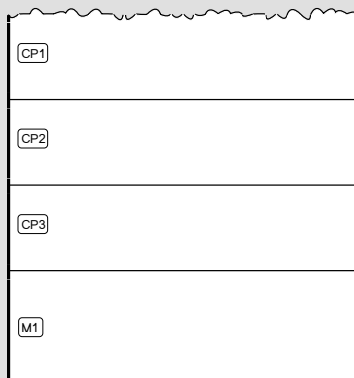
Fig. 4: Stratigraphic representation of the object in cross-section using the MiCorr application. The characteristics of the strata are only accessible by clicking on the drawing that redirects you to the search tool by stratigraphy representation. This representation can be compared to Figs. 7 and 8, Credit HE-Arc CR.
