TANG FRAGMENT OF A KNIFE HR-6567 - LEADED BRONZE - LATE BRONZE AGE - SWITZERLAND

Artefact name Tang fragment of a knife HR-6567

Authors Marianne. Senn (EMPA, Dübendorf, Zurich, Switzerland) & Christian. Degriigny (HE-Arc CR, Neuchâtel, Neuchâtel, Switzerland)

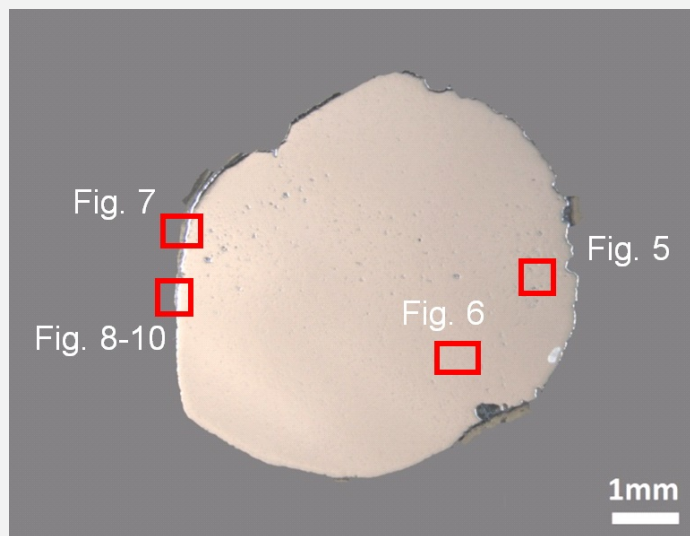
Fig. 3: Micrograph of the cross-section showing the location of Figs. 5 to 10,

Description of sample	This cross-section shows a lateral cut through the tang (Fig. 2). Most of the corrosion crust is absent (Fig. 3).
Alloy	Leaded Bronze
Technology	Cold worked after annealing
Lab number of sample	MAH 87-196
Sample location	Musées d'art et d'histoire, Genève, Geneva
Responsible institution	Musées d'art et d'histoire, Genève, Geneva
Date and aim of sampling	1987, metallography and corrosion characterisation

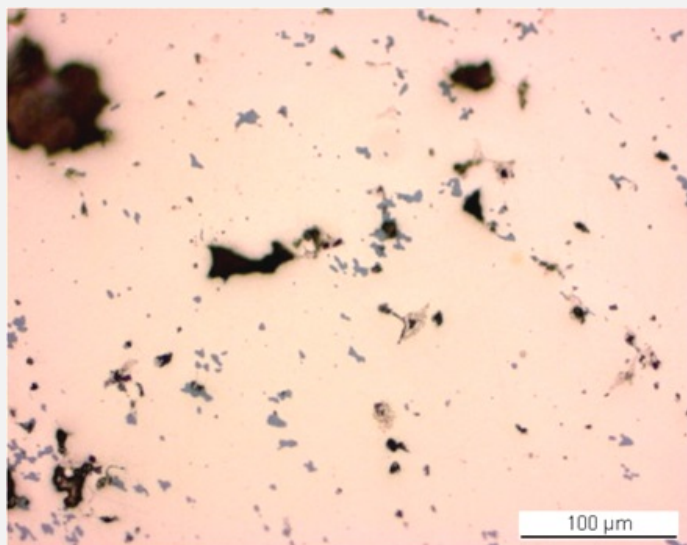
The remaining metal is a leaded bronze (Table 1) containing numerous copper sulphide and tiny Pb inclusions (Figs. 5-7, 10 and Table 2). The porosity within the metal is high, particularly along a band through the middle of the sample (Figs. 3 and 5). The etched structure of the leaded bronze shows small, regular polygonal grains, some with twinning (Fig. 6). Strain lines appear in grains close to the metal surface (Fig. 7). The average hardness of the metal is HV1 120.

Fig. 5: Micrograph of the metal sample from Fig. 3 (detail), unetched, bright field. In pink the metal, in black the porosity and in dark-grey copper sulphide inclusions,

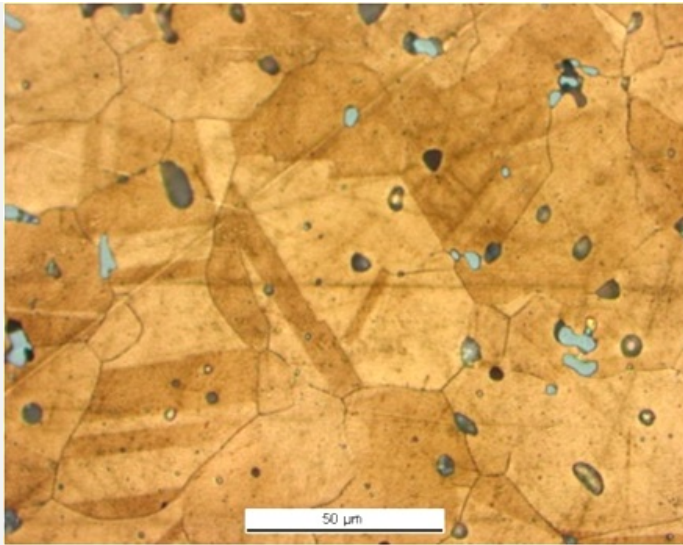
Fig. 6: Micrograph of the metal sample from Fig. 3 (detail), etched, bright field. Angular and twinned grains are revealed as well as copper sulphide inclusions in grey,

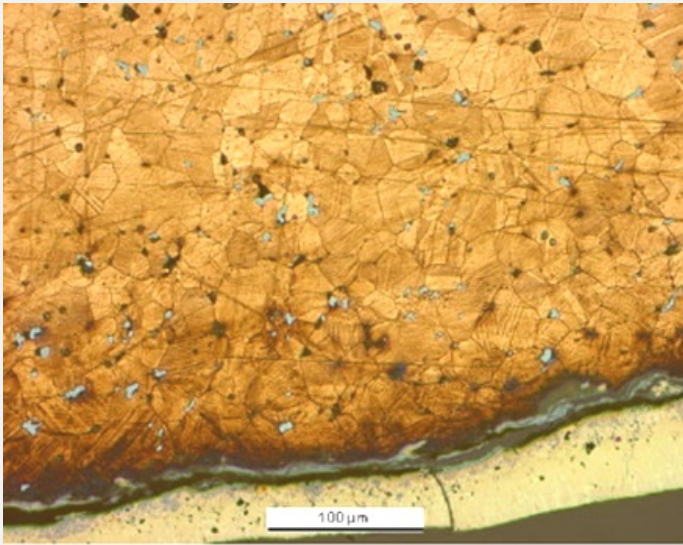
Fig. 7: Micrograph of the metal sample from Fig. 3, etched, bright field (rotated by 270°, detail). Angular grains with strain lines can be seen as well as copper sulphide inclusions in grey,

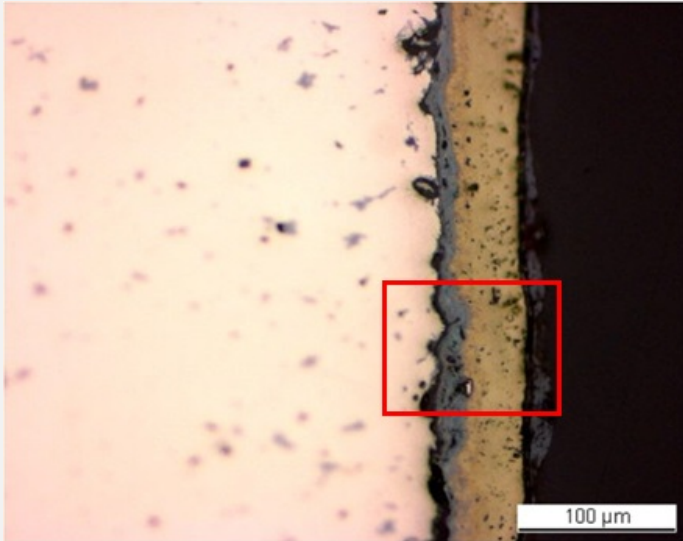
The metal has lost most of its original corrosion crust, the remainder having an average thickness between 60 and 190µm (Fig. 3). In some areas up to three corrosion layers are visible (Fig. 8). In polarised light (Fig. 9), the corrosion stratigraphy appears more clearly: it is composed of a dense black inner layer, an intermediate thick brown layer with bright spots (indicating porosity) and an outer red layer with white particles. The elemental chemical distribution of the SEM image reveals that the black inner layer (CP3) is Sn-rich, but contains Cu, O, Fe, Si, P, Pb, Ni, As, Ca and S (Table 3, Fig. 10). The brown layer (CP2) contains S, Fe and Cu and has a composition similar to chalcopyrite/CuFeS₂ (Table 3, Fig. 10). This was confirmed by past XRD analyses carried out by Schweizer (1994, museum report (1987)). The red layer (CP1) is an iron oxide (main elements Fe and O) and is contaminated with calcite/CaCO₃ particles (Table 3, Fig. 10).

Fig. 8: Micrograph of the metal sample from Fig. 3 (reversed picture, detail), unetched, bright field. From left to right: metal (in pink), inner light-grey layer, intermediate brown layer and top dark-grey layer. The mapped area of Fig. 10 is marked by a square,

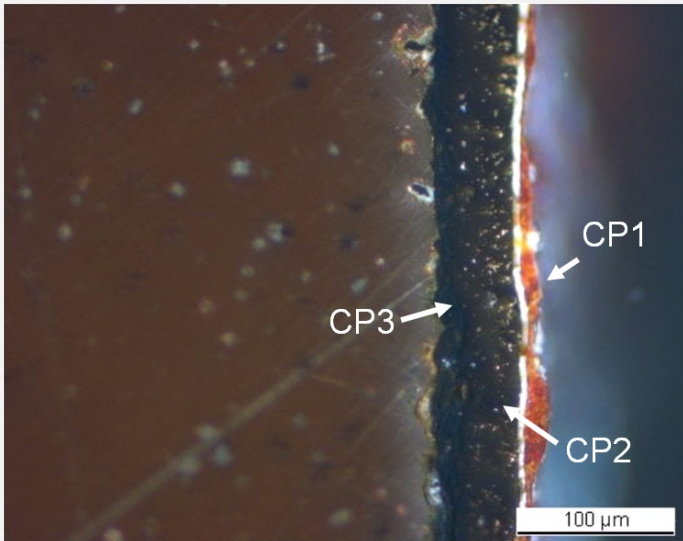
Fig. 9: Micrograph of the same area as Fig. 8 and corresponding to the stratigraphy of Fig. 4, polarized light. From left to right: metal (in brown) covered with a corrosion crust consisting of a black layer, an intermediate brown layer with bright spots, a crack (white line) and a red layer with white particles,

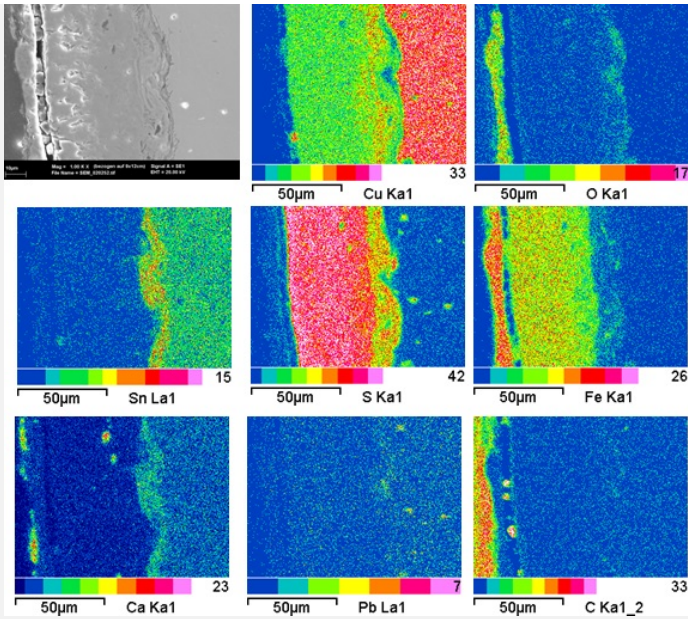
Fig. 10: SEM image, SE-mode, and elemental chemical distribution of the selected area of Fig. 7 (reversed picture). Method of examination: SEM/EDS, Laboratory of Analytical Chemistry, Empa,

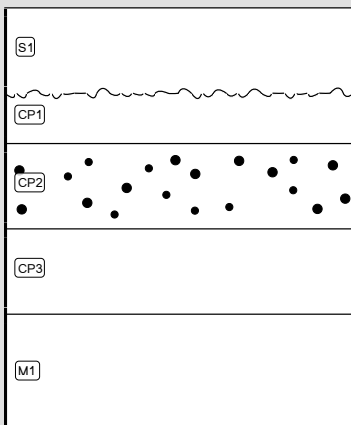
Fig. 4: Stratigraphic representation of the object in cross-section using the MiCorr application. The characteristics of the strata are only accessible by clicking on the drawing that redirects you to the search tool by stratigraphy representation. This representation can be compared to Fig. 9, Credit HE-Arc CR.
