SITULA EMT09-554.665 – TIN BRONZE – IRON AGE – SWITZERLAND

Artefact name	Situla EMT09-554.665
Authors	Christian. Degriigny (HE-Arc CR, Neuchâtel, Neuchâtel, Switzerland) & Marie-Jeanne. Scholl (HE-Arc CR, Neuchâtel, Neuchâtel, Switzerland) & Valentin. Boissonnas (HE-Arc CR, Neuchâtel, Neuchâtel, Switzerland)
Url	/artefacts/458/

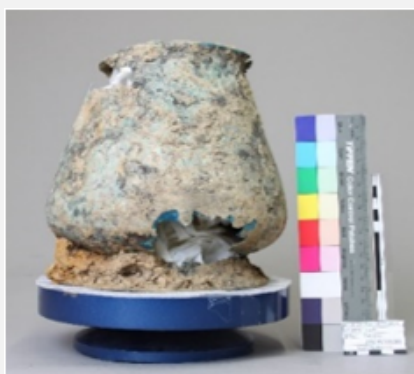
Fig. 1: Tin bronze Celtic situla (Archeodunum (Gollion), 2009) inverted as found in situ,

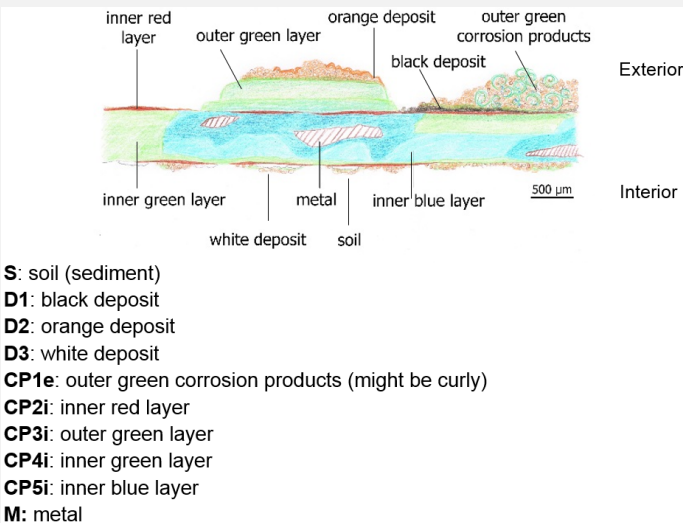
S: soil (sediment)
D1: black deposit
D2: orange deposit
D3: white deposit
CP1e: outer green corrosion products (might be curly)
CP2i: inner red layer
CP3i: outer green layer
CP4i: inner green layer
CP5i: inner blue layer
M: metal

Fig. 3: Stratigraphic representation of the situla in cross-section by macroscopic observation,

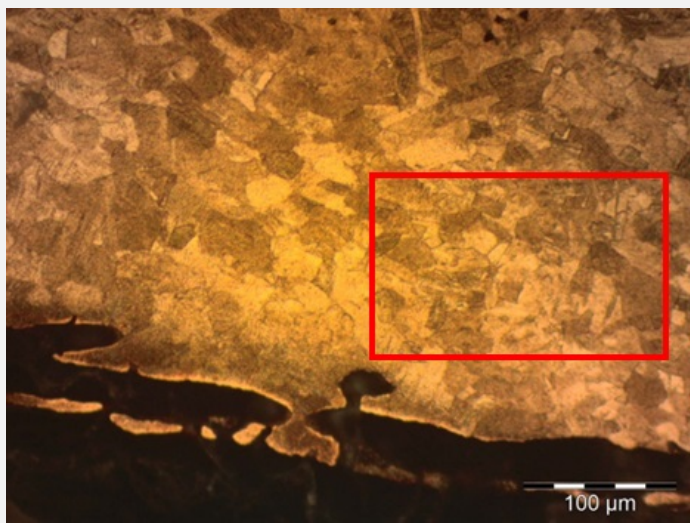
The remaining metal is a dense tin bronze (Fig. 7, Table 1), showing no inclusion. In bright field, the etched alloy shows a structure principally consisting of polygonal alpha phase grains (Fig. 8). Some of the grains include twin lines (Fig. 9). The presence of strain lines (slip lines) indicates a final cold work without annealing (Fig. 9).

Fig. 9: Micrograph of the selected area of Fig. 8, etched, bright field, 500x. The grains show both twin and strain lines,

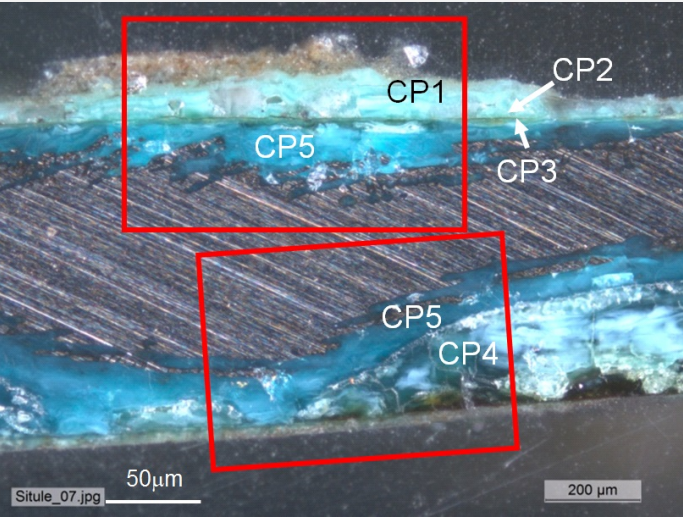
The corrosion crust is heterogeneous and has in places completely replaced the metal. The metal – corrosion products interface is irregular due to transgranular corrosion (Figs 7-8). In most cases, the corrosion crust can be divided in three main layers: an inner compact blue layer directly on the metal core (CP5, Figs. 6, 10 and 11 and CP3, Fig. 5). In areas of extensive corrosion this blue layer coexists with a friable green layer (CP4, Figs. 6, 10 and 11 and CP2, Fig. 5). Depending on the area either a very fine dark green (CP3, Fig. 6 and Fig. 10) or red corrosion layer (CP2, Fig. 6 and Fig. 10) marks the limit of the original surface. It is followed by an external fourth layer, consisting of friable and sometimes curly pale green corrosion products intermingled with soil products (CP1, Fig. 6 and Fig. 10 and 13). In heavily worked and fragile parts of the object a cleavage between the inner layers of blue and green corrosion is present, rendering the green corrosion vulnerable to loss (Fig. 11).

Fig. 10: Micrograph of the metal sample from Fig. 4, unetched, dark field, 50x. Areas of Fig. 11 (bottom, corresponding to the stratigraphy of Fig. 5) and Figs. 12 and 13 (top, corresponding to the stratigraphy of Fig. 6) are marked by a rectangle. Codes are those of Fig. 6,

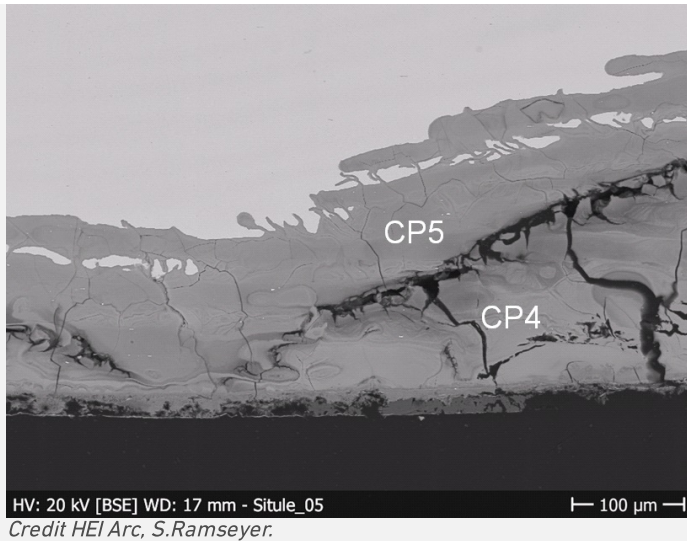
Fig. 11: SEM image, BSE-mode of the metal sample from Fig. 10 (detail) showing cleavage between the inner blue (CP5) and green (CP4) layers of Fig. 6,

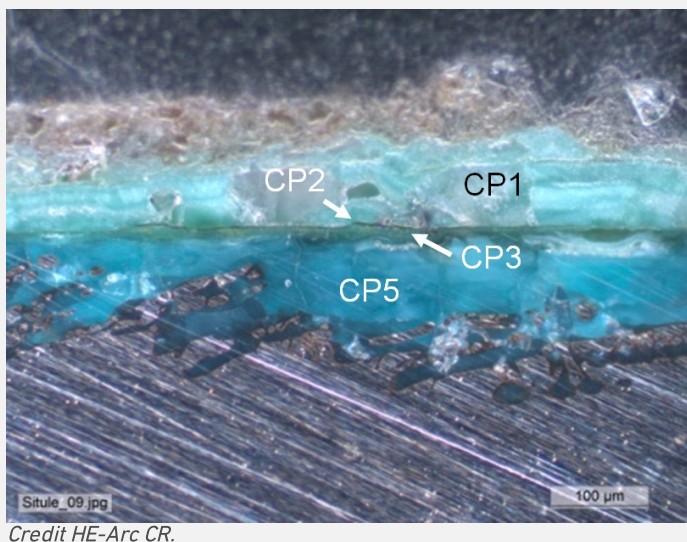
Fig. 13: Micrograph of the metal/corrosion interface (detail of Fig. 10) unetched, dark field, 100x. The outer layer (CP1 of Fig. 6) incorporates soil material and the thin dark layer (CP2 of Fig. 6) highlights the limit of the original surface,

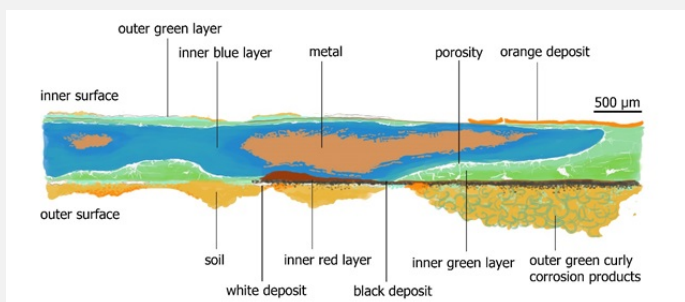
Based on the analyses carried out, the schematic representation of the stratigraphy of corrosion layers (Fig. 3) was corrected (additional e and i within the coding correspond to strata in contact with the environment (e) and internal strata (i)).

Fig. 16: Improved stratigraphic representation of the situla from visual observations and analyses,
