SITULA EMT09-554.665 – TIN BRONZE – IRON AGE – SWITZERLAND

Artefact name Situla EMT09-554.665

Authors Christian. Degrigny (HE-Arc CR, Neuchâtel, Neuchâtel, Switzerland) & Marie-Jeanne. Scholl (HE-Arc CR, Neuchâtel, Neuchâtel, Switzerland) & Valentin. Boissonnas (HE-Arc CR, Neuchâtel, Neuchâtel, Switzerland)

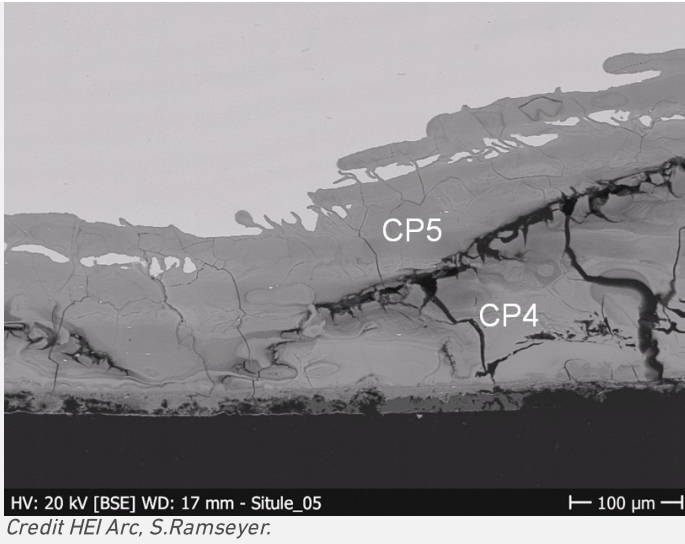
The corrosion crust is heterogeneous and has in places completely replaced the metal. The metal – corrosion products interface is irregular due to transgranular corrosion (Figs 7-8). In most cases, the corrosion crust can be divided in three main layers: an inner compact blue layer directly on the metal core (CP5, Figs. 6, 10 and 11 and CP3, Fig. 5). In areas of extensive corrosion this blue layer coexists with a friable green layer (CP4, Figs. 6, 10 and 11 and CP2, Fig. 5). Depending on the area either a very fine dark green (CP3, Fig. 6 and Fig. 10) or red corrosion layer (CP2, Fig. 6 and Fig. 10) marks the limit of the original surface. It is followed by an external fourth layer, consisting of friable and sometimes curly pale green corrosion products intermingled with soil products (CP1, Fig. 6 and Fig. 10 and 13). In heavily worked and fragile parts of the object a cleavage between the inner layers of blue and green corrosion is present, rendering the green corrosion vulnerable to loss (Fig. 11).

Fig. 11: SEM image, BSE-mode of the metal sample from Fig. 10 (detail) showing cleavage between the inner blue (CP5) and green (CP4) layers of Fig. 6,

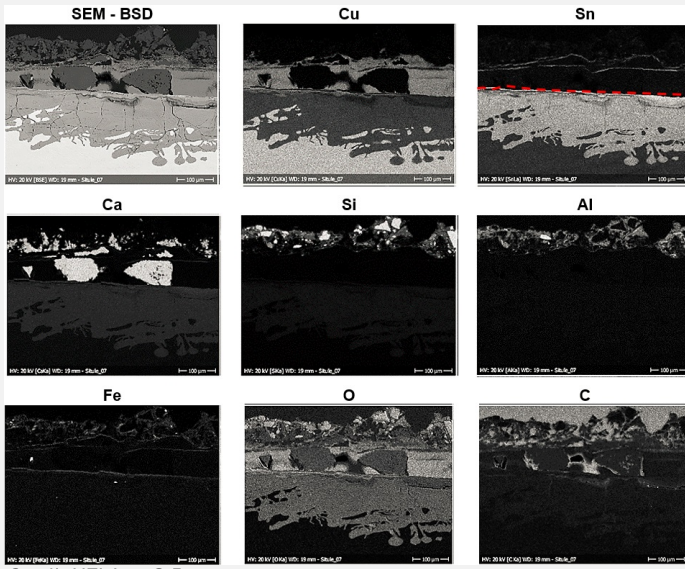
The inner layers (CP3-CP5) are Sn and O-rich and depleted in Cu (Table 2). The outer layers (CP1 and CP2) are Cu and O-rich, contain no Sn, and are contaminated with Ca, Si, Al and Fe coming from the soil (Fig. 12). The colour of the corrosion crust varies according to the content of Sn (the more Sn, the darker green or blue the corrosion). FTIR on the inner blue (CP5 and Fig. 14) and outer green (CP1 and Fig. 15) layers were difficult to interpret. Only malachite could be identified in both cases. XRD spectra could not be interpreted because of the deficiency of peaks.

Fig. 12: SEM image, SE-mode, and elemental chemical distribution of the selected area of Fig. 10. In red: the limit of the original surface highlighted by the enriched tin layer. Method of examination: SEM-EDS, Lab of Electronic Microscopy and Microanalysis, IMA (Néode), HEI Arc,

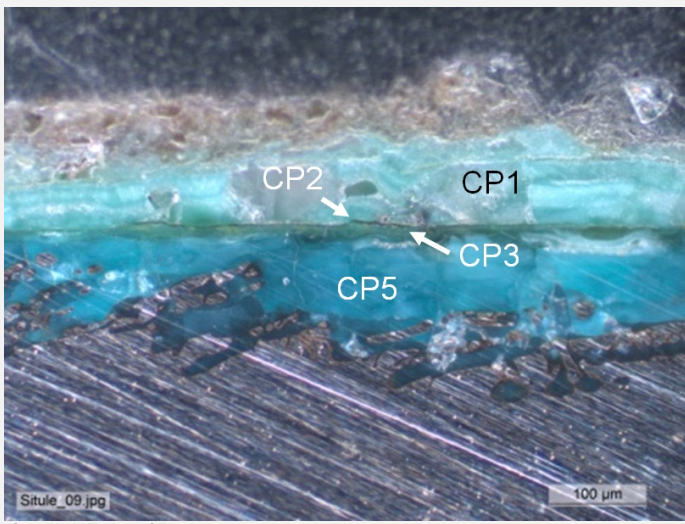
The limit of the original surface is well defined (interface of CP1 and CP2) but due to the fragility of the inner corrosion layers it was difficult to uncover.

Fig. 13: Micrograph of the metal/corrosion interface (detail of Fig. 10) unetched, dark field, 100x. The outer layer (CP1 of Fig. 6) incorporates soil material and the thin dark layer (CP2 of Fig. 6) highlights the limit of the original surface,

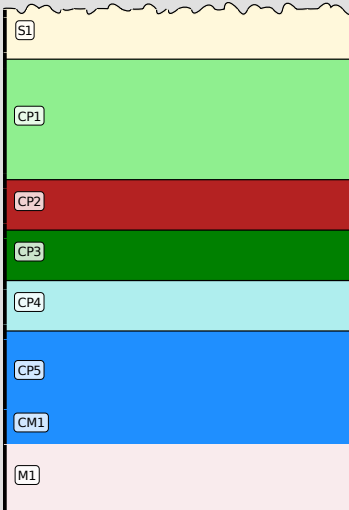
Fig. 6: Stratigraphic representation of the object in cross-section using the MiCorr application. The characteristics of the strata are only accessible by clicking on the drawing that redirects you to the search tool by stratigraphy representation. This representation shows the interior face and can be compared to Fig. 10 (top square), Credit HE-Arc CR, M-J.Scholl.

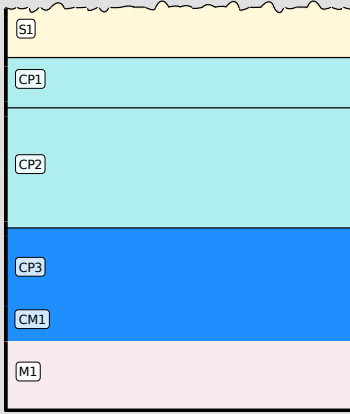
Fig. 5: Stratigraphic representation of the object in cross-section using the MiCorr application. The characteristics of the strata are only accessible by clicking on the drawing that redirects you to the search tool by stratigraphy representation. This representation shows the exterior face and can be compared to Fig. 10 (bottom square), Credit HE-Arc CR, M-J.Scholl.
