# SITULA EMT09-554.665 – TIN BRONZE – IRON AGE – SWITZERLAND

Artefact name	Situla EMT09-554.665
Authors	Christian. Degriigny (HE-Arc CR, Neuchâtel, Neuchâtel, Switzerland) & Marie-Jeanne. Scholl (HE-Arc CR, Neuchâtel, Neuchâtel, Switzerland) & Valentin. Boissonnas (HE-Arc CR, Neuchâtel, Neuchâtel, Switzerland)
Url	/artefacts/458/

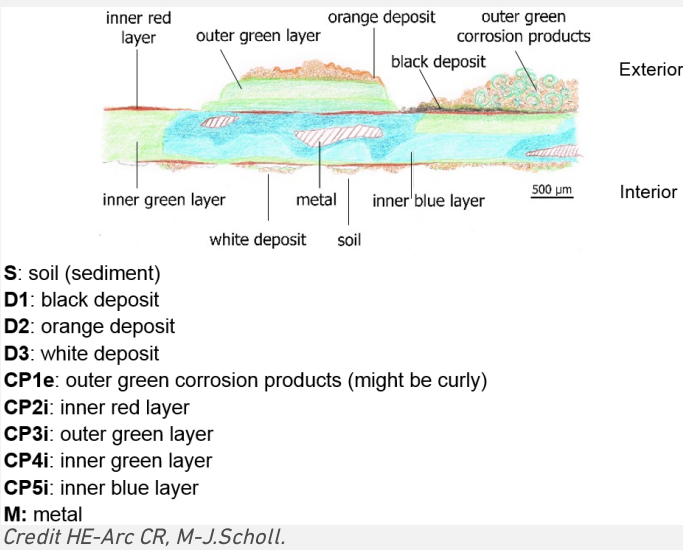
The schematic representation below gives an overview of the corrosion layers encountered on the situla from a first visual macroscopic observation (additional e and i within the coding correspond to strata in contact with the environment (e) and internal strata (i)).

Fig. 3: Stratigraphic representation of the situla in cross-section by macroscopic observation,

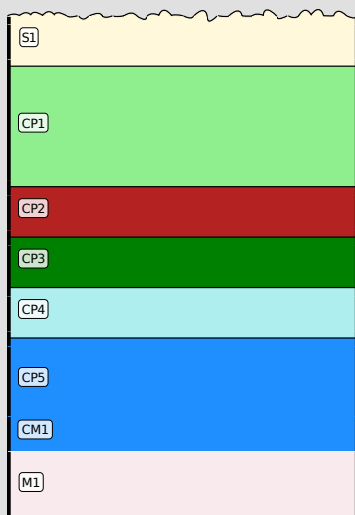
There are 2 stratigraphies (Fig. 5 corresponding to the interior face of the situla and Fig. 6 to its exterior face). The strata are similar in composition but their coding is different: CP1 to CP3 in Fig. 5 correspond to CP3 to CP5 in Fig. 6. Since the stratigraphy of Fig. 6 is more complete, the composition of each of its strata is given below.

Fig. 6: Stratigraphic representation of the object in cross-section using the MiCorr application. The characteristics of the strata are only accessible by clicking on the drawing that redirects you to the search tool by stratigraphy representation. This representation shows the interior face and can be compared to Fig. 10 (top square), Credit HE-Arc CR, M-J.Scholl.

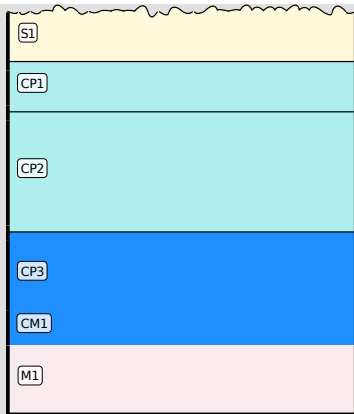
Fig. 5: Stratigraphic representation of the object in cross-section using the MiCorr application. The characteristics of the strata are only accessible by clicking on the drawing that redirects you to the search tool by stratigraphy representation. This representation shows the exterior face and can be compared to Fig. 10 (bottom square), Credit HE-Arc CR, M-J.Scholl.
