## SITULA EMT09-554.665 – TIN BRONZE – IRON AGE – SWITZERLAND

<b>Artefact name</b>	Situla EMT09-554.665
<b>Authors</b>	Christian. Degriigny (HE-Arc CR, Neuchâtel, Neuchâtel, Switzerland) & Marie-Jeanne. Scholl (HE-Arc CR, Neuchâtel, Neuchâtel, Switzerland) & Valentin. Boissonnas (HE-Arc CR, Neuchâtel, Neuchâtel, Switzerland)
<b>Url</b>	/artefacts/458/

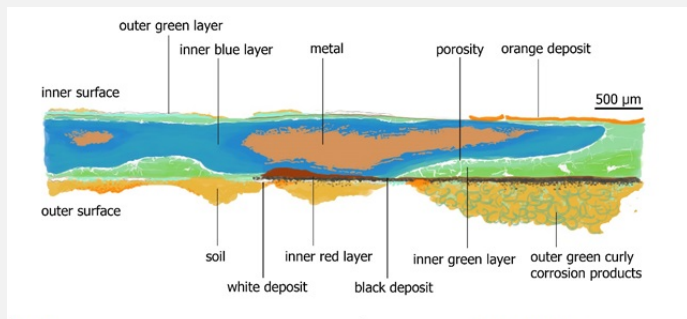
Fig. 16: Improved stratigraphic representation of the situla from visual observations and analyses,

Strata	Composition
Soil (S)	Ca, Si, Al, Fe
Black deposit (D1)	C
Orange deposit (D2)	Ferrous oxides
White deposit (D3)	Ca
Outer green curly corrosion product (CP1e)	Copper carbonates (curly malachite)
Inner red (CP2i)	Copper oxide (cuprite ?)
Outer green layer (CP3i)	Copper carbonates (malachite)
Inner green layer (CP4i)	Copper carbonates (?) + Sn
Inner blue layer (CP5i)	Copper carbonates (?) + Sn
Remnant metal phase (M)	Bronze (90%Cu, 10% Sn)
