## SITULA EMT09-554.665 – TIN BRONZE – IRON AGE – SWITZERLAND

<b>Artefact name</b>	Situla EMT09-554.665
<b>Authors</b>	Christian. Degriigny (HE-Arc CR, Neuchâtel, Neuchâtel, Switzerland) & Marie-Jeanne. Scholl (HE-Arc CR, Neuchâtel, Neuchâtel, Switzerland) & Valentin. Boissonnas (HE-Arc CR, Neuchâtel, Neuchâtel, Switzerland)
<b>Url</b>	/artefacts/458/

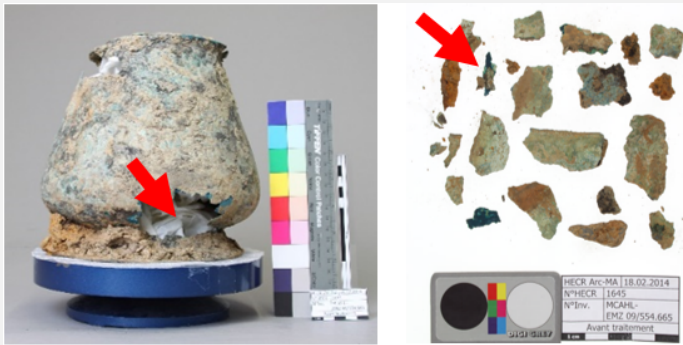
Fig. 2: Location of sampling area and sample selected from detached fragments,

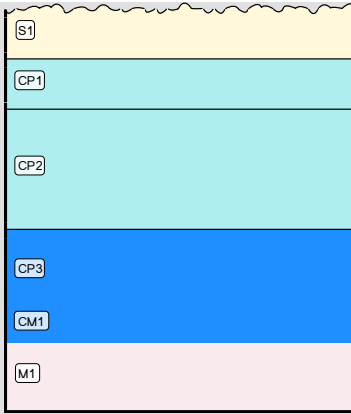
There are 2 stratigraphies (Fig. 5 corresponding to the interior face of the situla and Fig. 6 to its exterior face). The strata are similar in composition but their coding is different: CP1 to CP3 in Fig. 5 correspond to CP3 to CP5 in Fig. 6. Since the stratigraphy of Fig. 6 is more complete, the composition of each of its strata is given below.

Fig. 5: Stratigraphic representation of the object in cross-section using the MiCorr application. The characteristics of the strata are only accessible by clicking on the drawing that redirects you to the search tool by stratigraphy representation. This representation shows the exterior face and can be compared to Fig. 10 (bottom square), Credit HE-Arc CR, M-J.Scholl.
