SITULA EMT09/554.665 – TIN BRONZE – IRON AGE – SWITZERLAND

Artefact name	Situla EMT09/554.665
Authors	Christian. Degriigny (HE-Arc CR, Neuchâtel, Neuchâtel, Switzerland) & Marie-Jeanne. Scholl (HE-Arc CR, Neuchâtel, Neuchâtel, Switzerland) & Valentin. Boissonnas (HE-Arc CR, Neuchâtel, Neuchâtel, Switzerland)
Url	/artefacts/458/

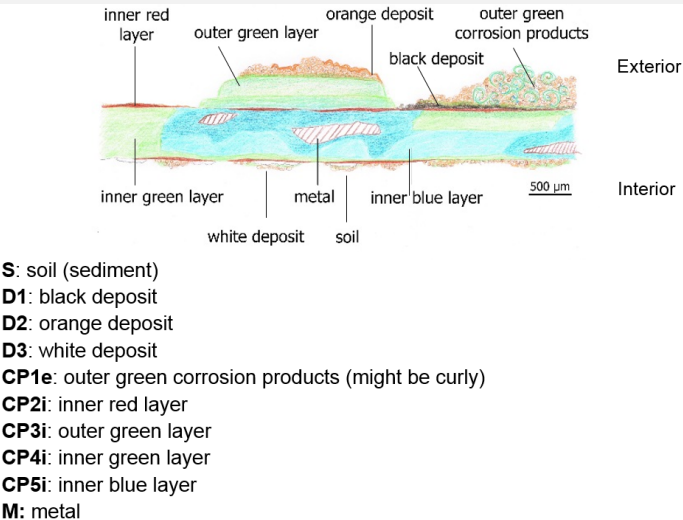
Fig. 3: Stratigraphic representation of the situla in cross-section by macroscopic observation,

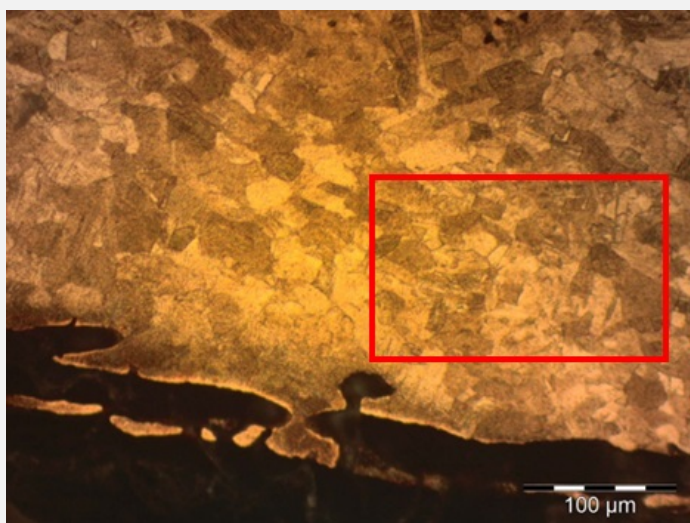
The remaining metal is a dense tin bronze (Fig. 7, Table 1), showing no inclusion. In bright field, the etched alloy shows a structure principally consisting of polygonal alpha phase grains (Fig. 8). Some of the grains include twin lines (Fig. 9). The presence of strain lines (slip lines) indicates a final cold work without annealing (Fig. 9).

Fig. 9: Micrograph of the selected area of Fig. 8, etched, bright field, 500x. The grains show both twin and strain lines,

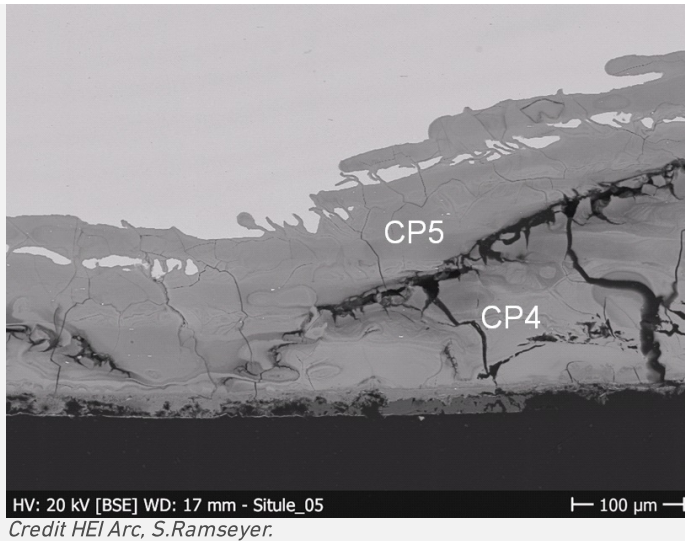
Fig. 11: SEM image, BSE-mode of the metal sample from Fig. 10 (detail) showing cleavage between the inner blue (CP5) and green (CP4) layers of Fig. 6,

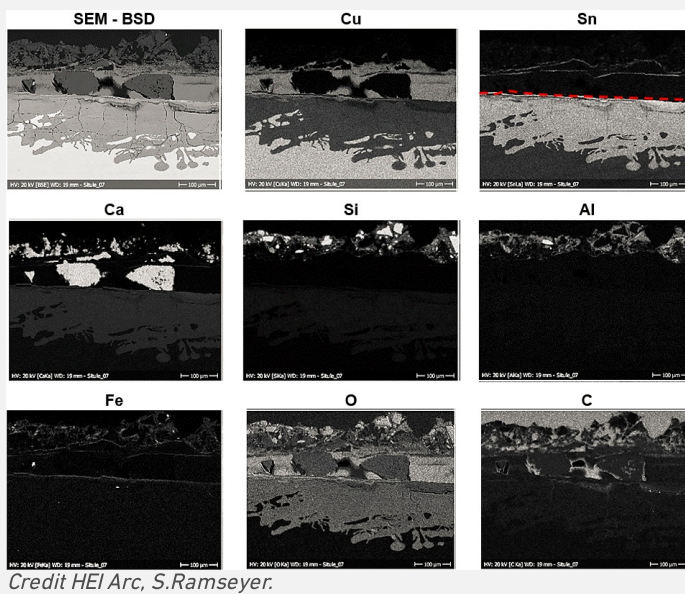
The inner layers (CP3-CP5) are Sn and O-rich and depleted in Cu (Table 2). The outer layers (CP1 and CP2) are Cu and O-rich, contain no Sn, and are contaminated with Ca, Si, Al and Fe coming from the soil (Fig. 12). The colour of the corrosion crust varies according to the content of Sn (the more Sn, the darker green or blue the corrosion). FTIR on the inner blue (CP5 and Fig. 14) and outer green (CP1 and Fig. 15) layers were difficult to interpret. Only malachite could be identified in both cases. XRD spectra could not be interpreted because of the deficiency of peaks.

Fig. 12: SEM image, SE-mode, and elemental chemical distribution of the selected area of Fig. 10. In red: the limit of the original surface highlighted by the enriched tin layer. Method of examination: SEM-EDS, Lab of Electronic Microscopy and Microanalysis, IMA (Néode), HEI Arc,

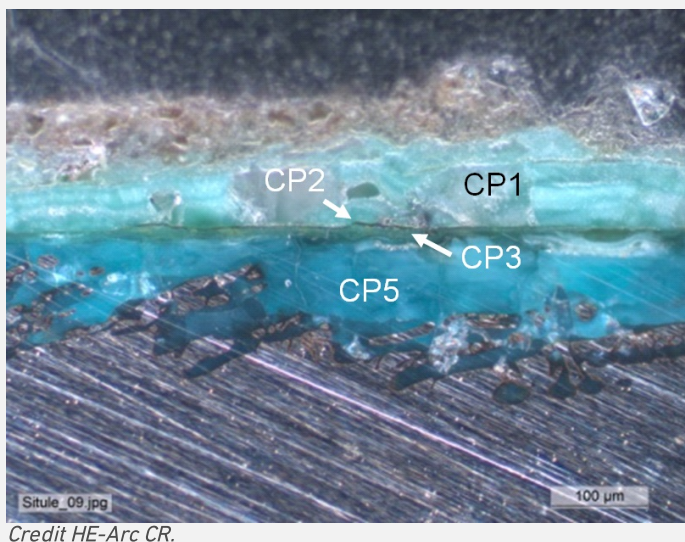
The limit of the original surface is well defined (interface of CP1 and CP2) but due to the fragility of the inner corrosion layers it was difficult to uncover.

Fig. 13: Micrograph of the metal/corrosion interface (detail of Fig. 10) unetched, dark field, 100x. The outer layer (CP1 of Fig. 6) incorporates soil material and the thin dark layer (CP2 of Fig. 6) highlights the limit of the original surface,

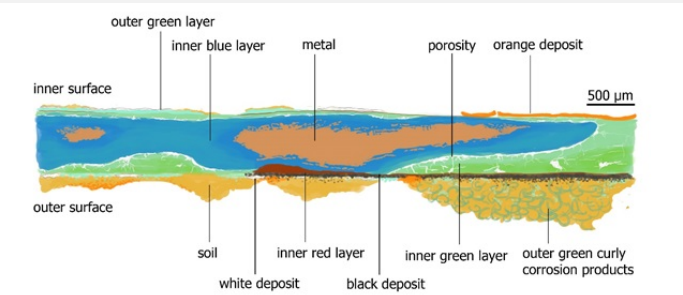
Fig. 16: Improved stratigraphic representation of the situla from visual observations and analyses,

The metal structure of this low-tin bronze shows extensive cold work and multiple annealing cycles with a final cold work. The total absence of inclusions highlights a highly developed knowledge in bronze metallurgy. The metal is much corroded. Transgranular corrosion is visible. The majority of the internal corrosion products are composed of copper carbonates that have replaced much of the metal. Curly malachite has developed in clusters on the outside of the surface. This pattern is characteristic of a long-term burial period. The presence of inner enriched Sn layers shows a decuprification phenomenon (dissolution of Cu). Because of the friable nature of the inner green layer that supports the limit of the original surface, as well as its cleavage with the blue layer underneath, the original surface has become very fragile. The corrosion is thought to be of type 1 according to Robbiola et al. 1998.
