SITULA EMT09-554.665 – TIN BRONZE – IRON AGE – SWITZERLAND

Artefact name	Situla EMT09-554.665
Authors	Christian. Degriigny (HE-Arc CR, Neuchâtel, Neuchâtel, Switzerland) & Marie-Jeanne. Scholl (HE-Arc CR, Neuchâtel, Neuchâtel, Switzerland) & Valentin. Boissonnas (HE-Arc CR, Neuchâtel, Neuchâtel, Switzerland)
Url	/artefacts/458/

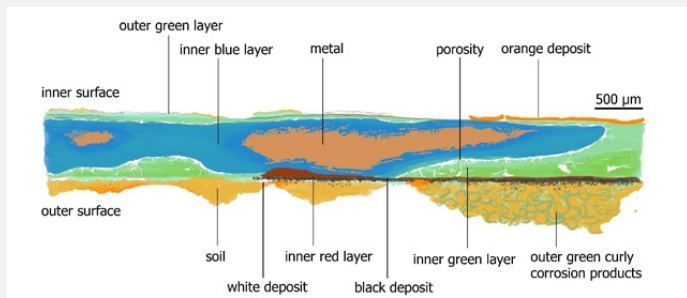
Fig. 16: Improved stratigraphic representation of the situla from visual observations and analyses,

Strata	Composition
Soil (S)	Ca, Si, Al, Fe
Black deposit (D1)	C
Orange deposit (D2)	Ferrous oxides
White deposit (D3)	Ca
Outer green curly corrosion product (CP1e)	Copper carbonates (curly malachite)
Inner red (CP2i)	Copper oxide (cuprite ?)
Outer green layer (CP3i)	Copper carbonates (malachite)
Inner green layer (CP4i)	Copper carbonates (?) + Sn
Inner blue layer (CP5i)	Copper carbonates (?) + Sn
Remnant metal phase (M)	Bronze (90%Cu, 10% Sn)
