# SITULA EMT09-554.665 – TIN BRONZE – IRON AGE – SWITZERLAND

Artefact name	Situla EMT09-554.665
Authors	Christian. Degriigny (HE-Arc CR, Neuchâtel, Neuchâtel, Switzerland) & Marie-Jeanne. Scholl (HE-Arc CR, Neuchâtel, Neuchâtel, Switzerland) & Valentin. Boissonnas (HE-Arc CR, Neuchâtel, Neuchâtel, Switzerland)
Url	/artefacts/459/

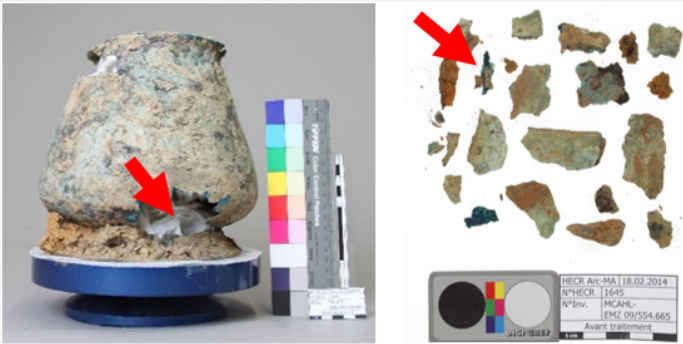
Fig. 2: Location of sampling area and sample selected from detached fragments,

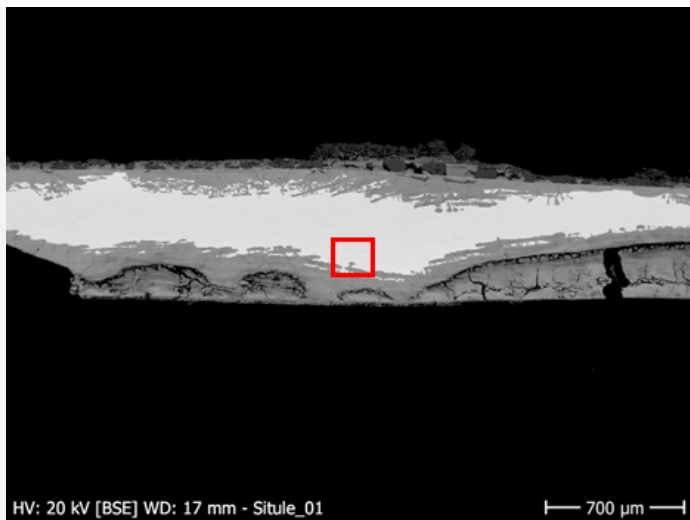
The remaining metal is a dense tin bronze (Fig. 7, Table 1), showing no inclusion. In bright field, the etched alloy shows a structure principally consisting of polygonal alpha phase grains (Fig. 8). Some of the grains include twin lines (Fig. 9). The presence of strain lines (slip lines) indicates a final cold work without annealing (Fig. 9).

Fig. 8: Micrograph of the etched metal structure from Fig. 7 (detail), etched, bright field, 50x. The alpha phase of the alloy shows polygonal grains. Area of Fig. 9 is marked by a rectangle,

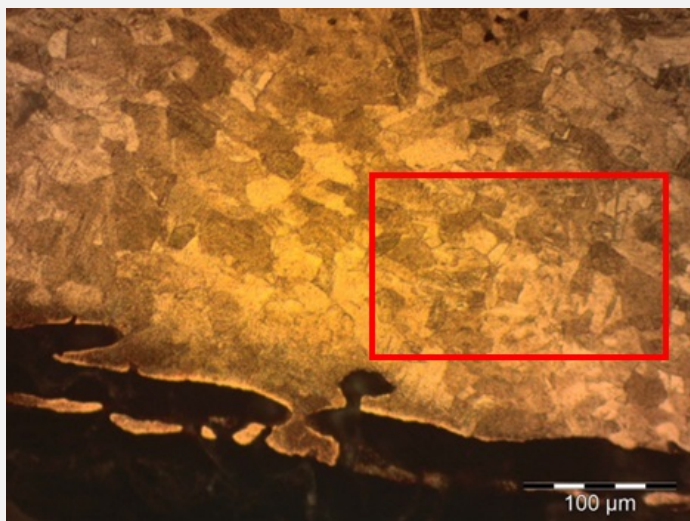
Fig. 9: Micrograph of the selected area of Fig. 8, etched, bright field, 500x. The grains show both twin and strain lines,

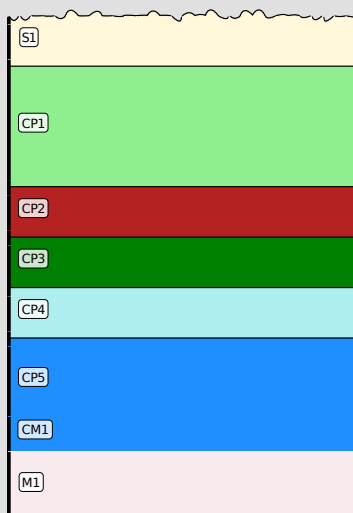
There are 2 stratigraphies (Fig. 5 corresponding to the interior face of the situla and Fig. 6 to its exterior face). The strata are similar in composition but their coding is different: CP1 to CP3 in Fig. 5 correspond to CP3 to CP5 in Fig. 6. Since the stratigraphy of Fig. 6 is more complete, the composition of each of its strata is given below.

Fig. 6: Stratigraphic representation of the object in cross-section using the MiCorr application. The characteristics of the strata are only accessible by clicking on the drawing that redirects you to the search tool by stratigraphy representation. This representation shows the interior face and can be compared to Fig. 10 (top square), Credit HE-Arc CR, M-J.Scholl.

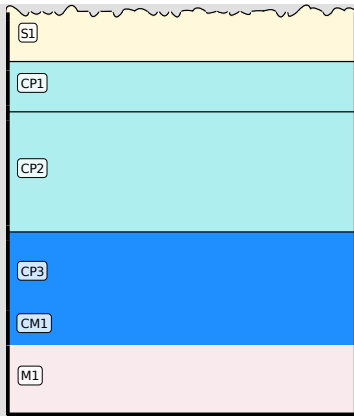
Fig. 5: Stratigraphic representation of the object in cross-section using the MiCorr application. The characteristics of the strata are only accessible by clicking on the drawing that redirects you to the search tool by stratigraphy representation. This representation shows the exterior face and can be compared to Fig. 10 (bottom square), Credit HE-Arc CR, M-J.Scholl.

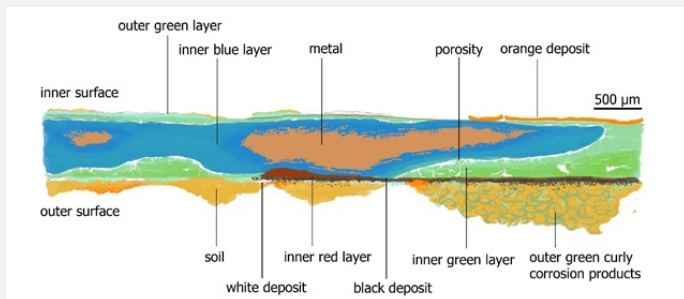
Based on the analyses carried out, the schematic representation of the stratigraphy of corrosion layers (Fig. 3) was corrected (additional e and i within the coding correspond to strata in contact with the environment (e) and internal strata (i)).

Fig. 16: Improved stratigraphic representation of the situla from visual observations and analyses,
