SITULA EMT09-554.665 – TIN BRONZE – IRON AGE – SWITZERLAND

Artefact name	Situla EMT09-554.665
Authors	Christian. Degriigny (HE-Arc CR, Neuchâtel, Neuchâtel, Switzerland) & Marie-Jeanne. Scholl (HE-Arc CR, Neuchâtel, Neuchâtel, Switzerland) & Valentin. Boissonnas (HE-Arc CR, Neuchâtel, Neuchâtel, Switzerland)
Url	/artefacts/459/

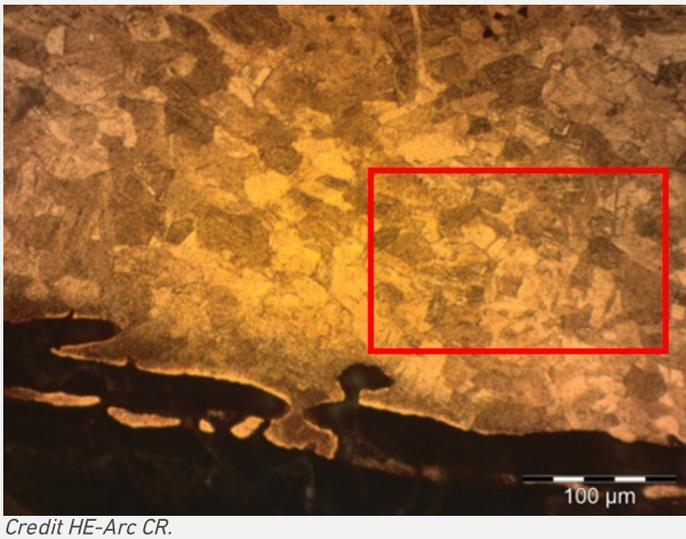
Fig. 8: Micrograph of the etched metal structure from Fig. 7 (detail), etched, bright field, 50x. The alpha phase of the alloy shows polygonal grains. Area of Fig. 9 is marked by a rectangle,

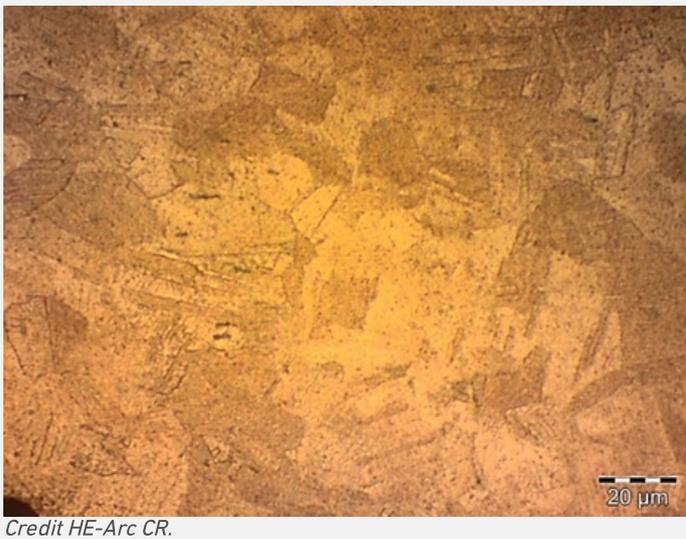
Fig. 9: Micrograph of the selected area of Fig. 8, etched, bright field, 500x. The grains show both twin and strain lines,

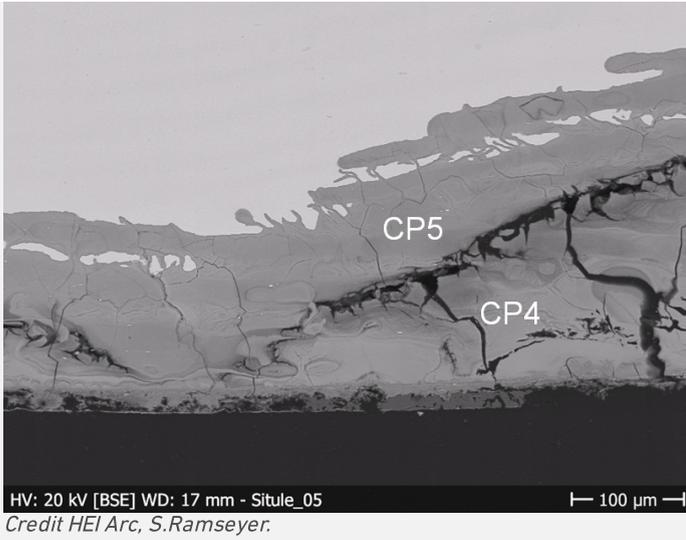
Fig. 11: SEM image, BSE-mode of the metal sample from Fig. 10 (detail) showing cleavage between the inner blue (CP5) and green (CP4) layers of Fig. 6,

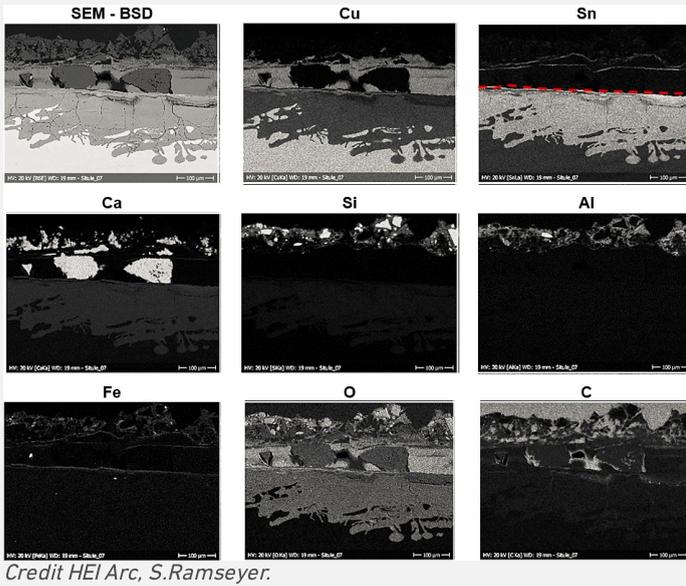
Fig. 12: SEM image, SE-mode, and elemental chemical distribution of the selected area of Fig. 10. In red: the limit of the original surface highlighted by the enriched tin layer. Method of examination: SEM-EDS, Lab of Electronic Microscopy and Microanalysis, IMA (Néode), HEI Arc,

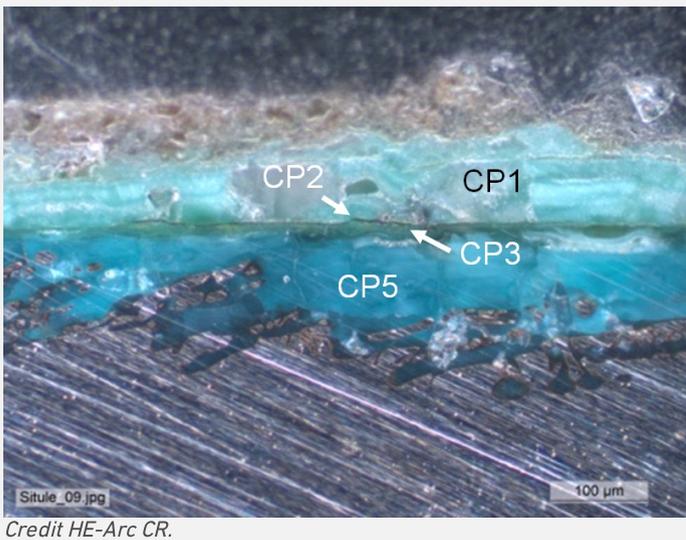
Fig. 13: Micrograph of the metal/corrosion interface (detail of Fig. 10) unetched, dark field, 100x. The outer layer (CP1 of Fig. 6) incorporates soil material and the thin dark layer (CP2 of Fig. 6) highlights the limit of the original surface,

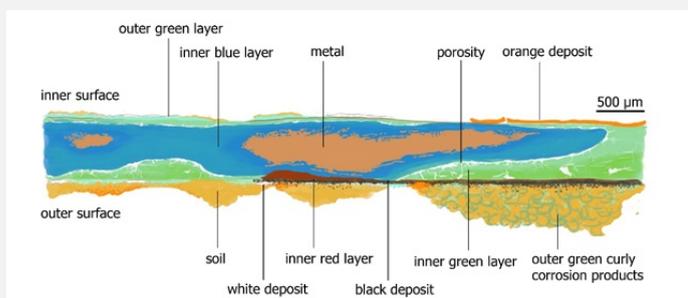
Fig. 16: Improved stratigraphic representation of the situla from visual observations and analyses,

Strata	Composition
Soil (S)	Ca, Si, Al, Fe
Black deposit (D1)	C
Orange deposit (D2)	Ferrous oxides
White deposit (D3)	Ca
Outer green curly corrosion product (CP1e)	Copper carbonates (curly malachite)
Inner red (CP2i)	Copper oxide (cuprite ?)
Outer green layer (CP3i)	Copper carbonates (malachite)
Inner green layer (CP4i)	Copper carbonates (?) + Sn
Inner blue layer (CP5i)	Copper carbonates (?) + Sn
Remnant metal phase (M)	Bronze (90%Cu, 10% Sn)
