SITULA EMT09-554.665 – TIN BRONZE – IRON AGE – SWITZERLAND

Artefact name Situla EMT09-554.665

Authors Christian. Degrigny (HE-Arc CR, Neuchâtel, Neuchâtel, Switzerland) & Marie-Jeanne. Scholl (HE-Arc CR, Neuchâtel, Neuchâtel, Switzerland) & Valentin. Boissonnas (HE-Arc CR, Neuchâtel, Neuchâtel, Switzerland)

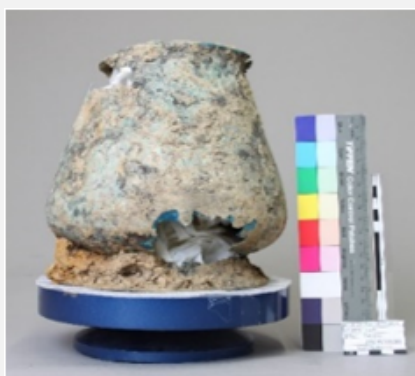
Fig. 1: Tin bronze Celtic situla (Archeodunum (Gollion), 2009) inverted as found in situ,

Description of the artefact	Copper alloy situla (Fig. 1). Attached to two riveted iron loops is an iron handle terminating in two swan heads (not shown here). Dimensions of the main body: Hmax = 340mm, Ømax = 220mm.
Type of artefact	Situla
Origin	Mormont sanctuary, La Sarraz, Vaud, Switzerland
Recovering date	Excavated in 2011
Chronology category	Iron Age
chronology tpq	<input type="text" value="140"/> B.C. ▾
chronology taq	<input type="text" value="30"/> B.C. ▾
Chronology comment	La Tène D
Burial conditions / environment	Soil
Artefact location	Musée cantonal d'archéologie et d'histoire, Lausanne, Vaud
Owner	Musée cantonal d'archéologie et d'histoire, Lausanne, Vaud
Inv. number	EMT09/554.665

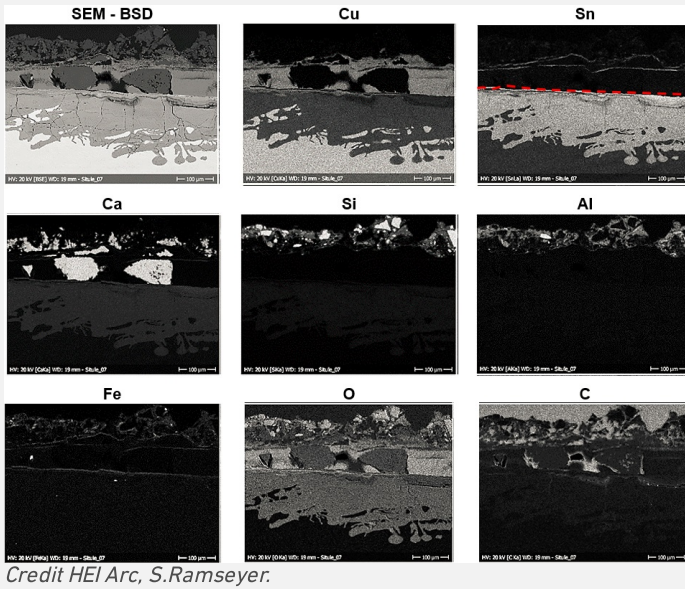
Fig. 12: SEM image, SE-mode, and elemental chemical distribution of the selected area of Fig. 10. In red: the limit of the original surface highlighted by the enriched tin layer. Method of examination: SEM-EDS, Lab of Electronic Microscopy and Microanalysis, IMA (Néode), HEI Arc,

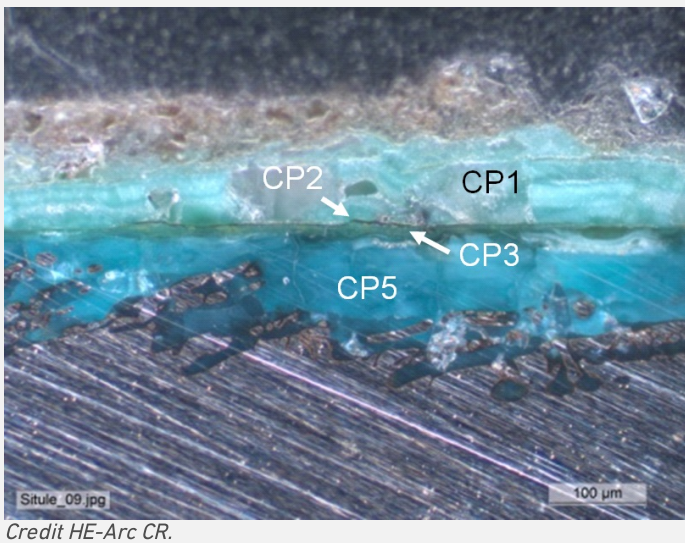
Fig. 13: Micrograph of the metal/corrosion interface (detail of Fig. 10) unetched, dark field, 100x. The outer layer (CP1 of Fig. 6) incorporates soil material and the thin dark layer (CP2 of Fig. 6) highlights the limit of the original surface,

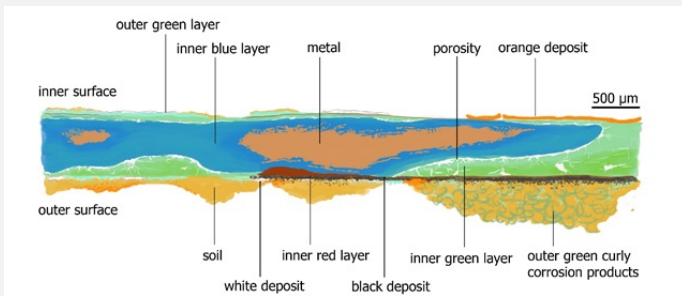
Fig. 16: Improved stratigraphic representation of the situla from visual observations and analyses,

Strata	Composition
Soil (S)	Ca, Si, Al, Fe
Black deposit (D1)	C
Orange deposit (D2)	Ferrous oxides
White deposit (D3)	Ca
Outer green curly corrosion product (CP1e)	Copper carbonates (curly malachite)
Inner red (CP2i)	Copper oxide (cuprite ?)
Outer green layer (CP3i)	Copper carbonates (malachite)
Inner green layer (CP4i)	Copper carbonates (?) + Sn
Inner blue layer (CP5i)	Copper carbonates (?) + Sn
Remnant metal phase (M)	Bronze (90%Cu, 10% Sn)
