SITULA EMT09-554.665 – TIN BRONZE – IRON AGE – SWITZERLAND

Artefact name	Situla EMT09-554.665
Authors	Christian. Degriigny (HE-Arc CR, Neuchâtel, Neuchâtel, Switzerland) & Marie-Jeanne. Scholl (HE-Arc CR, Neuchâtel, Neuchâtel, Switzerland) & Valentin. Boissonnas (HE-Arc CR, Neuchâtel, Neuchâtel, Switzerland)
Url	/artefacts/459/

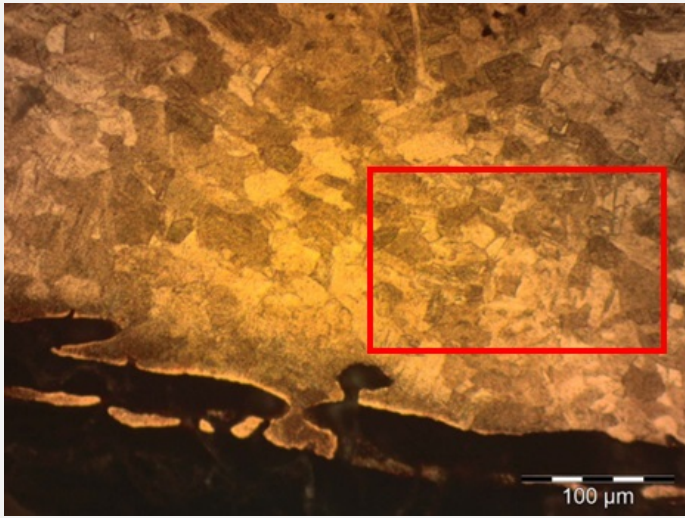
Fig. 8: Micrograph of the etched metal structure from Fig. 7 (detail), etched, bright field, 50x. The alpha phase of the alloy shows polygonal grains. Area of Fig. 9 is marked by a rectangle,

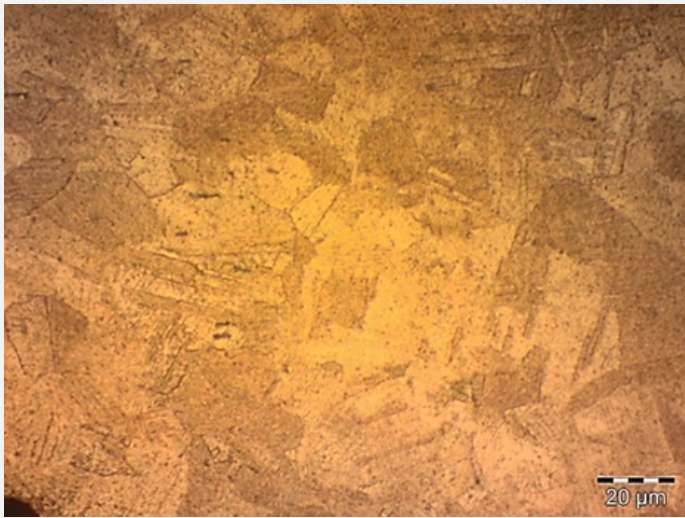
The remaining metal is a dense tin bronze (Fig. 7, Table 1), showing no inclusion. In bright field, the etched alloy shows a structure principally consisting of polygonal alpha phase grains (Fig. 8). Some of the grains include twin lines (Fig. 9). The presence of strain lines (slip lines) indicates a final cold work without annealing (Fig. 9).

Fig. 9: Micrograph of the selected area of Fig. 8, etched, bright field, 500x. The grains show both twin and strain lines,

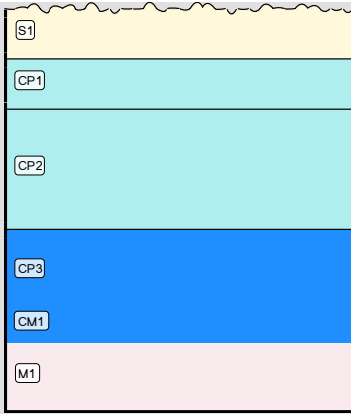
There are 2 stratigraphies (Fig. 5 corresponding to the interior face of the situla and Fig. 6 to its exterior face). The strata are similar in composition but their coding is different: CP1 to CP3 in Fig. 5 correspond to CP3 to CP5 in Fig. 6. Since the stratigraphy of Fig. 6 is more complete, the composition of each of its strata is given below.

Fig. 5: Stratigraphic representation of the object in cross-section using the MiCorr application. The characteristics of the strata are only accessible by clicking on the drawing that redirects you to the search tool by stratigraphy representation. This representation shows the exterior face and can be compared to Fig. 10 (bottom square), Credit HE-Arc CR, M-J.Scholl.
