# ARMATURE FROM A CLOCK MOVEMENT MIH IV-212 – ZN AL SN CU ALLOY – MODERN TIMES

**Artefact name** Armature from a clock movement MIH IV-212

**Authors** Marianne. Senn (EMPA, Dübendorf, Zurich, Switzerland) & Christian. Degrigny (HE-Arc CR, Neuchâtel, Neuchâtel, Switzerland)

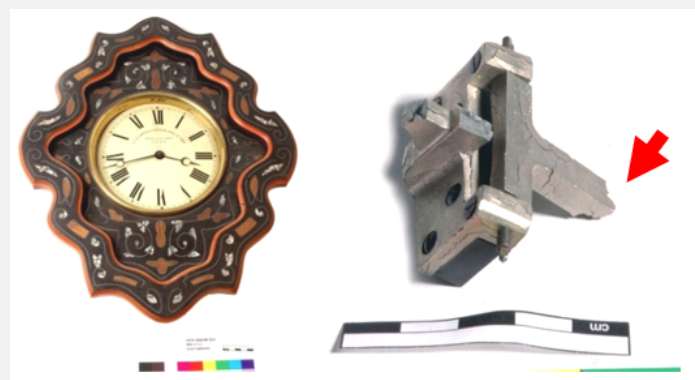
Fig. 1: Wooden wall clock, zinc alloy armature from the clock movement (after Seematter 2009),

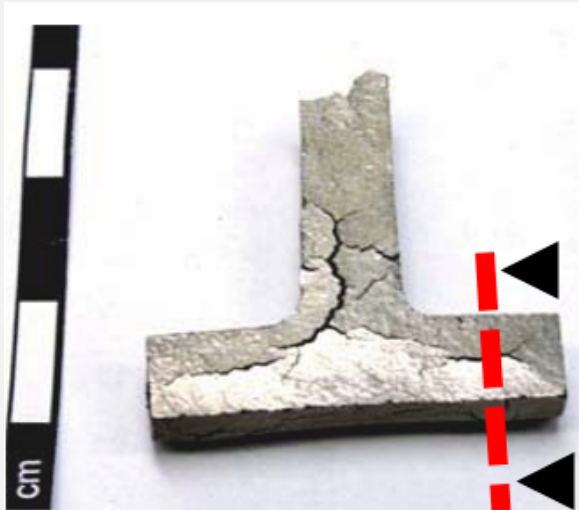
Fig. 2: Location of sampling area.

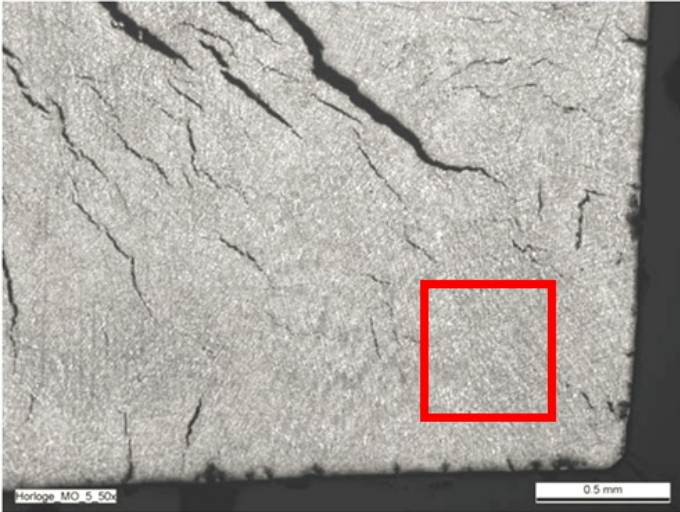
The metal is a Zn-Al-Sn-Cu alloy (Table 1) with an average hardness of HV1 105. A fine dendritic structure is observed (Fig. 5) which consists of clearly separated Zn, Al-Cu and Sn-rich phases (Figs. 6 and 7). Pb is associated with Sn but also forms tiny nodules.

Fig. 5: Micrograph of the metal sample from Fig. 3 (inverted picture, rotated by 270°, detail), unetched, bright field. A dendritic structure is visible. The micrograph of Fig. 6 is marked by a square,
