ARMATURE FROM A CLOCK MOVEMENT MIH IV-212 – ZN AL SN CU ALLOY – MODERN TIMES

Artefact name Armature from a clock movement MIH IV-212

Authors Marianne. Senn (EMPA, Dübendorf, Zurich, Switzerland) & Christian. Degrieny (HE-Arc CR, Neuchâtel, Neuchâtel, Switzerland)

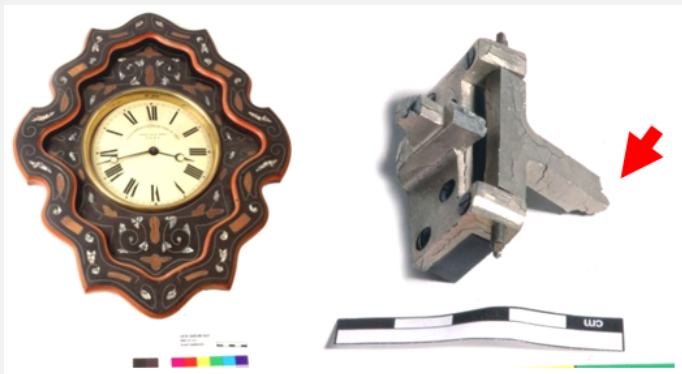
Fig. 1: Wooden wall clock, zinc alloy armature from the clock movement (after Seematter 2009),

Description of the artefact Armature from the clock movement of a wooden wall clock with electric movement (fig. 1).

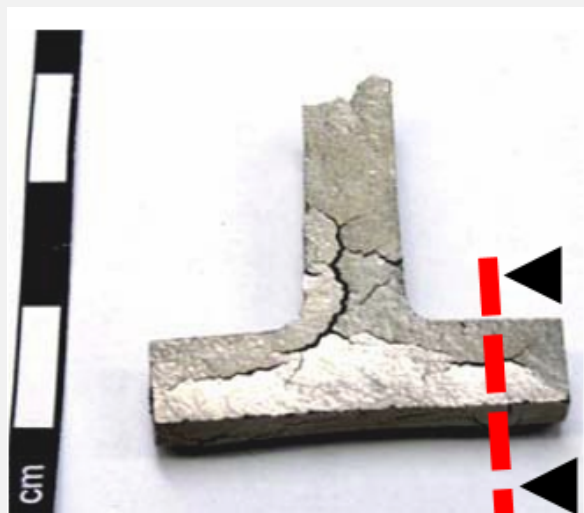
Fig. 2: Location of sampling area,

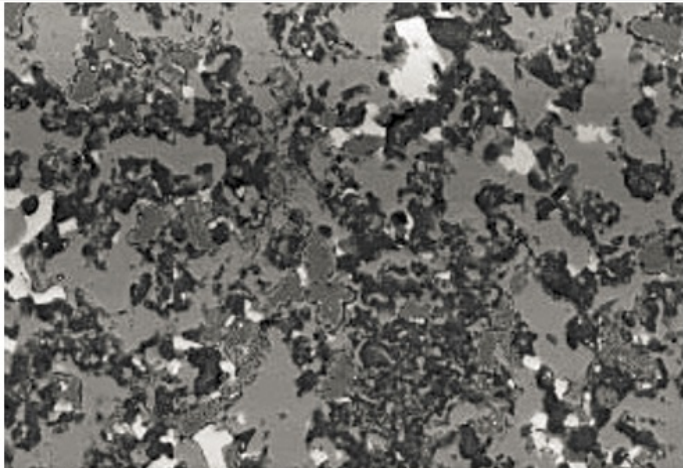
Fig. 6: SEM image, BSE-mode, detail from Fig. 5 (detail), unetched, bright field. Three phases appear: in light-grey the Zn-rich phase, in dark-grey the Al and Cu-rich phase and in white the Sn-rich phase,

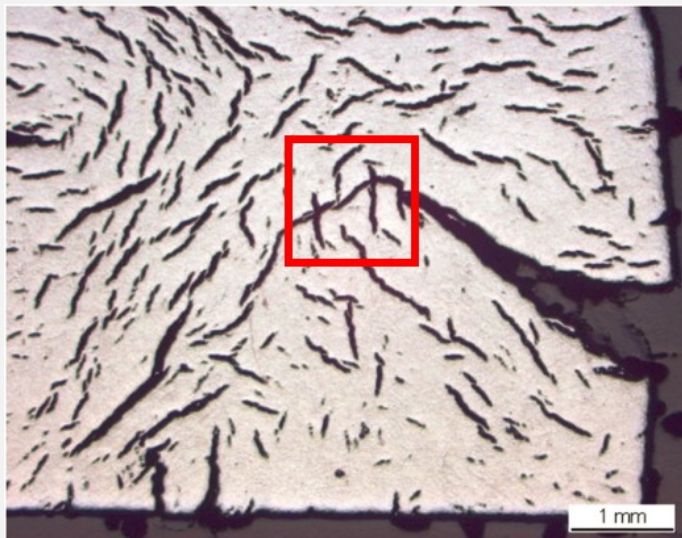
Fig. 8: Micrograph showing the metal - "corrosion products" interface from Fig. 3 (reversed picture, detail), unetched, bright field. We observe in white the metal matrix and dark-grey the adhering material,

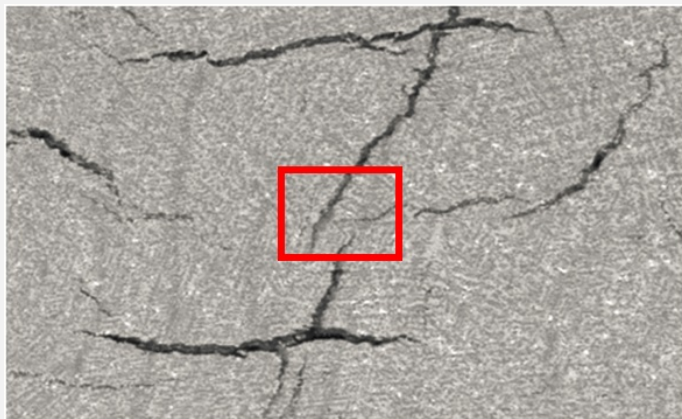
Fig. 9: Micrograph of the metal sample, detail from Fig. 8 (reversed and rotated by 90°), unetched, bright field. A dendritic structure is visible. The micrograph of Fig. 10 is marked by a rectangle,
