MILITARY ID TAG 5668-MXX-1008-1 - ZN PB ALLOY - MODERN TIMES - FRANCE

Artefact name	Military ID tag 5668-MXX-1008-1
Authors	Christian. Degryny (HE-Arc CR, Neuchâtel, Neuchâtel, Switzerland) & Marie-Jeanne. Scholl (HE-Arc CR, Neuchâtel, Neuchâtel, Switzerland) & Valentin. Boissonnas (HE-Arc CR, Neuchâtel, Neuchâtel, Switzerland)
Url	/artefacts/464/

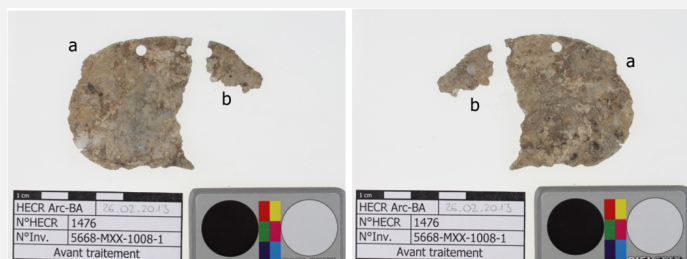
Fig. 1: German military ID tag from First World War, recto and verso, 2013,

Description of the artefact	Fragments from an oval shaped German military plate with two circular holes at the central upper edge (Fig. 1). Information concerning the soldier were given in the centre of the plate. The plate is covered with sediments. Dimensions (70 x 50 mm initially): L = 65mm; W = 50mm; T = 1 mm; WT = 6.3g.
Type of artefact	Military object
Origin	German army, 94th Infantry Regiment, 1918, Carspach, Alsace, France
Recovering date	Recovered in 2011
Chronology category	Modern Times
chronology tpe	1915 A.D. ▼
chronology tag	---- ▼
Chronology comment	First World War
Burial conditions / environment	Soil
Artefact location	Pôle d'Archéologie Interdépartemental Rhénan, Sélestat, Alsace
Owner	Pôle d'Archéologie Interdépartemental Rhénan, Sélestat, Alsace
Inv. number	5668-MXX-1008-1
Recorded conservation data	Not conserved

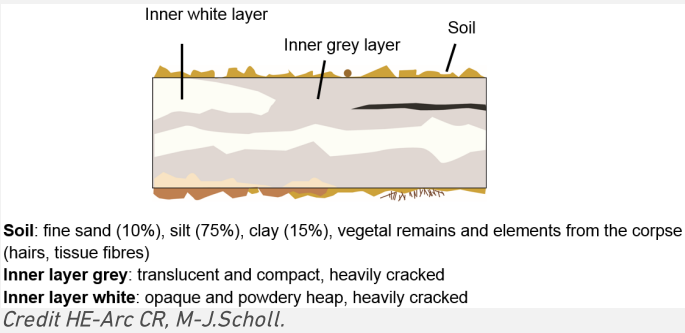
Fig. 3: Stratigraphic representation of the military tag in cross-section by macroscopic observation,

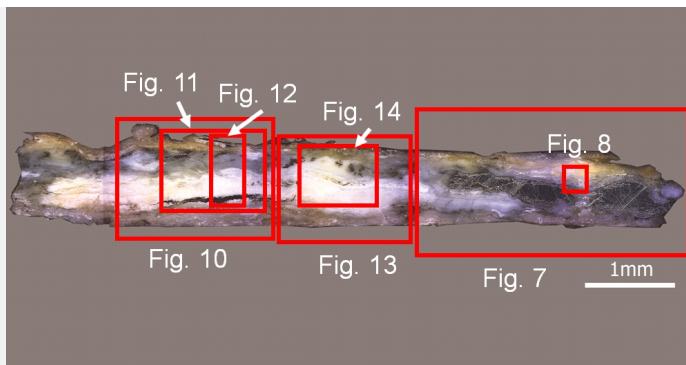
Fig. 4: Micrograph of the cross-section showing the location of Figs. 7, 8 and 10 to 14. Unetched, dark field, 50x,

This sample was cut out of fragment b in Fig. 1. The cross-section shows the entire thickness of the plate (L = 8 mm, W= 1 mm). The corrosion goes through the whole metal thickness but a metallic core remains (Fig. 4).

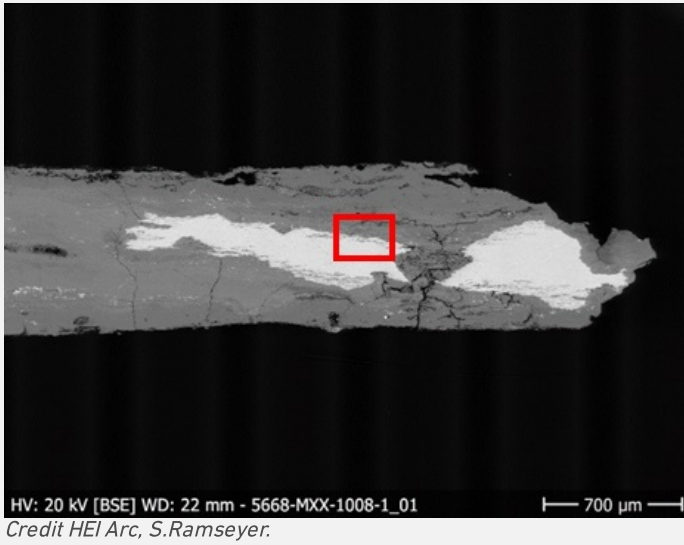
The remaining metal is an almost pure zinc alloy (Table 1) containing 1.8% in weight lead. Lead appears in the metal in the form of small flattened white Pb inclusions (Figs. 7 and 8), confirming the manufacturing technique, namely lamination. The etched metal does not show any specific microstructure (Fig. 9).

Fig. 7: SEM image of the cross-section, from Fig. 4 (detail), BSE-mode. Note the presence of Pb inclusions all through the thickness of the heavily cracked corrosion layers,

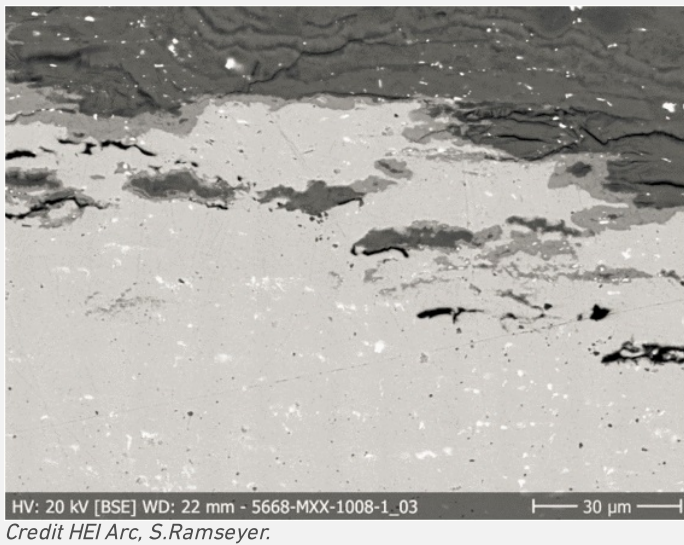
Fig. 8: SEM image of the cross-section, from Fig. 5 (detail), BSE-mode,

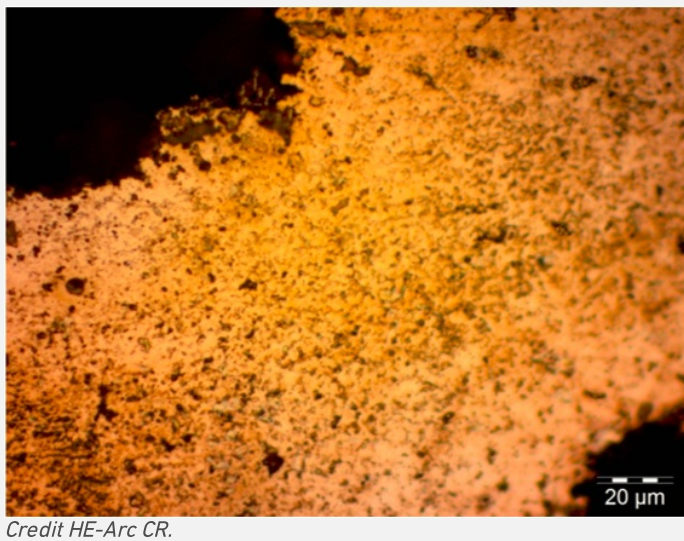
Fig. 9: Micrograph of the cross-section, etched, bright field, 500x,

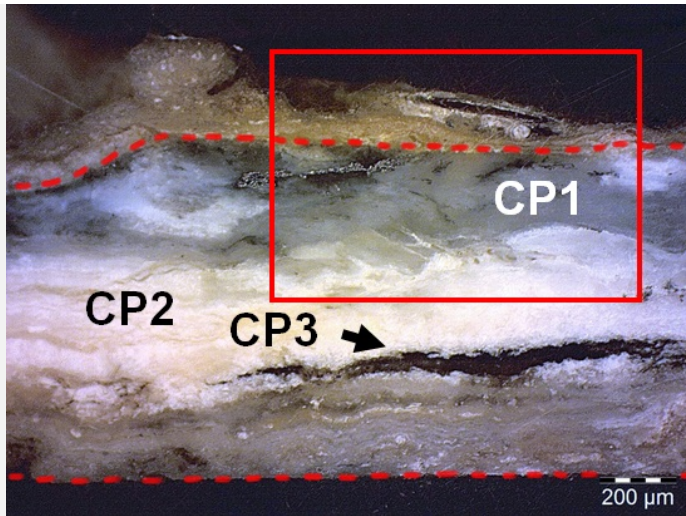
The inner grey layer (CP1, Figs. 5 and 10) has been identified by FTIR as a zinc carbonate (smithsonite), mixed with other unidentified corrosion products. Raman spectra seems to confirm it (Fig. 15). The exact composition of the inner white layer (CP2) is unknown. It shows a bluish fluorescence under UV light and has been identified by FTIR as a mixture of zinc oxides and carbonates, that could be zinc hydroxycarbonates (hydrozincite). Raman spectroscopy shows also a mixture of carbonates and other corrosion products (Fig. 16). The inner black layer (CP3) is a zinc carbonate as well, identified by FTIR and Raman spectroscopy (Fig. 17) appearing as a vein between layers of grey and white (Fig. 10).

Fig. 10: Micrograph of the cross-section, from Fig. 4 (detail) and corresponding to the stratigraphy of Fig. 5, unetched, dark field, 50x. View of the inner layers and the limit of the original surface (red line). We can see that the interfaces between the different layers are not well defined: some of the white corrosion product is found inside the inner grey layer. The micrograph of Fig. 11 is marked by a rectangle,

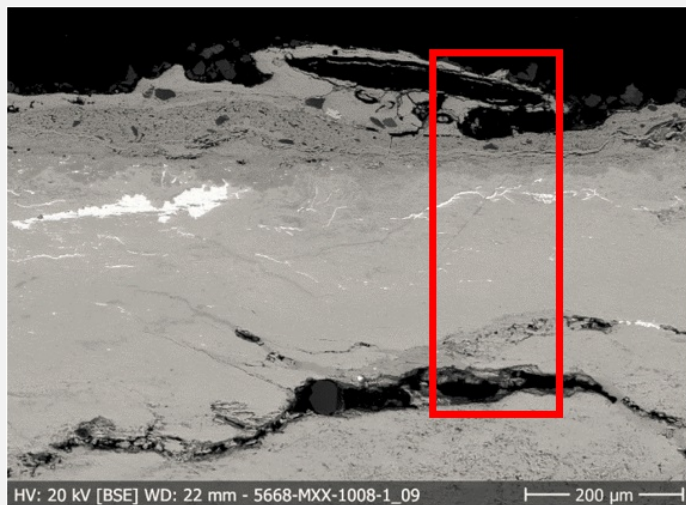
Fig. 11: SEM image of the cross-section from Fig. 10 (detail), BSE-mode. The mapped area (Fig. 12) is marked by a rectangle,

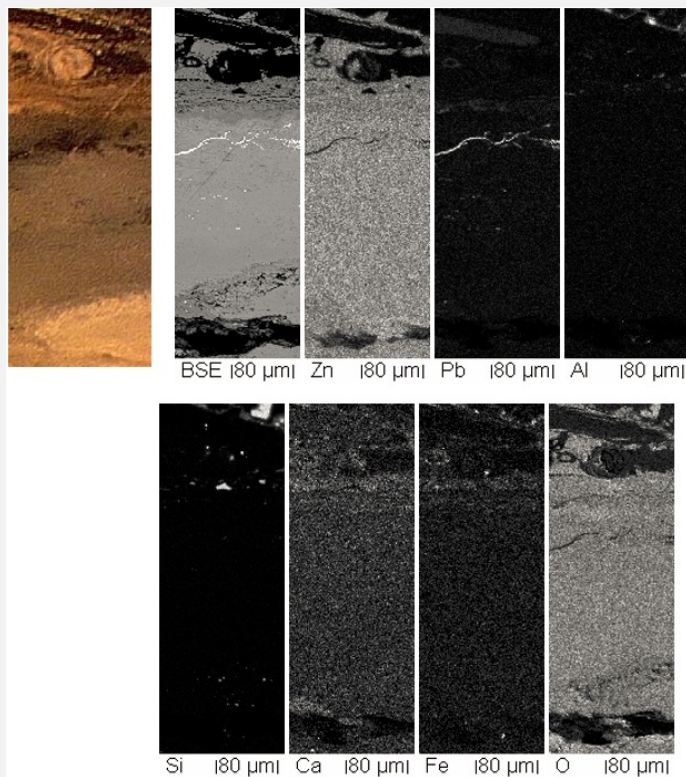
Fig. 12: SEM image of the cross-section from Fig. 11 (detail), SE-mode, and elemental chemical distribution. Method of examination: SEM/EDS, Lab of Electronic Microscopy and microanalysis, IMA (Néode), HEI Arc,

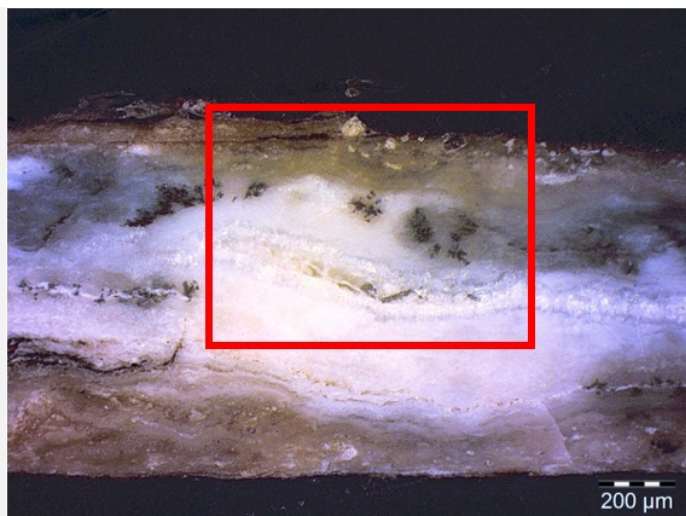
- Inner grey layer – CP1 (up to 1 mm thick) is a translucent, compact layer and constitutes most part of the corrosion products. Corroded metal appears inside this layer as lead inclusions within a black corrosion product (Figs. 13 and 14). Sulphur has also been detected by SEM-EDS inside this layer, near the surface, where the colour turns into grey-orange (zinc sulfide or sulphates but to be confirmed, table 2).

Fig. 13: Micrograph of the cross-section, from Fig. 4 (detail), unetched, dark field, 50x. The micrograph of Fig. 14 is marked by a rectangular,

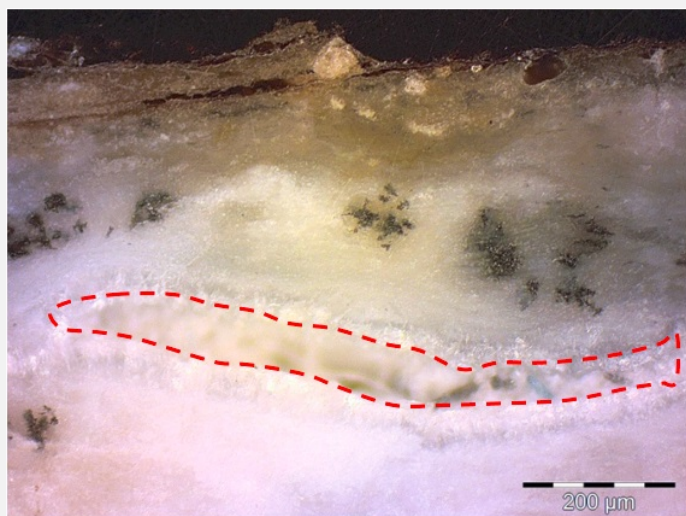
- Inner white layer – CP2 (up to 0.6 mm thick) is an opaque and powdery heap, occurring in different places inside inner grey layer and sometimes near the surface, as pitting corrosion. The interface between inner layers grey and white is diffuse. Localized aggregates showing a crystalline microstructure of thickness of 50 µm are located against the walls of a structural void, inside the white corrosion product (Fig. 14).

Fig. 14: Micrograph of the cross-section, from Fig. 11 (detail) unetched, dark field, 100x. Structural void (dotted red line) with aggregates,

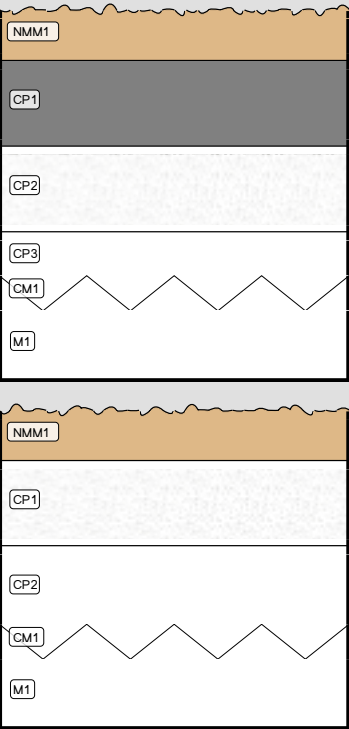
Fig. 5: Stratigraphic representation of the object in cross-section using the MiCorr application. The characteristics of the strata are only accessible by clicking on the drawing that redirects you to the search tool by stratigraphy representation. This representation can be compared to Fig. 10, Credit HE-Arc CR, M-J.Scholl.

Fig. 6: Stratigraphic representation of the object in cross-section using the MiCorr application. The characteristics of the strata are only accessible by clicking on the drawing that redirects you to the search tool by stratigraphy representation. This representation is different from Fig. 10 due to the inversion of CP1 and CP2. Furthermore, CP3 is not represented, Credit HE-Arc CR, M-J.Scholl.

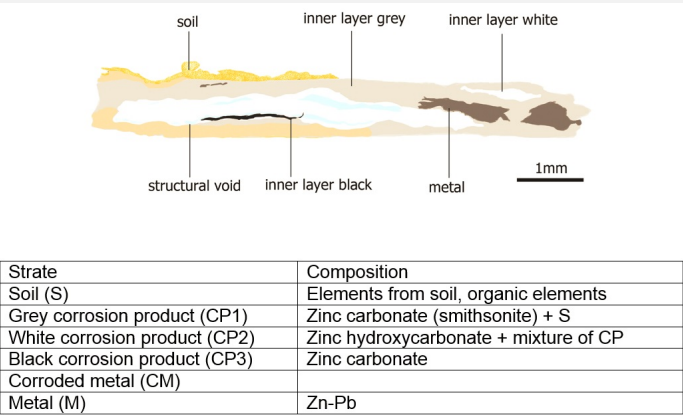
Fig. 16: Improved stratigraphic representation of the stratigraphy of corrosion layers on the military tag from visual observations and analyses,

The military tag is made of a laminated sheet of zinc-lead alloy. The corrosion has entirely penetrated the objet leaving though some spots of remaining original metal inside the corrosion products. Lead particles are not affected by the corrosion process. The main corrosion products are zinc carbonates (smithsonite) and hydroxycarbonates (hydrozincite) but mixtures of different corrosion products can occur. These corrosion products are intermixed and heavily cracked.
