# MILITARY ID TAG 5668-MXX-1008-1 - ZN PB ALLOY - MODERN TIMES - FRANCE

Artefact name	Military ID tag 5668-MXX-1008-1
Authors	Christian. Degryny (HE-Arc CR, Neuchâtel, Neuchâtel, Switzerland) & Marie-Jeanne. Scholl (HE-Arc CR, Neuchâtel, Neuchâtel, Switzerland) & Valentin. Boissonnas (HE-Arc CR, Neuchâtel, Neuchâtel, Switzerland)
Url	/artefacts/464/

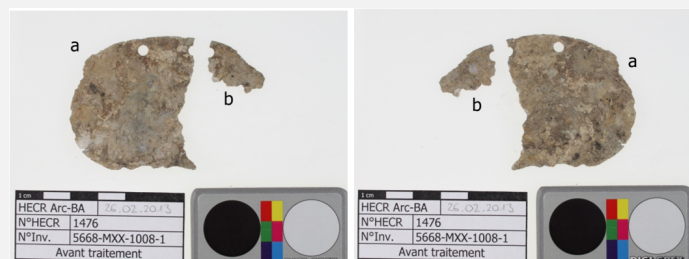
Fig. 1: German military ID tag from First World War, recto and verso, 2013,

Description of the artefact	Fragments from an oval shaped German military plate with two circular holes at the central upper edge (Fig. 1). Information concerning the soldier were given in the centre of the plate. The plate is covered with sediments. Dimensions (70 x 50 mm initially): L = 65mm; W = 50mm; T = 1 mm; WT = 6.3g.
Type of artefact	Military object
Origin	German army, 94th Infantry Regiment, 1918, Carspach, Alsace, France
Recovering date	Recovered in 2011
Chronology category	Modern Times
chronology tpg	1915 A.D. ▼
chronology tag	---- ▼
Chronology comment	First World War
Burial conditions / environment	Soil
Artefact location	Pôle d'Archéologie Interdépartemental Rhénan, Sélestat, Alsace
Owner	Pôle d'Archéologie Interdépartemental Rhénan, Sélestat, Alsace
Inv. number	5668-MXX-1008-1
Recorded conservation data	Not conserved

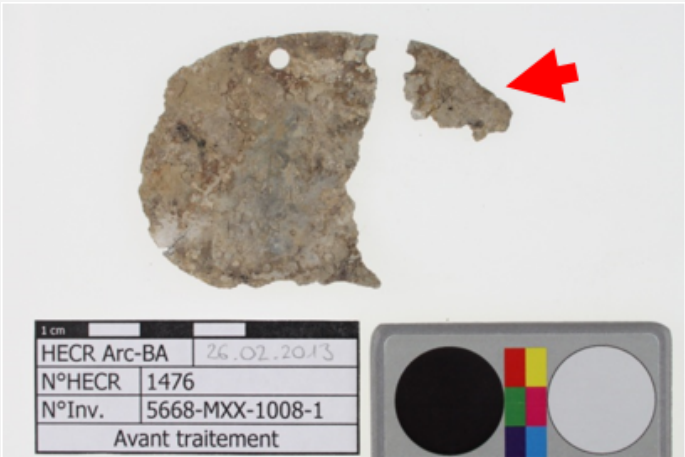
Fig. 2: Location of sample,

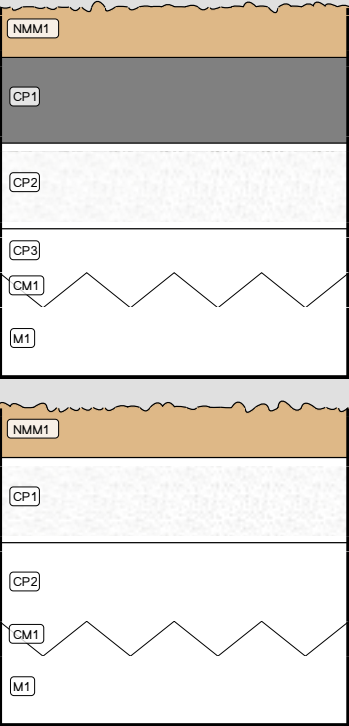
Fig. 5: Stratigraphic representation of the object in cross-section using the MiCorr application. The characteristics of the strata are only accessible by clicking on the drawing that redirects you to the search tool by stratigraphy representation. This representation can be compared to Fig. 10, Credit HE-Arc CR, M-J.Scholl.

Fig. 6: Stratigraphic representation of the object in cross-section using the MiCorr application. The characteristics of the strata are only accessible by clicking on the drawing that redirects you to the search tool by stratigraphy representation. This representation is different from Fig. 10 due to the inversion of CP1 and CP2. Furthermore, CP3 is not represented, Credit HE-Arc CR, M-J.Scholl.
