MILITARY ID TAG 5668-MXX-1008-1 - ZN PB ALLOY - MODERN TIMES - FRANCE

Artefact name	Military ID tag 5668-MXX-1008-1
Authors	Christian. Degrygn (HE-Arc CR, Neuchâtel, Neuchâtel, Switzerland) & Marie-Jeanne. Scholl (HE-Arc CR, Neuchâtel, Neuchâtel, Switzerland) & Valentin. Boissonnas (HE-Arc CR, Neuchâtel, Neuchâtel, Switzerland)
Url	/artefacts/464/

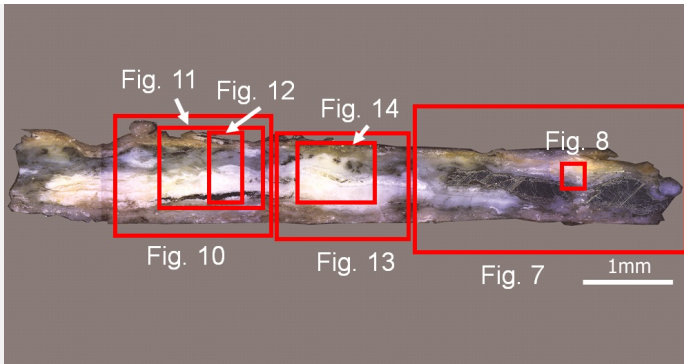
Fig. 4: Micrograph of the cross-section showing the location of Figs. 7, 8 and 10 to 14. Unetched, dark field, 50x,

Description of sample	This sample was cut out of fragment b in Fig. 1. The cross-section shows the entire thickness of the plate (L = 8 mm, W= 1 mm). The corrosion goes through the whole metal thickness but a metallic core remains (Fig. 4).
Alloy	Zn Pb Alloy
Technology	Cold worked (laminated)
Lab number of sample	-
Sample location	HE-Arc CR, Neuchâtel, Neuchâtel
Responsible institution	Pôle d'Archéologie Interdépartemental Rhénan, Sélestat, Alsace
Date and aim of sampling	2013, metallography and chemical analyses

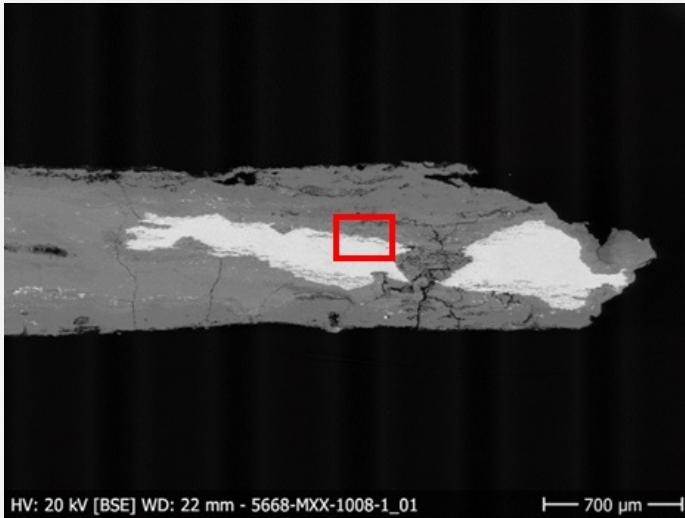
The remaining metal is an almost pure zinc alloy (Table 1) containing 1.8% in weight lead. Lead appears in the metal in the form of small flattened white Pb inclusions (Figs. 7 and 8), confirming the manufacturing technique, namely lamination. The etched metal does not show any specific microstructure (Fig. 9).

Fig. 7: SEM image of the cross-section, from Fig. 4 (detail), BSE-mode. Note the presence of Pb inclusions all through the thickness of the heavily cracked corrosion layers,

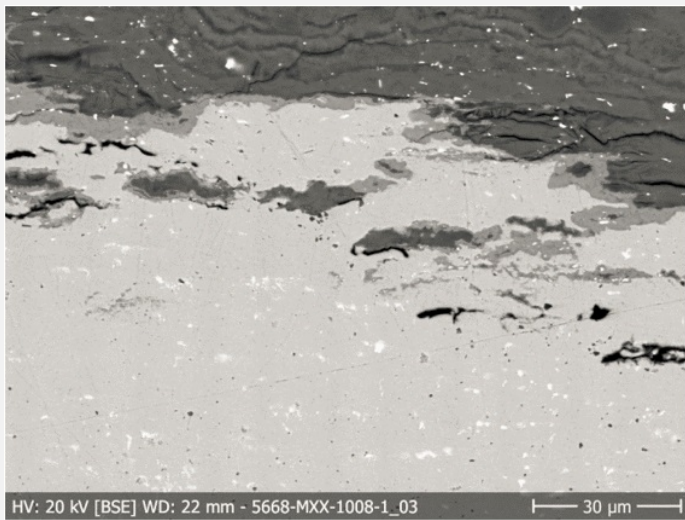
Fig. 8: SEM image of the cross-section, from Fig. 5 (detail), BSE-mode,

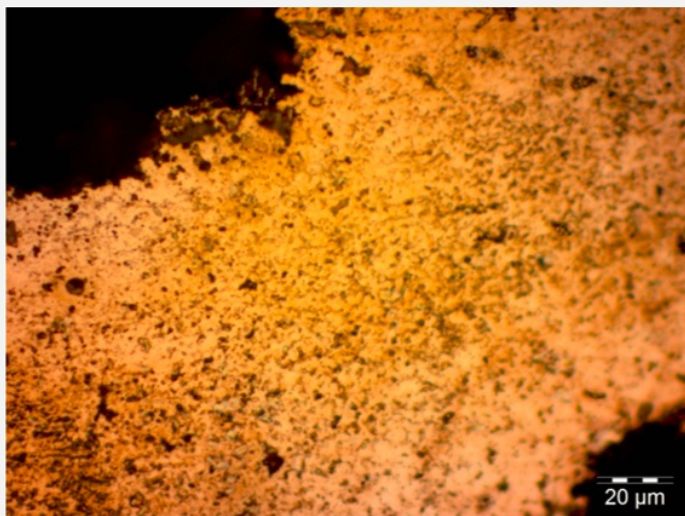
Fig. 9: Micrograph of the cross-section, etched, bright field, 500x,

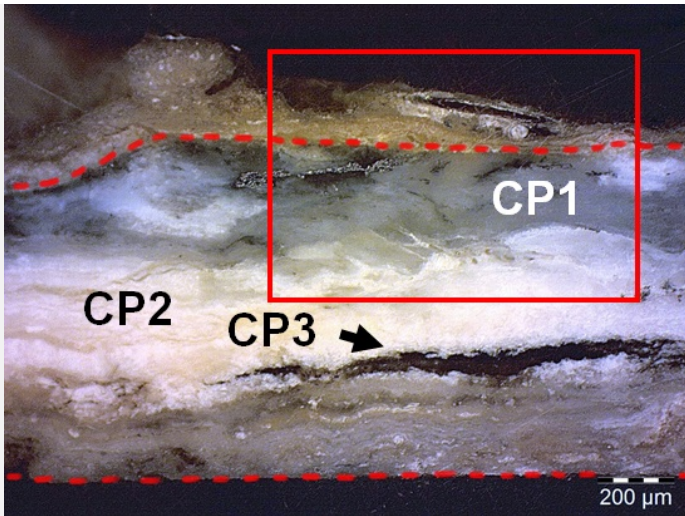
The inner grey layer (CP1, Figs. 5 and 10) has been identified by FTIR as a zinc carbonate (smithsonite), mixed with other unidentified corrosion products. Raman spectra seems to confirm it (Fig. 15). The exact composition of the inner white layer (CP2) is unknown. It shows a bluish fluorescence under UV light and has been identified by FTIR as a mixture of zinc oxides and carbonates, that could be zinc hydroxycarbonates (hydrozincite). Raman spectroscopy shows also a mixture of carbonates and other corrosion products (Fig. 16). The inner black layer (CP3) is a zinc carbonate as well, identified by FTIR and Raman spectroscopy (Fig. 17) appearing as a vein between layers of grey and white (Fig. 10).

Fig. 10: Micrograph of the cross-section, from Fig. 4 (detail) and corresponding to the stratigraphy of Fig. 5, unetched, dark field, 50x. View of the inner layers and the limit of the original surface (red line). We can see that the interfaces between the different layers are not well defined: some of the white corrosion product is found inside the inner grey layer. The micrograph of Fig. 11 is marked by a rectangle,

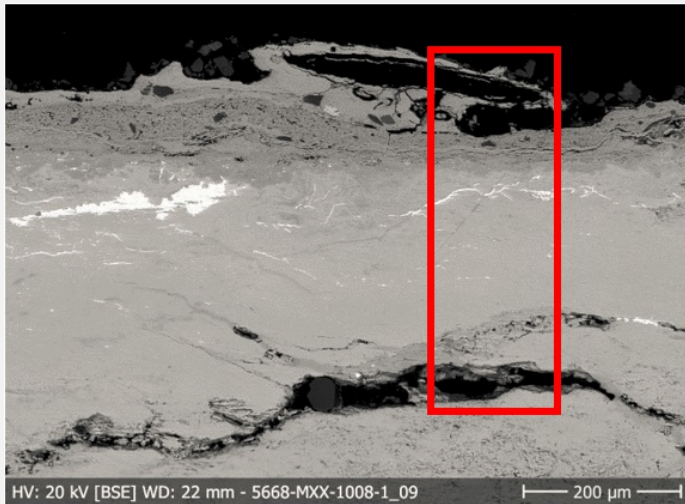
Fig. 11: SEM image of the cross-section from Fig. 10 (detail), BSE-mode. The mapped area (Fig. 12) is marked by a rectangle,

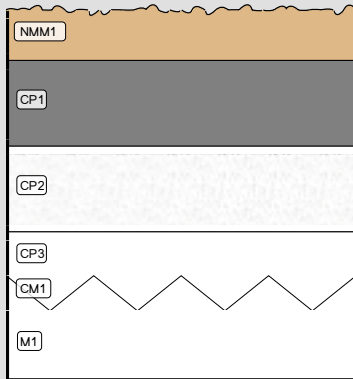
Fig. 5: Stratigraphic representation of the object in cross-section using the MiCorr application. The characteristics of the strata are only accessible by clicking on the drawing that redirects you to the search tool by stratigraphy representation. This representation can be compared to Fig. 10, Credit HE-Arc CR, M-J.Scholl.

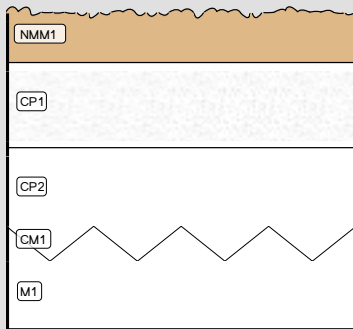
Fig. 6: Stratigraphic representation of the object in cross-section using the MiCorr application. The characteristics of the strata are only accessible by clicking on the drawing that redirects you to the search tool by stratigraphy representation. This representation is different from Fig. 10 due to the inversion of CP1 and CP2. Furthermore, CP3 is not represented, Credit HE-Arc CR, M-J.Scholl.

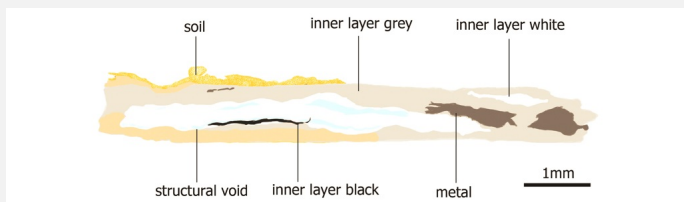
Fig. 16: Improved stratigraphic representation of the stratigraphy of corrosion layers on the military tag from visual observations and analyses,

Strate	Composition
Soil (S)	Elements from soil, organic elements
Grey corrosion product (CP1)	Zinc carbonate (smithsonite) + S
White corrosion product (CP2)	Zinc hydroxycarbonate + mixture of CP
Black corrosion product (CP3)	Zinc carbonate
Corroded metal (CM)	
Metal (M)	Zn-Pb
