AIRCRAFT FRONT FASTENING PLATE VHS-497 (2) – AL CU SN ZN SI ALLOY – MODERN TIMES

| Artefact name | Aircraft front fastening plate VHS-497 (2) |
| Authors | Marianne. Senn (EMPA, Dübendorf, Zurich, Switzerland) & Christian. Degrigny (HE-Arc CR, Neuchâtel, Neuchâtel, Switzerland) |

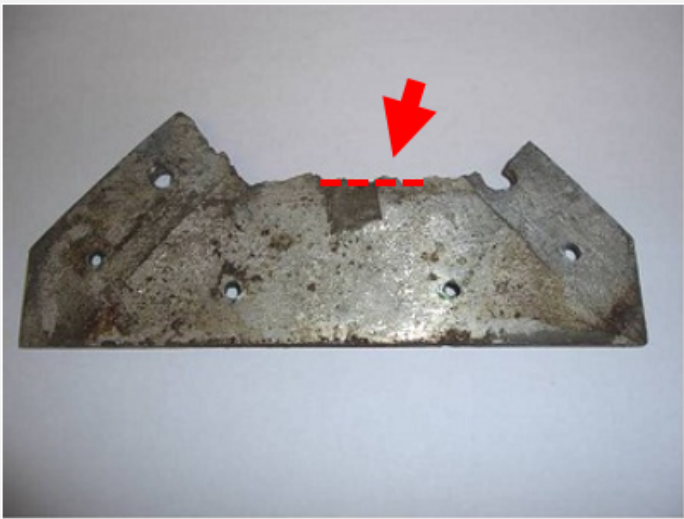
Fig. 2: Location of sampling area,

| Description of sample | The top part has been cut during sampling (Fig. 2). The more regular right side is the plate surface and the irregular side is the broken edge (Fig. 3). Dimensions: L = 4mm ; W = 4mm. |

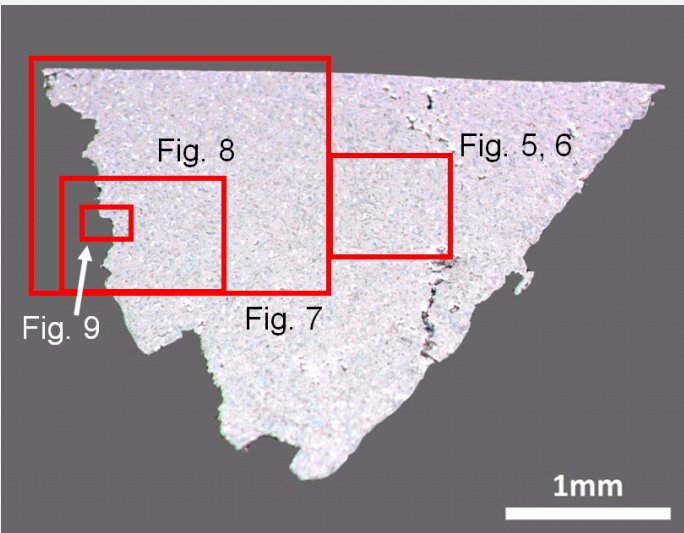
Fig. 3: Micrograph of the cross-section showing the location of Figs. 5 to 9,

The metal is an aluminium alloy containing Cu, Sn, Zn and Si (Table 1). The unetched metal shows an as-cast structure consisting of the aluminium matrix with Sn (not soluble in Al) inclusions (Figs. 5 and 6), intermetallic compounds such as Al₂Cu (Fig. 5, red arrows) and clusters of Al,Fe,Cu & Si phases (Fig. 5, black arrows). There are porosities in the metal (Figs. 3 and 5). The average hardness of the metal is HV1 80.

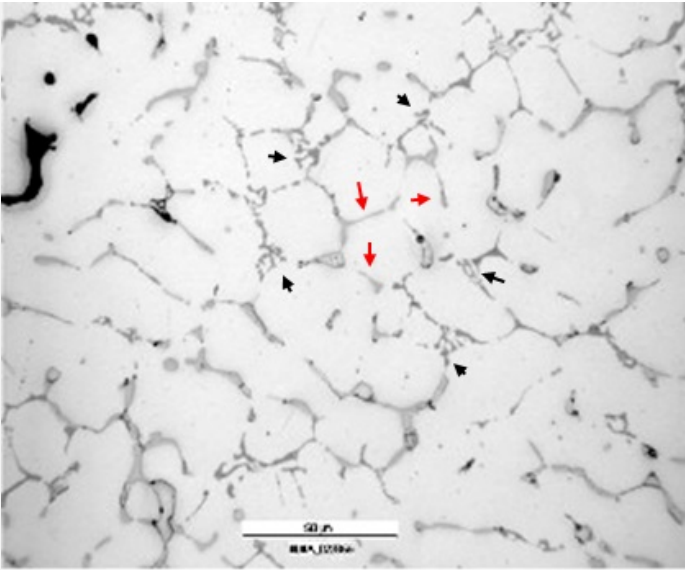
Fig. 5: Micrograph of the metal sample from Fig. 3 (detail), unetched, bright field. The cast structure is revealed by light grey intermetallic compounds (Al₂Cu, red arrows), dark-grey Al,Fe,Si & Cu phase clusters (black arrows) and Sn inclusions (nodules). On the top left some pores can be seen,

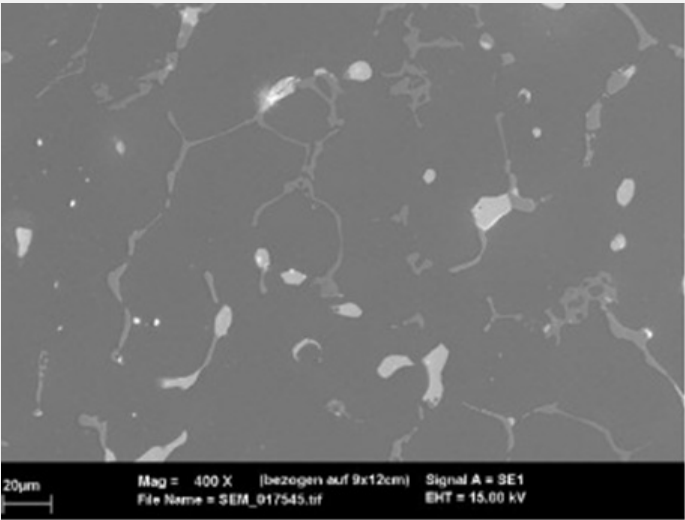
Fig. 6: SEM image of the metal sample from Fig. 3 (detail), SE-mode, unetched. We observe in dark-grey the metal matrix, in medium-grey the intermetallic compound Al₂Cu as well as Al,Fe,Si & Cu phase clusters and in light-grey the Sn inclusions,

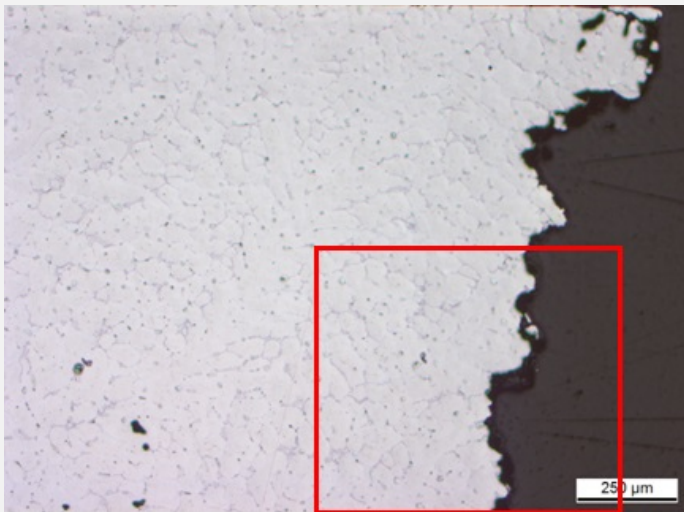
No corrosion layer can be seen on the metal surface (Figs. 3 and 7). Under polarized light small white and brown particles are visible on the broken edge (D1, Fig. 8). Their analysis reveals the presence of silica particles surrounded by dirt (Table 2 and Fig. 9). The metal surface is covered by a thin oxygen bearing skin (CP1, Fig. 9).

Fig. 7: Micrograph showing the metal - "corrosion products" interface from Fig. 3 (reversed picture, detail), unetched, bright field. We observe in white the metal matrix, in dark-grey Al, Fe, Si & Cu phase and light-grey Al₂Cu intermetallic compounds. The micrograph of Fig. 8 is marked by a rectangle,

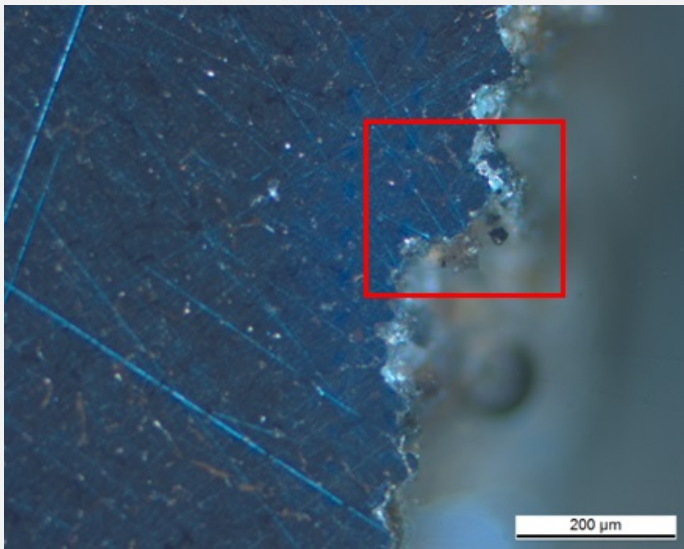
Fig. 8: Micrograph from Fig. 7 (detail) and corresponding to the stratigraphy of Fig. 4, unetched, polarised light. We observe in grey the metal matrix and blue-brown the adherent material. The micrograph of Fig. 9 is marked by a rectangle,

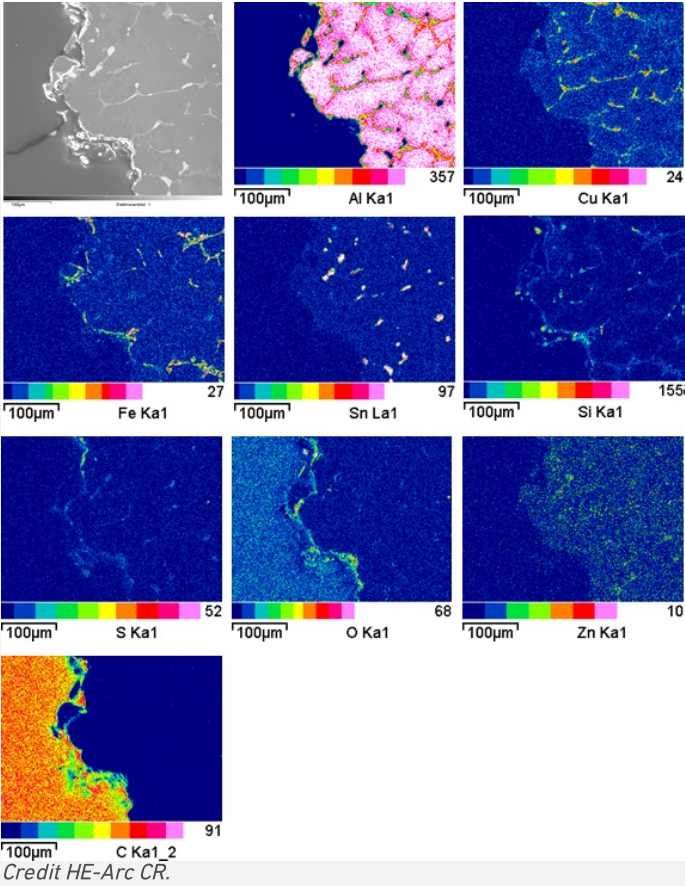
Fig. 9: SEM image, BSE-mode, and elemental chemical distribution of the selected area from Fig. 8 (reversed picture, detail). Method of examination: SEM/EDS, Laboratory of Analytical Chemistry, Empa,

Although not common at the beginning of the 20th, this Al-Cu-Sn-Zn-Si cast alloy was extensively used on the Dufaux IV plane. No corrosion layer has been found on the metal surface except adherent silica-rich particles and the thin oxidised skin typical of Al alloys. The presence of these materials might be explained by the regular maintenance of the metal using abrasive silicon carbide paper.
