AIRCRAFT FRONT FASTENING PLATE VHS-497 (2) - AL CU SN ZN SI ALLOY - MODERN TIMES

Artefact name Aircraft front fastening plate VHS-497 (2)

Authors Marianne. Senn (EMPA, Dübendorf, Zurich, Switzerland) & Christian. Degriigny (HE-Arc CR, Neuchâtel, Neuchâtel, Switzerland)

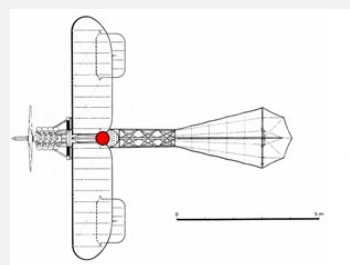
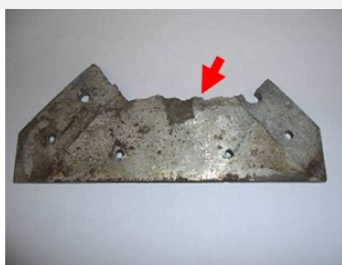
Fig. 1: Photograph of the aeroplane showing the location of the fixation plate (red dot) (www.hepta.aero),

Description of the artefact	Fixation plate for the wooden construction, broken by use (Fig. 1).
Type of artefact	Aeroplane part
Origin	Dufaux IV aeroplane
Recovering date	Biplane built by Henri and Armand Dufaux in 1909/10
Chronology category	Modern Times
chronology tpq	<input type="text" value="1909"/> A.D. ▾
chronology taq	<input type="text" value="1910"/> A.D. ▾
Chronology comment	
Burial conditions / environment	Outdoor to indoor atmosphere
Artefact location	Swiss Museum of Transport, Luzern, Lucerne
Owner	Swiss Museum of Transport, Luzern, Lucerne
Inv. number	VHS-497 (2)
Recorded conservation data	Not known

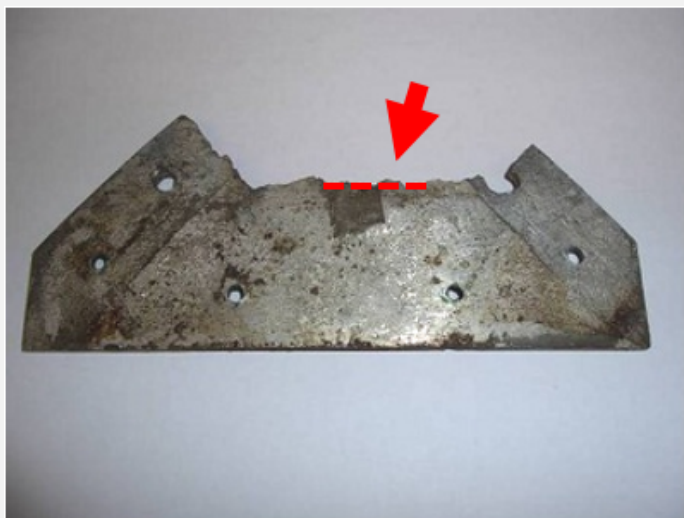
Fig. 2: Location of sampling area,

Description of sample	The top part has been cut during sampling (Fig. 2). The more regular right side is the plate surface and the irregular side is the broken edge (Fig. 3). Dimensions: L = 4mm ; W = 4mm.
Alloy	Al Cu Sn Zn Si Alloy
Technology	As-cast
Lab number of sample	DUF-4
Sample location	Empa (Marianne Senn)
Responsible institution	Swiss Museum of Transport, Luzern, Lucerne
Date and aim of sampling	September 2007, metallography and alloy composition

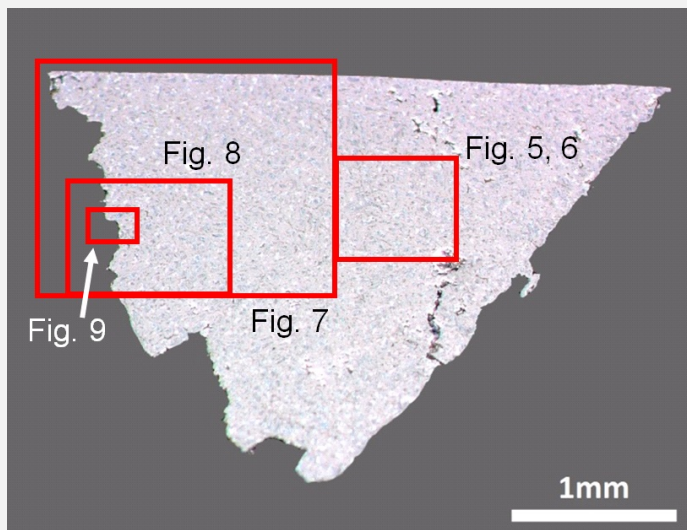
Fig. 3: Micrograph of the cross-section showing the location of Figs. 5 to 9,

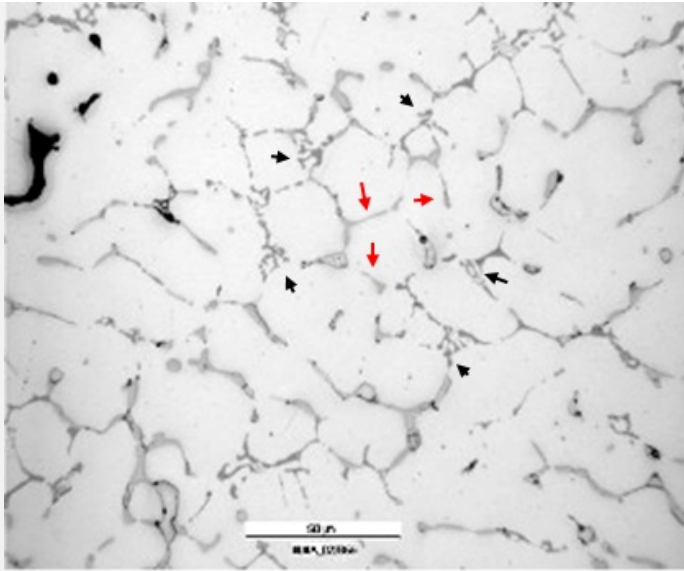
The metal is an aluminium alloy containing Cu, Sn, Zn and Si (Table 1). The unetched metal shows an as-cast structure consisting of the aluminium matrix with Sn (not soluble in Al) inclusions (Figs. 5 and 6), intermetallic compounds such as Al₂Cu (Fig. 5, red arrows) and clusters of Al,Fe,Cu & Si phases (Fig. 5, black arrows). There are porosities in the metal (Figs. 3 and 5). The average hardness of the metal is HV1 80.

Fig. 5: Micrograph of the metal sample from Fig. 3 (detail), unetched, bright field. The cast structure is revealed by light grey intermetallic compounds (Al₂Cu, red arrows), dark-grey Al,Fe,Si & Cu phase clusters (black arrows) and Sn inclusions (nodules). On the top left some pores can be seen,

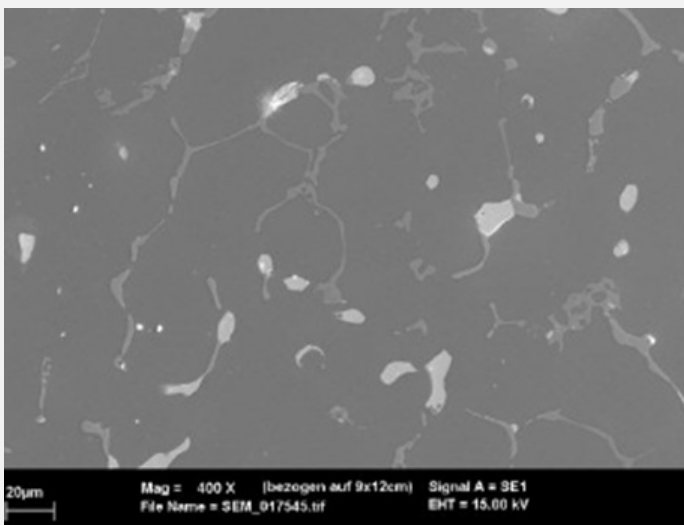
Fig. 6: SEM image of the metal sample from Fig. 3 (detail), SE-mode, unetched. We observe in dark-grey the metal matrix, in medium-grey the intermetallic compound Al₂Cu as well as Al,Fe,Si & Cu phase clusters and in light-grey the Sn inclusions,

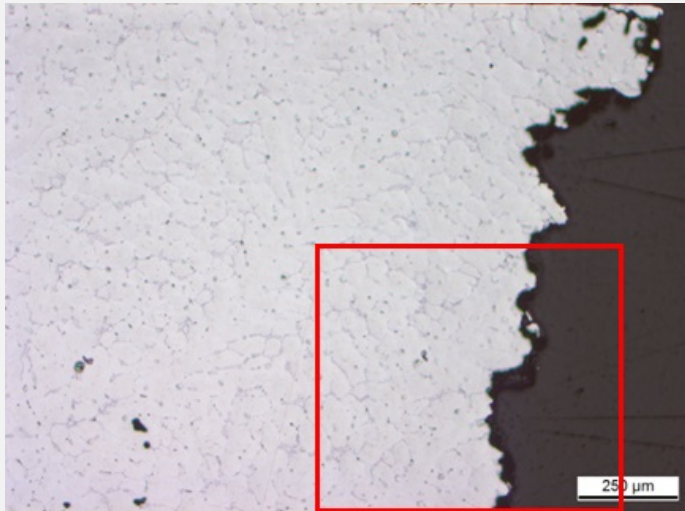
No corrosion layer can be seen on the metal surface (Figs. 3 and 7). Under polarized light small white and brown particles are visible on the broken edge (D1, Fig. 8). Their analysis reveals the presence of silica particles surrounded by dirt (Table 2 and Fig. 9). The metal surface is covered by a thin oxygen bearing skin (CP1, Fig. 9).

Fig. 7: Micrograph showing the metal - "corrosion products" interface from Fig. 3 (reversed picture, detail), unetched, bright field. We observe in white the metal matrix, in dark-grey Al, Fe, Si & Cu phase and light-grey Al₂Cu intermetallic compounds. The micrograph of Fig. 8 is marked by a rectangle,

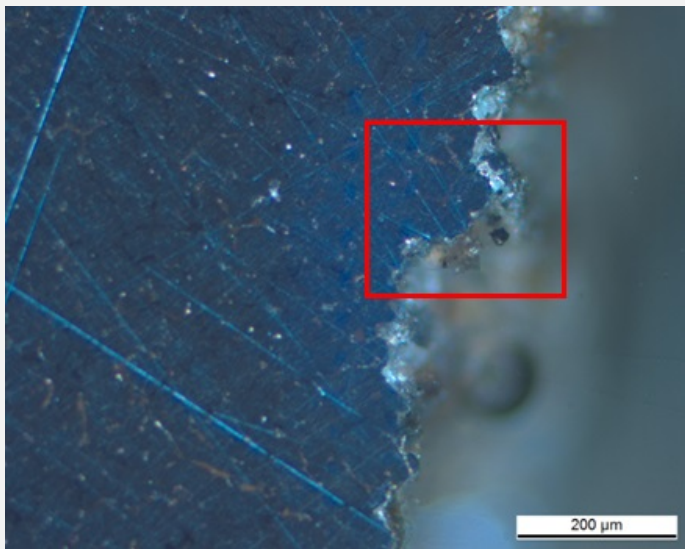
Fig. 8: Micrograph from Fig. 7 (detail) and corresponding to the stratigraphy of Fig. 4, unetched, polarised light. We observe in grey the metal matrix and blue-brown the adherent material. The micrograph of Fig. 9 is marked by a rectangle,

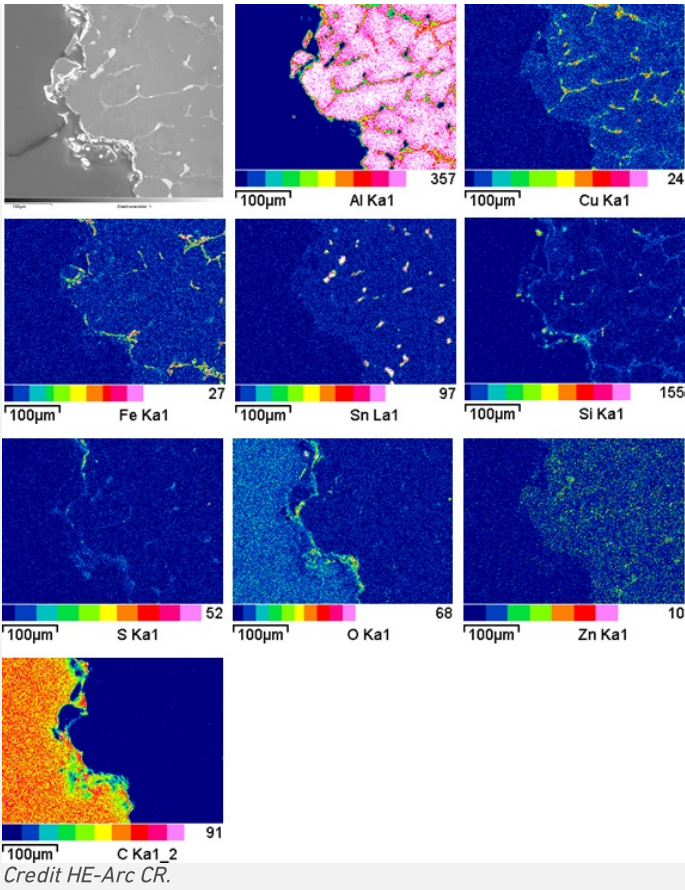
Fig. 9: SEM image, BSE-mode, and elemental chemical distribution of the selected area from Fig. 8 (reversed picture, detail). Method of examination: SEM/EDS, Laboratory of Analytical Chemistry, Empa,

Although not common at the beginning of the 20th, this Al-Cu-Sn-Zn-Si cast alloy was extensively used on the Dufaux IV plane. No corrosion layer has been found on the metal surface except adherent silica-rich particles and the thin oxidised skin typical of Al alloys. The presence of these materials might be explained by the regular maintenance of the metal using abrasive silicon carbide paper.
