# AIRCRAFT FRONT FASTENING PLATE VHS-497 (2) - AL CU SN ZN SI ALLOY - MODERN TIMES

Artefact name	Aircraft front fastening plate VHS-497 (2)
Authors	Marianne. Senn (EMPA, Dübendorf, Zurich, Switzerland) & Christian. Degrigny (HE-Arc CR, Neuchâtel, Neuchâtel, Switzerland)
Url	/artefacts/465/

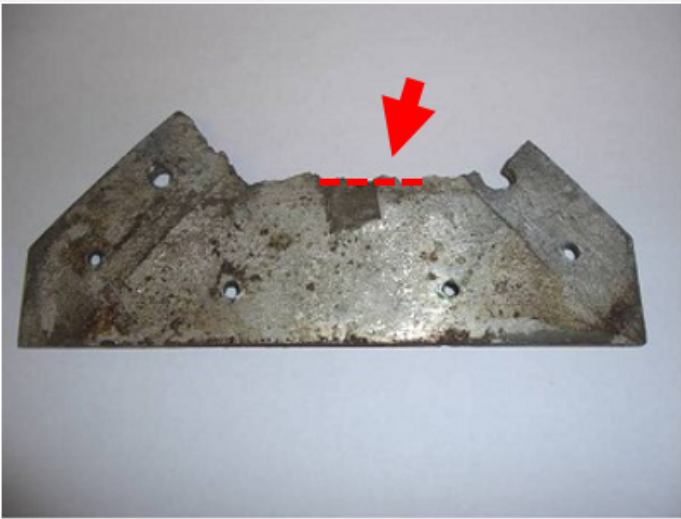
Fig. 2: Location of sampling area,

Description of sample	The top part has been cut during sampling (Fig. 2). The more regular right side is the plate surface and the irregular side is the broken edge (Fig. 3). Dimensions: L = 4mm ; W = 4mm.
Alloy	Al Cu Sn Zn Si Alloy
Technology	As-cast
Lab number of sample	DUF-4
Sample location	Empa (Marianne Senn)
Responsible institution	Swiss Museum of Transport, Luzern, Lucerne
Date and aim of sampling	September 2007, metallography and alloy composition

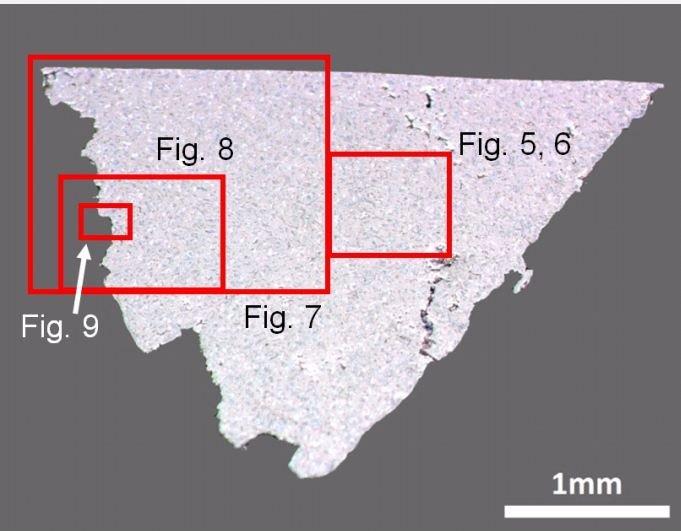
Fig. 3: Micrograph of the cross-section showing the location of Figs. 5 to 9,

The metal is an aluminium alloy containing Cu, Sn, Zn and Si (Table 1). The unetched metal shows an as-cast structure consisting of the aluminium matrix with Sn (not soluble in Al) inclusions (Figs. 5 and 6), intermetallic compounds such as Al<sub>2</sub>Cu (Fig. 5, red arrows) and clusters of Al,Fe,Cu & Si phases (Fig. 5, black arrows). There are porosities in the metal (Figs. 3 and 5). The average hardness of the metal is HV1 80.

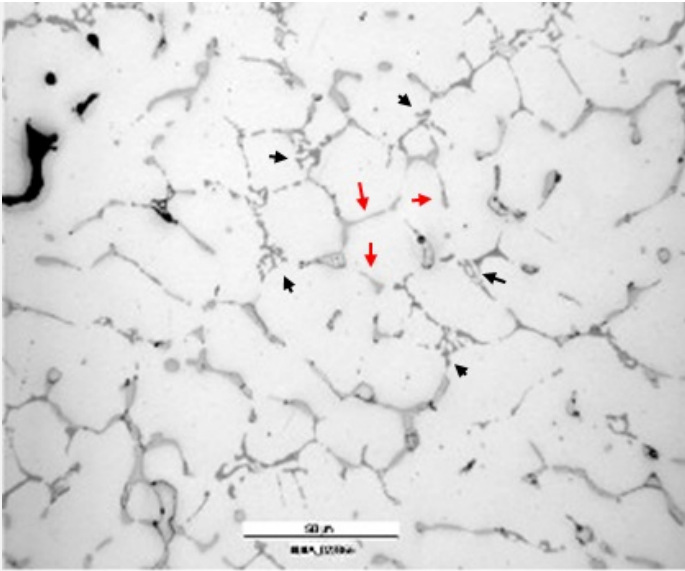
Fig. 5: Micrograph of the metal sample from Fig. 3 (detail), unetched, bright field. The cast structure is revealed by light grey intermetallic compounds (Al<sub>2</sub>Cu, red arrows), dark-grey Al,Fe,Si & Cu phase clusters (black arrows) and Sn inclusions (nodules). On the top left some pores can be seen,

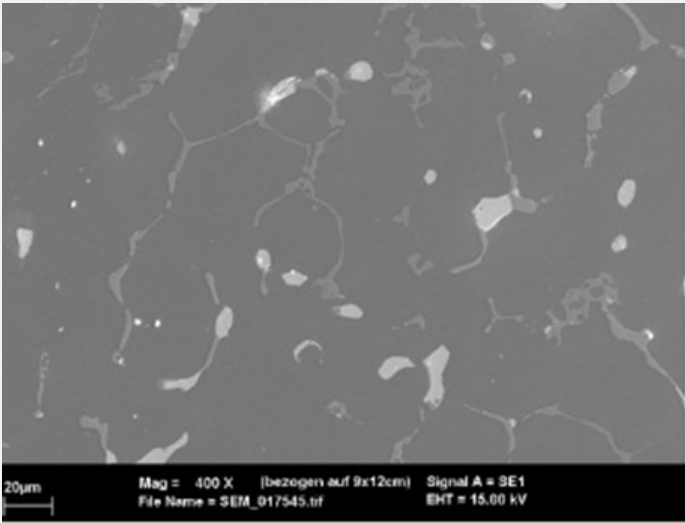
Fig. 6: SEM image of the metal sample from Fig. 3 (detail), SE-mode, unetched. We observe in dark-grey the metal matrix, in medium-grey the intermetallic compound Al<sub>2</sub>Cu as well as Al,Fe,Si & Cu phase clusters and in light-grey the Sn inclusions,

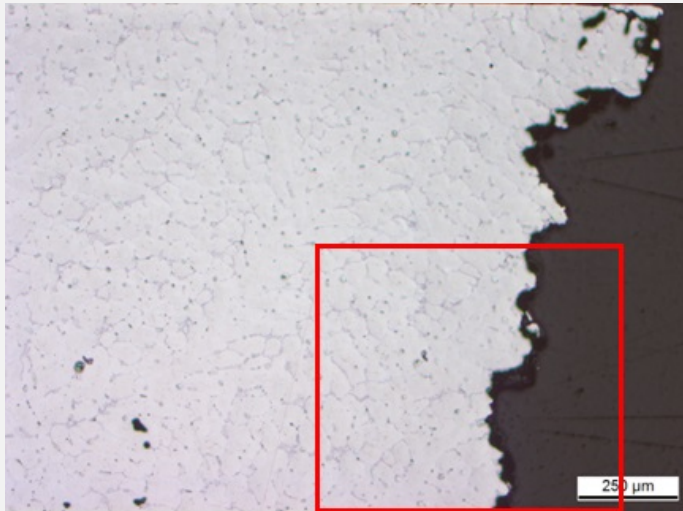
No corrosion layer can be seen on the metal surface (Figs. 3 and 7). Under polarized light small white and brown particles are visible on the broken edge (D1, Fig. 8). Their analysis reveals the presence of silica particles surrounded by dirt (Table 2 and Fig. 9). The metal surface is covered by a thin oxygen bearing skin (CP1, Fig. 9).

Fig. 7: Micrograph showing the metal - "corrosion products" interface from Fig. 3 (reversed picture, detail), unetched, bright field. We observe in white the metal matrix, in dark-grey Al, Fe, Si & Cu phase and light-grey Al<sub>2</sub>Cu intermetallic compounds. The micrograph of Fig. 8 is marked by a rectangle,

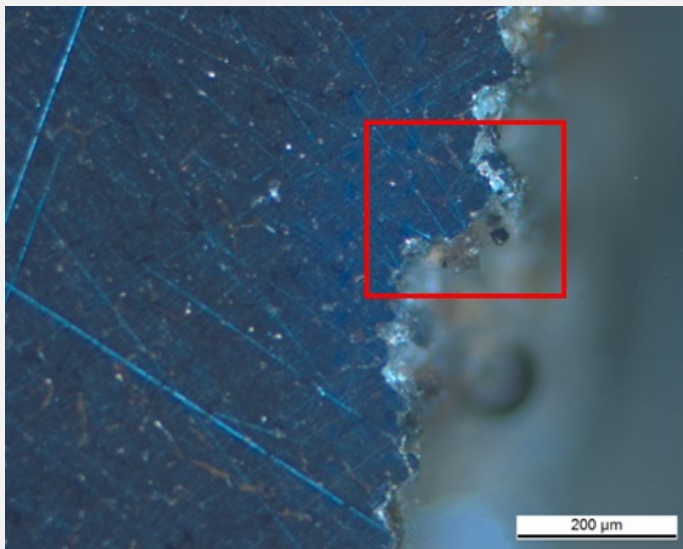
Fig. 8: Micrograph from Fig. 7 (detail) and corresponding to the stratigraphy of Fig. 4, unetched, polarised light. We observe in grey the metal matrix and blue-brown the adherent material. The micrograph of Fig. 9 is marked by a rectangle,

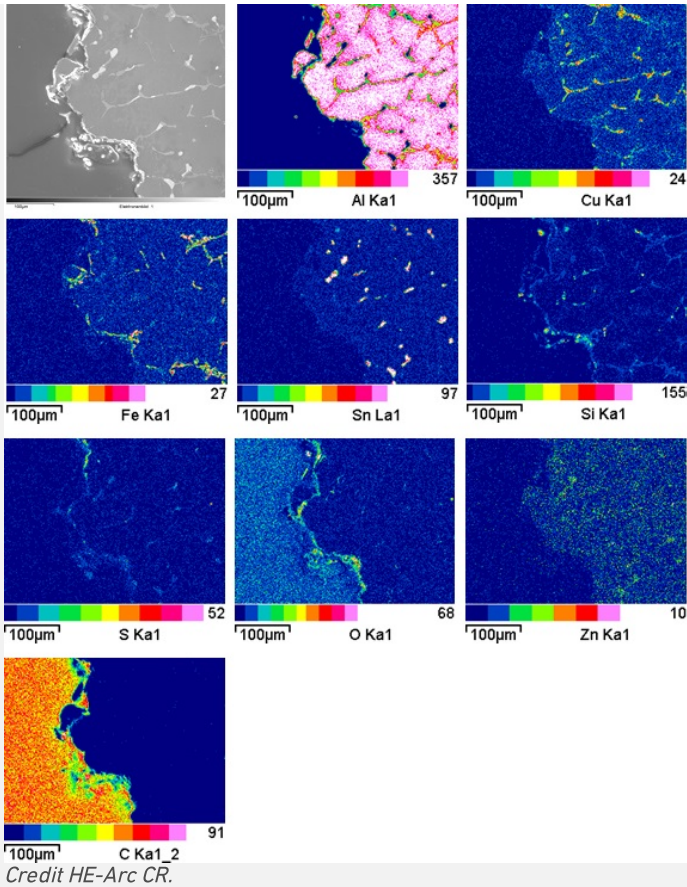
Fig. 9: SEM image, BSE-mode, and elemental chemical distribution of the selected area from Fig. 8 (reversed picture, detail). Method of examination: SEM/EDS, Laboratory of Analytical Chemistry, Empa,

Although not common at the beginning of the 20<sup>th</sup>, this Al-Cu-Sn-Zn-Si cast alloy was extensively used on the Dufaux IV plane. No corrosion layer has been found on the metal surface except adherent silica-rich particles and the thin oxidised skin typical of Al alloys. The presence of these materials might be explained by the regular maintenance of the metal using abrasive silicon carbide paper.
