AIRCRAFT REAR FASTENING PLATE VHS-497 – AL ALLOY – MODERN TIMES

Artefact name Aircraft rear fastening plate VHS-497

Authors Marianne. Senn (EMPA, Dübendorf, Zurich, Switzerland) & Christian. Degrieny (HE-Arc CR, Neuchâtel, Neuchâtel, Switzerland)

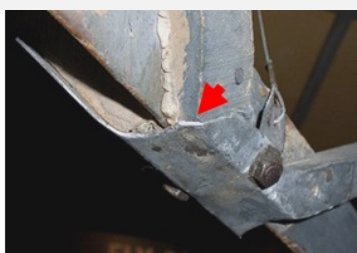
Fig. 1: Photograph of the aeroplane showing the location of the fixation plate (red dot) (www.hepta.aero),

Description of the artefact	Fixation plate for the wooden construction at the back of the aeroplane (Fig. 1).
Type of artefact	Aeroplane part
Origin	Dufaux IV aeroplane
Recovering date	Biplane built by Henri and Armand Dufaux in 1909/10
Chronology category	Modern Times
chronology tpq	<input type="text" value="1909"/> A.D. ▾
chronology taq	<input type="text" value="1910"/> A.D. ▾
Chronology comment	
Burial conditions / environment	Outdoor to indoor atmosphere
Artefact location	Swiss Museum of Transport, Luzern, Lucerne
Owner	Swiss Museum of Transport, Luzern, Lucerne
Inv. number	VHS-497
Recorded conservation data	Not known

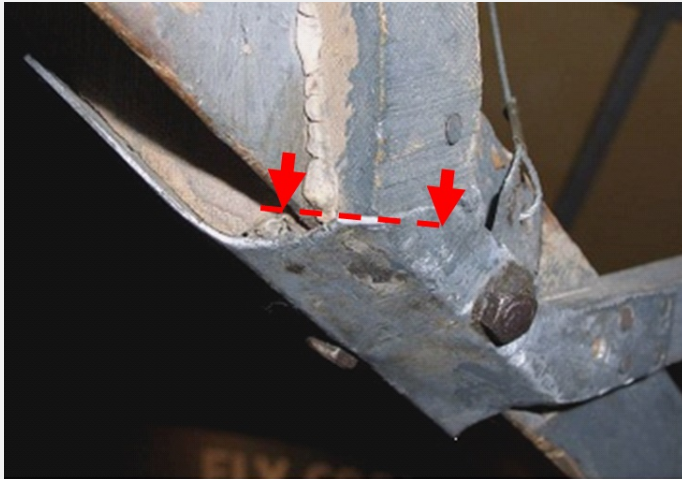
Fig. 2: Location of sampling area,

Sample cut from the corner of the fixation plate (Fig. 2). Dimensions: L = 4mm ; W = 1.2mm.

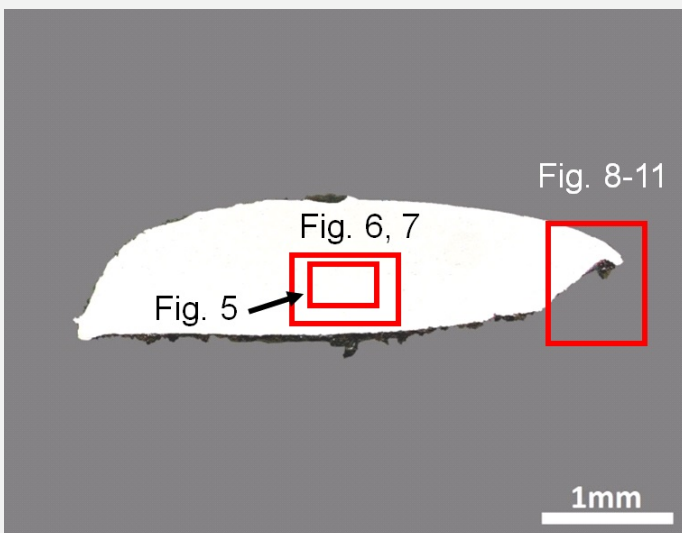
Fig. 3: Micrograph of the cross-section showing the location of Figs. 5 to 11,

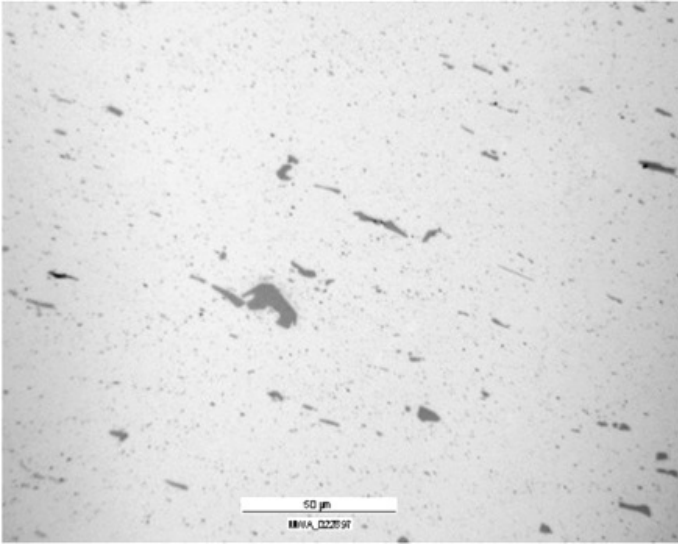
The metal is a relatively pure aluminium alloy with numerous inclusions (Table 1). From the chemical composition of the inclusions they can be interpreted as alpha-AlFeSi intermetallic compounds. In bright field we observe elongated inclusions indicating that the metal was rolled (Fig. 5). The alloy composition is similar to an unalloyed primary aluminium (Al content between 99 and 99.8 mass%). The O content reflects the immediate oxidation of the metal and is not part of the alloy. After etching the organisation of inclusions in rows is more easily seen (Fig. 6). The SEM image shows large grains formed after annealing (Fig. 7). The average hardness of the metal is HV1 40.

Fig. 5: Micrograph of the metal sample from Fig. 3 (detail), unetched, bright field. The metal matrix is in white, the elongated inclusions in grey,

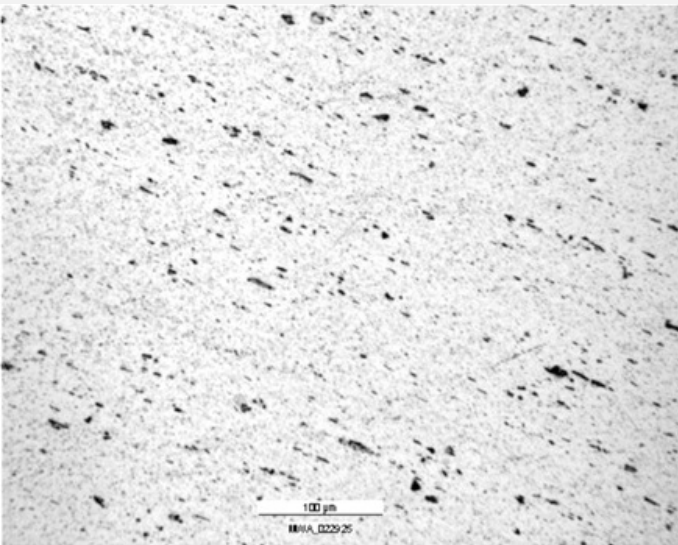
Fig. 6: Micrograph of the metal sample from Fig. 3 (detail), etched, bright field. The metal matrix is in white, the elongated inclusions in dark-grey and black,

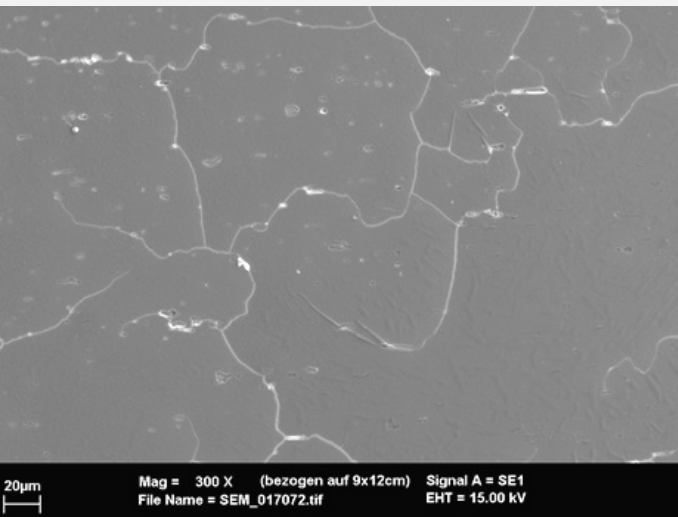
Fig. 7: SEM image of the metal sample from Fig. 3 (detail), SE-mode, etched. We observe the presence of large grains and numerous elongated inclusions,

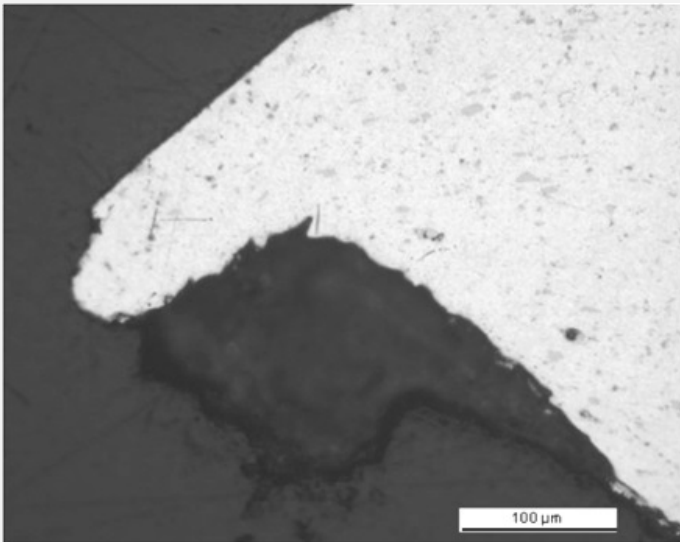
The metal is covered by a very thin corrosion layer (CP1). In addition to this, locally thicker "corrosion products" or adherent material can be observed (D1, appearing as dark-grey area in Fig. 8). Under polarized light, they appear blue-brown (Fig. 9). Analysis by SEM-EDS indicates that the metal is, as expected, covered by a very thin Al and O-rich layer whereas the particles in the adherent material contain C, O, Si, Ca, Fe, Zn, S and even Ti (Figs. 10 and 11). The location of the adherent material and the presence of both Zn and Ti suggest that it is a residue of a paint coating.

Fig. 8: Micrograph showing the metal - "corrosion products" interface from Fig. 3 (reversed picture, detail), unetched, bright field. We observe in white the metal matrix and dark-grey the adhering material,

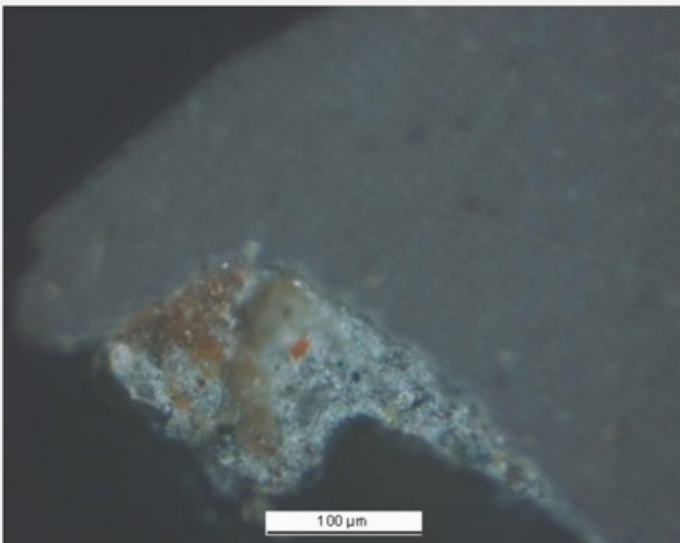
Fig. 9: Micrograph (same as Fig. 8) and corresponding to the stratigraphy of Fig. 4, unetched, polarised light. We observe in grey the metal matrix and blue-brown the adherent material,

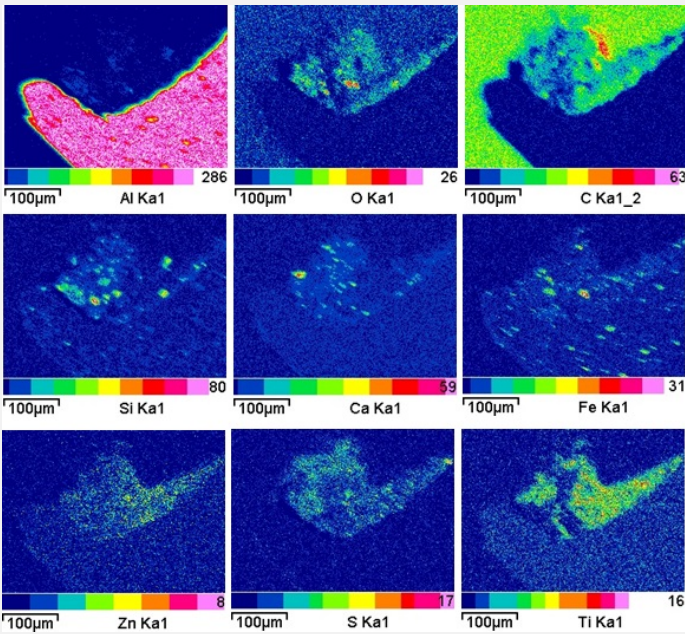
Fig. 11: Elemental chemical distribution of the selected area from Fig. 10. Method of examination: SEM/EDS, Laboratory of Analytical Chemistry, Empa,
