# AIRCRAFT REAR FASTENING PLATE VHS-497 - AL ALLOY - MODERN TIMES

**Artefact name** Aircraft rear fastening plate VHS-497

**Authors** Marianne. Senn (EMPA, Dübendorf, Zurich, Switzerland) & Christian. Degriigny (HE-Arc CR, Neuchâtel, Neuchâtel, Switzerland)

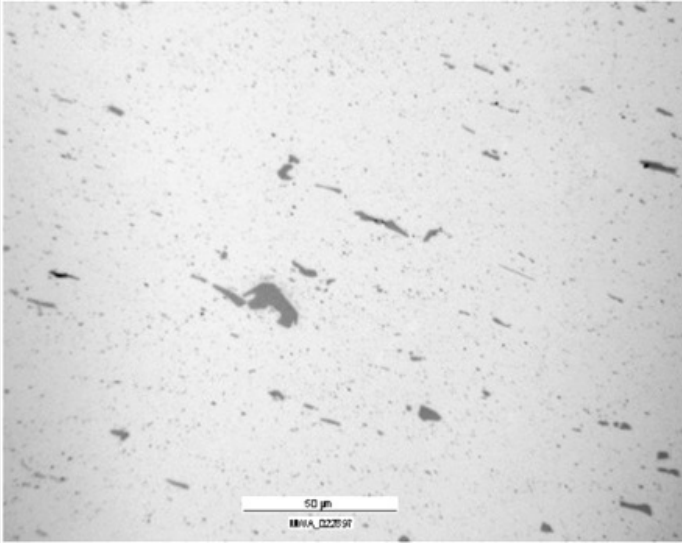
The metal is a relatively pure aluminium alloy with numerous inclusions (Table 1). From the chemical composition of the inclusions they can be interpreted as alpha-AlFeSi intermetallic compounds. In bright field we observe elongated inclusions indicating that the metal was rolled (Fig. 5). The alloy composition is similar to an unalloyed primary aluminium (Al content between 99 and 99.8 mass%). The O content reflects the immediate oxidation of the metal and is not part of the alloy. After etching the organisation of inclusions in rows is more easily seen (Fig. 6). The SEM image shows large grains formed after annealing (Fig. 7). The average hardness of the metal is HV1 40.

Fig. 5: Micrograph of the metal sample from Fig. 3 (detail), unetched, bright field. The metal matrix is in white, the elongated inclusions in grey.

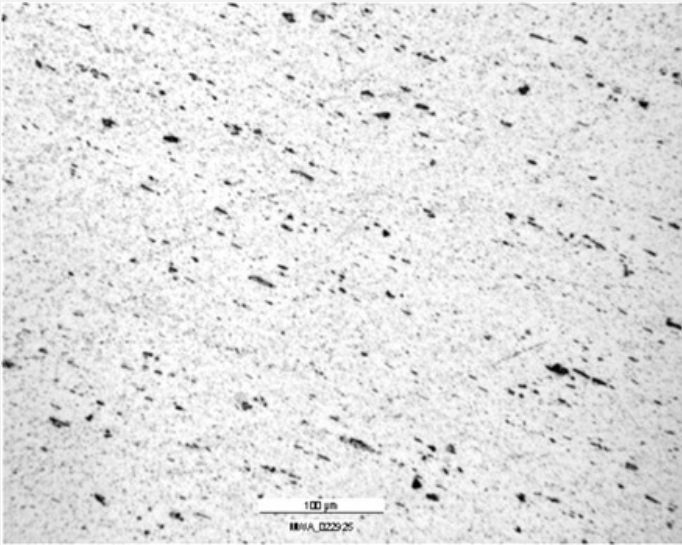
Fig. 6: Micrograph of the metal sample from Fig. 3 (detail), etched, bright field. The metal matrix is in white, the elongated inclusions in dark-grey and black,

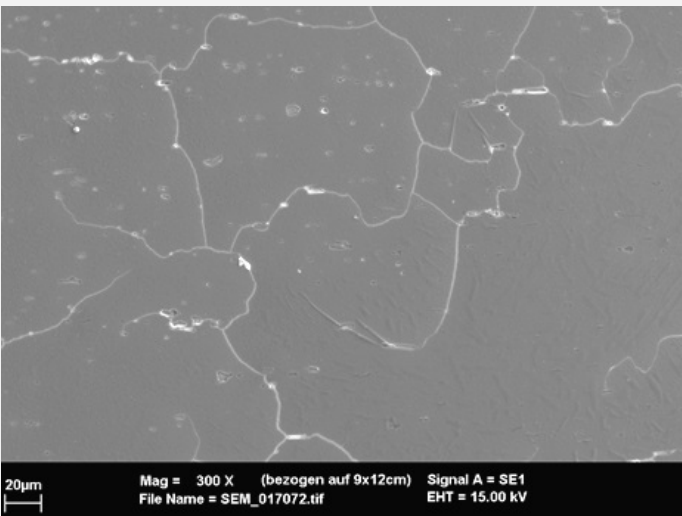
Fig. 7: SEM image of the metal sample from Fig. 3 (detail), SE-mode, etched. We observe the presence of large grains and numerous elongated inclusions,

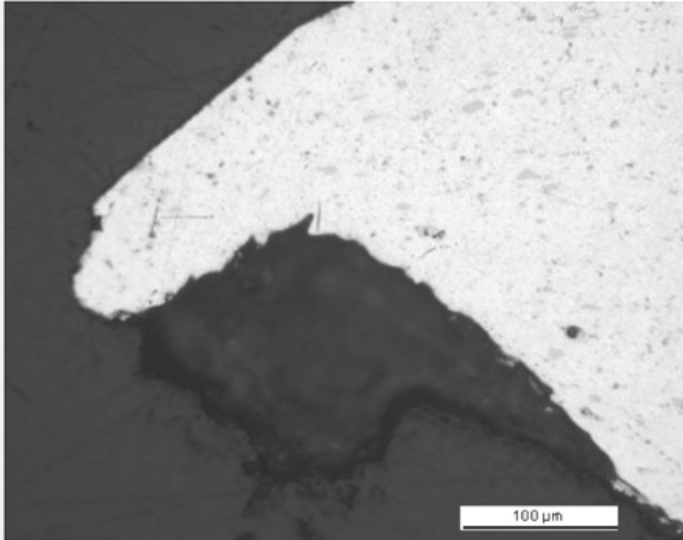
The metal is covered by a very thin corrosion layer (CP1). In addition to this, locally thicker "corrosion products" or adherent material can be observed (D1, appearing as dark-grey area in Fig. 8). Under polarized light, they appear blue-brown (Fig. 9). Analysis by SEM-EDS indicates that the metal is, as expected, covered by a very thin Al and O-rich layer whereas the particles in the adherent material contain C, O, Si, Ca, Fe, Zn, S and even Ti (Figs. 10 and 11). The location of the adherent material and the presence of both Zn and Ti suggest that it is a residue of a paint coating.

Fig. 8: Micrograph showing the metal - "corrosion products" interface from Fig. 3 (reversed picture, detail), unetched, bright field. We observe in white the metal matrix and dark-grey the adhering material,

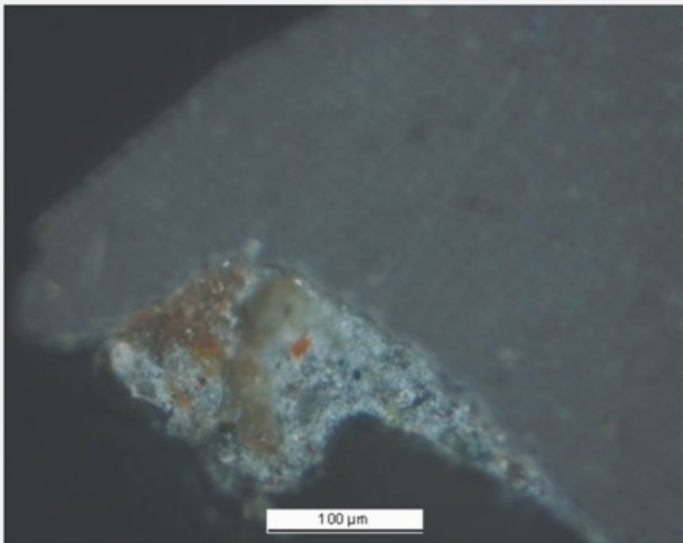
Fig. 9: Micrograph (same as Fig. 8) and corresponding to the stratigraphy of Fig. 4, unetched, polarised light. We observe in grey the metal matrix and blue-brown the adherent material,

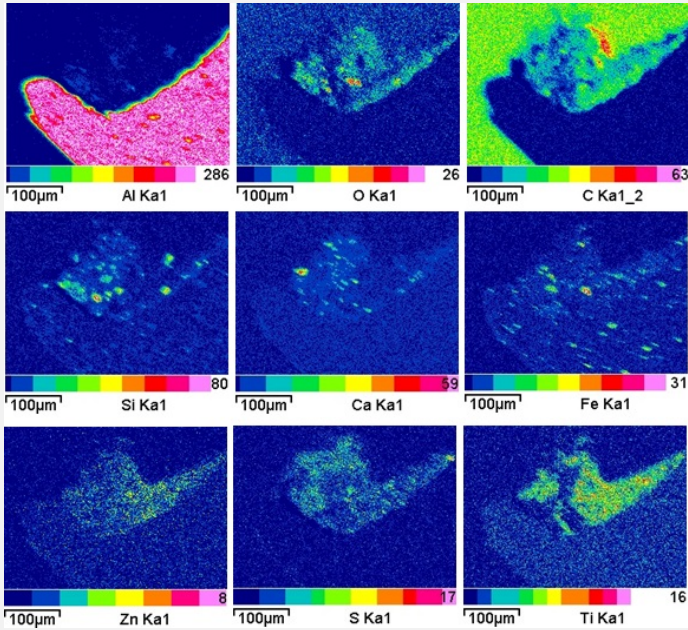
Fig. 11: Elemental chemical distribution of the selected area from Fig. 10. Method of examination: SEM/EDS, Laboratory of Analytical Chemistry, Empa,
