AIRCRAFT REAR FASTENING PLATE VHS-497 - AL ALLOY - MODERN TIMES

Artefact name	Aircraft rear fastening plate VHS-497
Authors	Marianne. Senn (EMPA, Dübendorf, Zurich, Switzerland) & Christian. Degriy (HE-Arc CR, Neuchâtel, Neuchâtel, Switzerland)
Url	/artefacts/466/

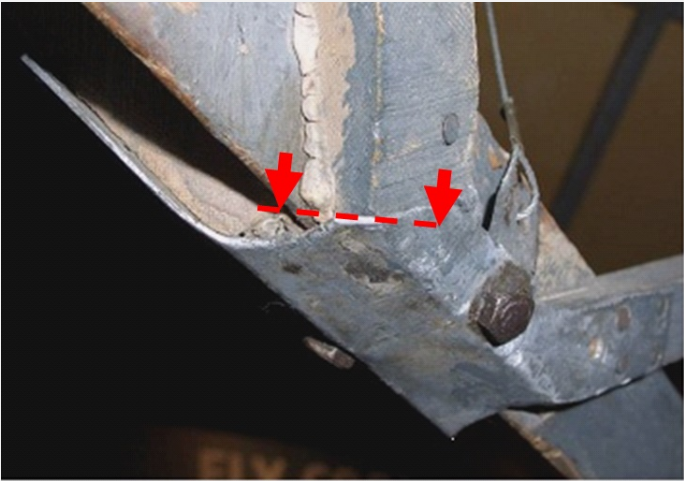
Fig. 2: Location of sampling area,

Sample cut from the corner of the fixation plate (Fig. 2). Dimensions: L = 4mm ; W = 1.2mm.

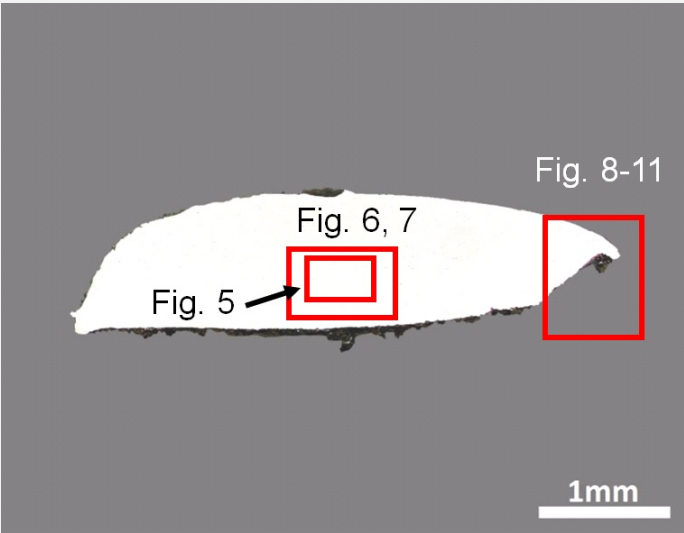
Fig. 3: Micrograph of the cross-section showing the location of Figs. 5 to 11,

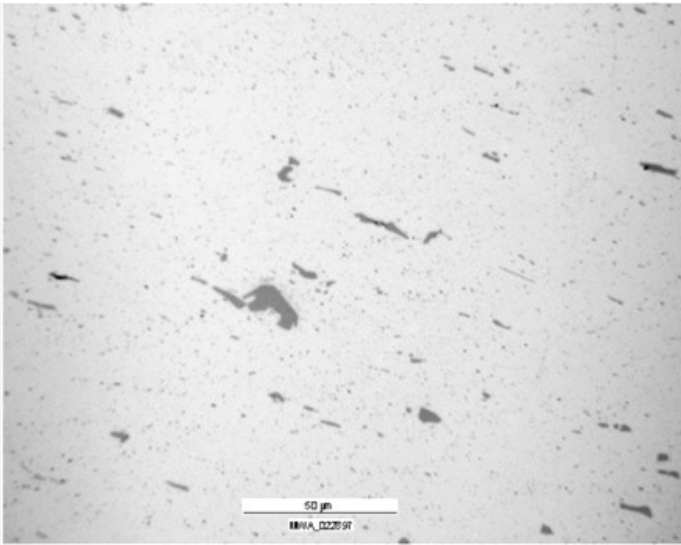
The metal is a relatively pure aluminium alloy with numerous inclusions (Table 1). From the chemical composition of the inclusions they can be interpreted as alpha-AlFeSi intermetallic compounds. In bright field we observe elongated inclusions indicating that the metal was rolled (Fig. 5). The alloy composition is similar to an unalloyed primary aluminium (Al content between 99 and 99.8 mass%). The O content reflects the immediate oxidation of the metal and is not part of the alloy. After etching the organisation of inclusions in rows is more easily seen (Fig. 6). The SEM image shows large grains formed after annealing (Fig. 7). The average hardness of the metal is HV1 40.

Fig. 5: Micrograph of the metal sample from Fig. 3 (detail), unetched, bright field. The metal matrix is in white, the elongated inclusions in grey,

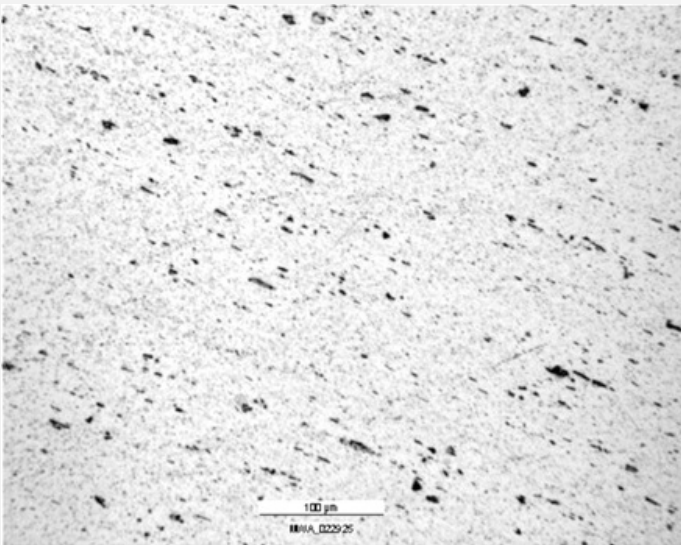
Fig. 6: Micrograph of the metal sample from Fig. 3 (detail), etched, bright field. The metal matrix is in white, the elongated inclusions in dark-grey and black,

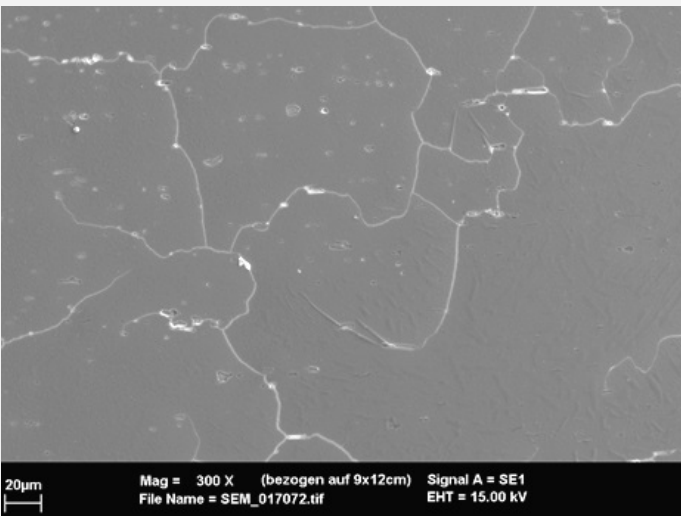
Fig. 7: SEM image of the metal sample from Fig. 3 (detail), SE-mode, etched. We observe the presence of large grains and numerous elongated inclusions,

Microstructure	Recrystallized structure with large grains
First metal element	Al
Other metal elements	Si

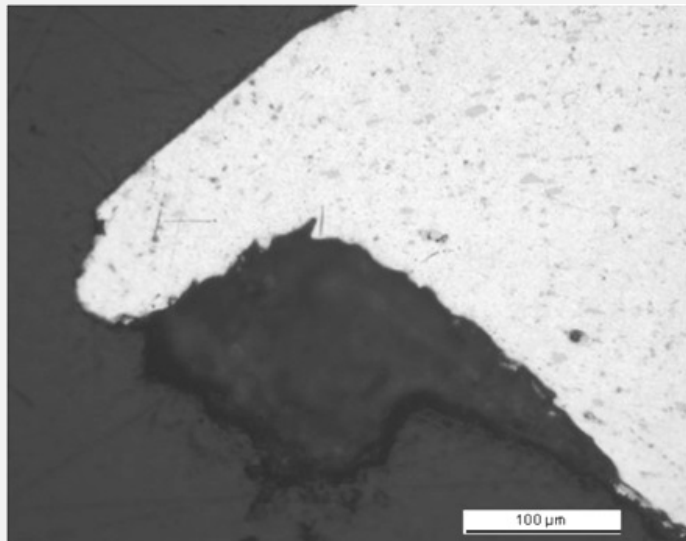
The metal is covered by a very thin corrosion layer (CP1). In addition to this, locally thicker “corrosion products” or adherent material can be observed (D1, appearing as dark-grey area in Fig. 8). Under polarized light, they appear blue-brown (Fig. 9). Analysis by SEM-EDS indicates that the metal is, as expected, covered by a very thin Al and O-rich layer whereas the particles in the adherent material contain C, O, Si, Ca, Fe, Zn, S and even Ti (Figs. 10 and 11). The location of the adherent material and the presence of both Zn and Ti suggest that it is a residue of a paint coating.

Fig. 8: Micrograph showing the metal - “corrosion products” interface from Fig. 3 (reversed picture, detail), unetched, bright field. We observe in white the metal matrix and dark-grey the adhering material,

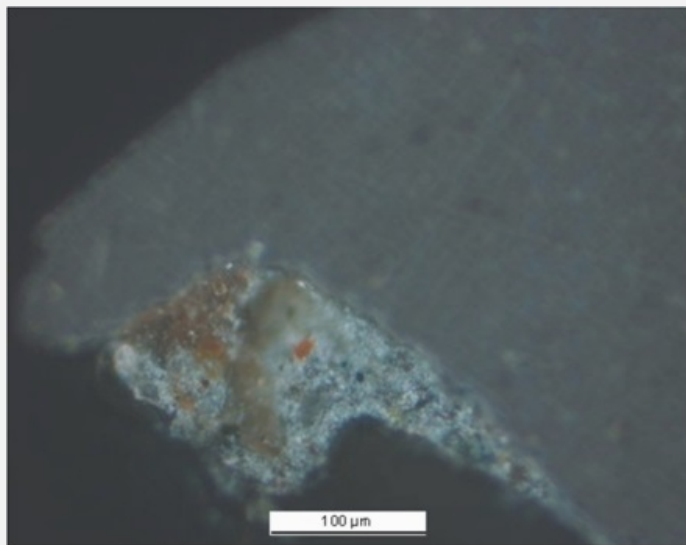
Fig. 9: Micrograph (same as Fig. 8) and corresponding to the stratigraphy of Fig. 4, unetched, polarised light. We observe in grey the metal matrix and blue-brown the adherent material,

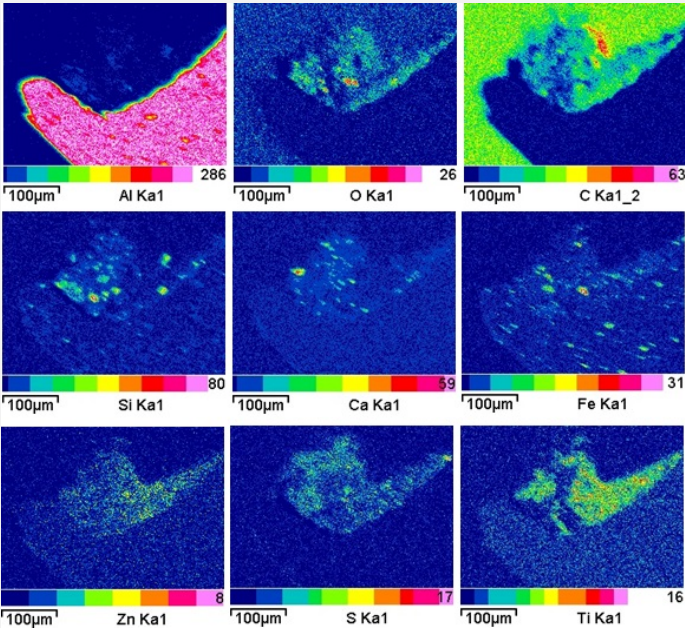
Fig. 11: Elemental chemical distribution of the selected area from Fig. 10. Method of examination: SEM/EDS, Laboratory of Analytical Chemistry, Empa,
