AIRCRAFT REAR FASTENING PLATE VHS-497 – AL ALLOY – MODERN TIMES

Artefact name Aircraft rear fastening plate VHS-497

Authors Marianne. Senn (EMPA, Dübendorf, Zurich, Switzerland) & Christian. Degriy (HE-Arc CR, Neuchâtel, Neuchâtel, Switzerland)

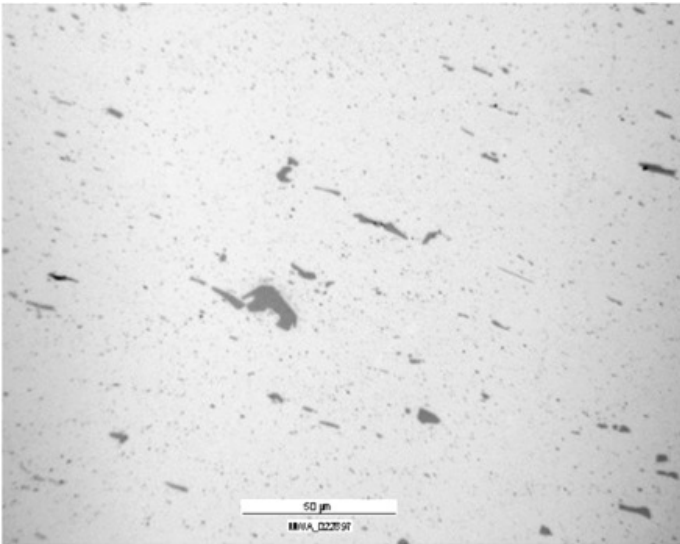
The metal is a relatively pure aluminium alloy with numerous inclusions (Table 1). From the chemical composition of the inclusions they can be interpreted as alpha-AlFeSi intermetallic compounds. In bright field we observe elongated inclusions indicating that the metal was rolled (Fig. 5). The alloy composition is similar to an unalloyed primary aluminium (Al content between 99 and 99.8 mass%). The O content reflects the immediate oxidation of the metal and is not part of the alloy. After etching the organisation of inclusions in rows is more easily seen (Fig. 6). The SEM image shows large grains formed after annealing (Fig. 7). The average hardness of the metal is HV1 40.

Fig. 5: Micrograph of the metal sample from Fig. 3 (detail), unetched, bright field. The metal matrix is in white, the elongated inclusions in grey,

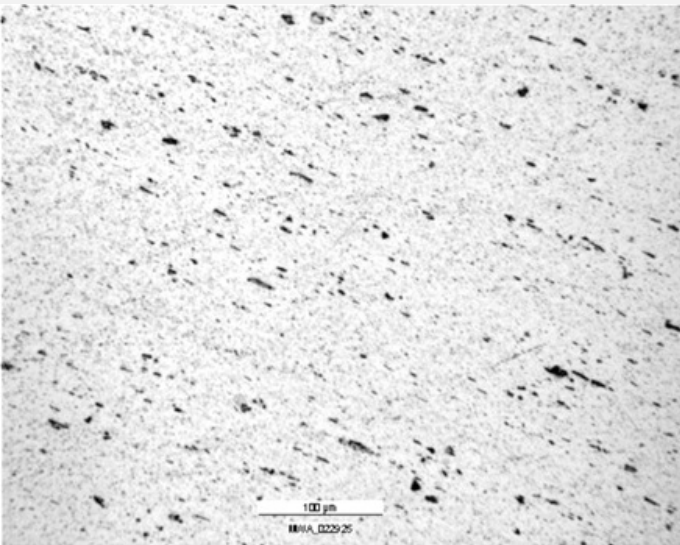
Fig. 6: Micrograph of the metal sample from Fig. 3 (detail), etched, bright field. The metal matrix is in white, the elongated inclusions in dark-grey and black,

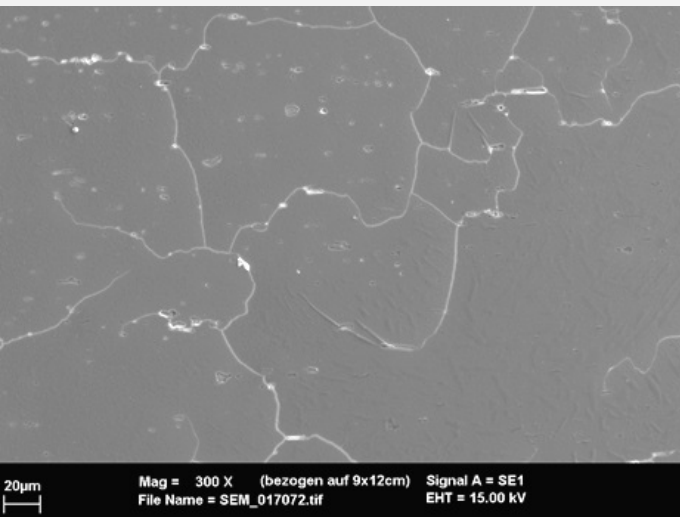
Fig. 7: SEM image of the metal sample from Fig. 3 (detail), SE-mode, etched. We observe the presence of large grains and numerous elongated inclusions,

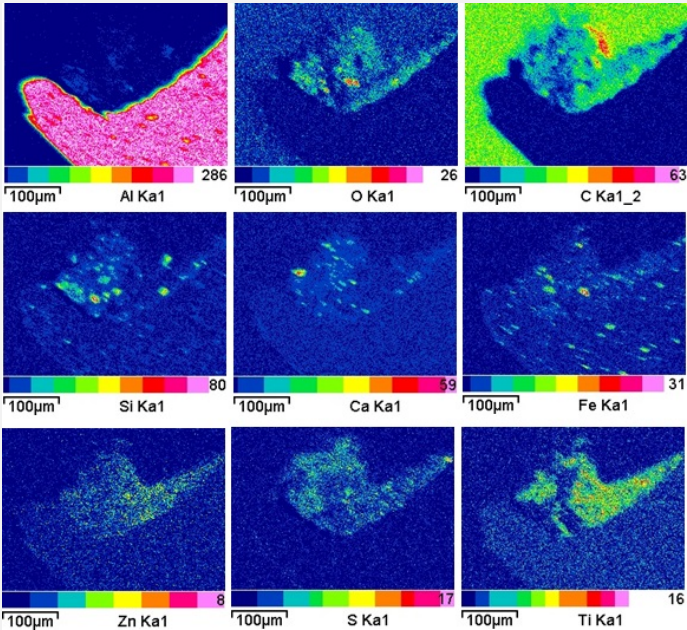
Fig. 11: Elemental chemical distribution of the selected area from Fig. 10. Method of examination: SEM/EDS, Laboratory of Analytical Chemistry, Empa,
