FITTING ON BACK PANEL OF A MILITARY CARRIAGE – THOMAS STEEL – MODERN TIMES – SWITZERLAND

Artefact name Fitting on back panel of a military carriage

Authors Marianne. Senn (EMPA, Dübendorf, Zurich, Switzerland) & Christian. Degrigny (HE-Arc CR, Neuchâtel, Neuchâtel,

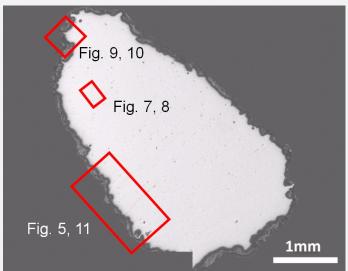
Fig. 3: Micrograph of the cross-section showing the location of Figs. 5 and 7 to 11, $\,$

covered by a thin corrosion layer (Fig. 3).

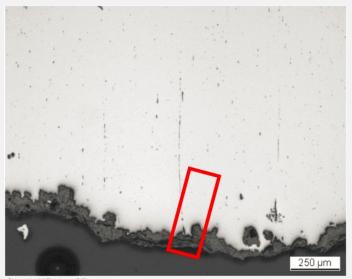
The remaining metal is a Mn-rich soft steel (C content around 0.1 mass%) containing manganese sulphide inclusions with a varying Fe content (Tables 1 and 2). The numerous inclusions form parallel rows (Fig. 5). This orientation is typical for hot rolled metal. After etching with Oberhoffer's reagent, three main welding seams (P-rich) become visible (Fig. 6). Near the surface they are also outlined by corrosion (Figs. 5 and 11). After nital etching, the metal shows a ferritic structure with tertiary cementite and lamellar pearlite at the grain boundaries (Figs. 7 and 8). The grains are small with an ASTM grain size of 10 and are recrystallized due to annealing after hot rolling. The average hardness of the metal is HV1 165. The hardness is slightly high for such a structure and this is due to the Mn content of the metal. The chemical composition, especially the Mn content and the presence of carbo-nitrides (not analysed here), is typical for Thomas steel.

Fig. 5: Micrograph of the metal sample from Fig. 3 (rotated by 270°, detail), unetched, bright field. We observe the metal including welding seams outlined by corrosion products and MnS inclusions. The mapped area of Fig. 11 is marked by the rectangle,

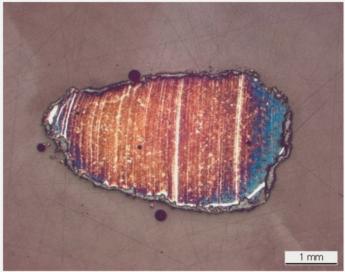
Fig. 6: Micrograph of the metal sample from Fig. 3, etched with Oberhoffer's reagent, bright field. We observe three P-rich welding seams in white,

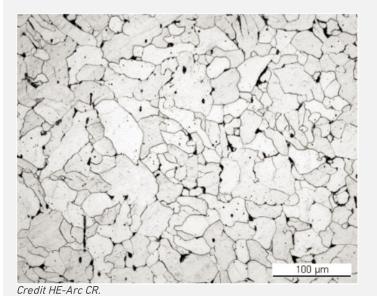
Fig. 7: Micrograph of the metal sample, nital etched, bright field. We observe tertiary cementite (black) on the grain boundaries,

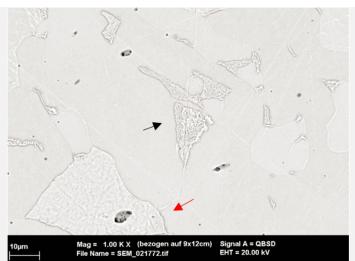
Fig. 8: SEM image of the metal sample from Fig. 3 (detail), BSE-mode, nital etched, bright field. The white ferrite grains contain lamellar pearlite (black arrow) and lenticular grey MnS inclusions (red arrow) in between the grain boundaries,

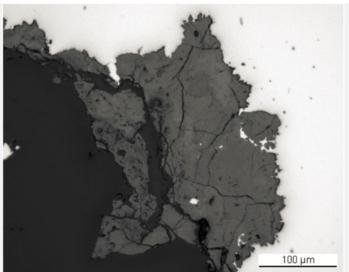
The average thickness of the corrosion products is about 80µm (Figs. 5 and 9). In bright field they appear grey, marbled and heavily cracked (Fig. 9). Under polarised light, the corrosion products appear orange to dark-brown (Fig. 10). At the metal - corrosion products interface they are dark-brown (CP3). The middle part (CP2) is red-orange and the outer part is bright orange (CP1). The elemental mapping of the corrosion layers shows no distinctive stratification, but areas near the metal - corrosion crust interface (CP3) as well as the top surface of the corrosion layer (CP1) seem to have a lower 0 content (Fig. 11). The 0 content indicates the presence of iron hydroxides (Table 3). Soil materials (such as rock fragments and dust) are found in the welding seams near the surface.

Fig. 9: Micrograph showing the metal - corrosion crust interface from Fig. 3 (rotated by 270°, detail), unetched, bright field. We observe in white the metal, in grey the corrosion products and in black the resin,

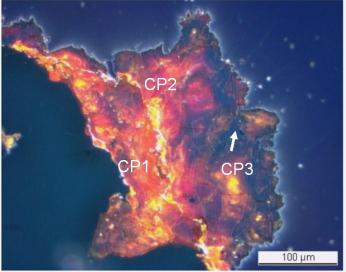
Fig. 10: Micrograph (same as Fig. 9) and corresponding to the stratigraphy of Fig. 4, unetched, polarised light. The corrosion products are dark-brown at the metal - corrosion crust interface and red-orange on the outside,

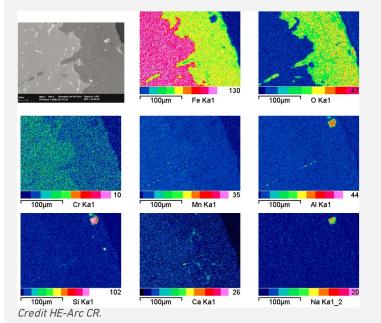
Table 3: Chemical composition (mass %) of the corrosion layer (from Fig. 11). Method of analysis: SEM/EDS, Laboratory of Analytical Chemistry, Empa.

Fig. 11: SEM image, BSE-mode, and elemental chemical distribution of the selected area from Fig. 5 (rotated by 270°, detail). Method of examination: SEM/EDS, Laboratory of Analytical Chemistry, Empa.
