FITTING ON BACK PANEL OF A MILITARY CARRIAGE – THOMAS STEEL – MODERN TIMES – SWITZERLAND

Fitting on back panel of a military carriage

Marianne. Senn (EMPA, Dübendorf, Zurich, Switzerland) & Christian. Degrigny (HE-Arc CR, Neuchâtel, Neuchâtel, Switzerland)

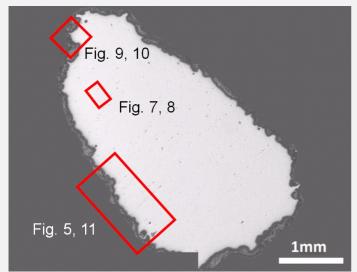
Fig. 2: Location of sampling area,

This sample is a cut from the corner of one of the two fittings on the back panel (Fig. 2). The metal is covered by a thin corrosion layer (Fig. 3).
Alloy	Thomas steel
Technology	Piled from several strips, hot rolled and annealed
Lab number of sample	POINT-Fe2
Sample location	Empa (Marianne Senn)
Responsible institution	Historical Swiss Army Material Foundation, Burgdorf, Bern
Date and aim of sampling	05/2009 metallography

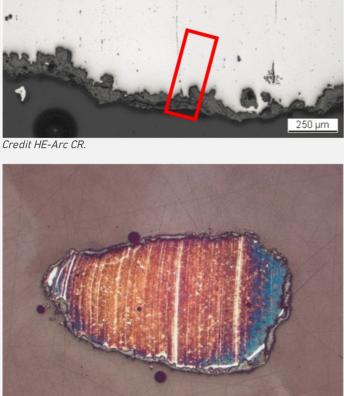
The remaining metal is a Mn-rich soft steel (C content around 0.1 mass%) containing manganese sulphide inclusions with a varying Fe content (Tables 1 and 2). The numerous inclusions form parallel rows (Fig. 5). This orientation is typical for hot rolled metal. After etching with Oberhoffer's reagent, three main welding seams (P-rich) become visible (Fig. 6). Near the surface they are also outlined by corrosion (Figs. 5 and 11). After nital etching, the metal shows a ferritic structure with tertiary cementite and lamellar pearlite at the grain boundaries (Figs. 7 and 8). The grains are small with an ASTM grain size of 10 and are recrystallized due to annealing after hot rolling. The average hardness of the metal is HV1 165. The hardness is slightly high for such a structure and this is due to the Mn content of the metal. The chemical composition, especially the Mn content and the presence of carbo-nitrides (not analysed here), is typical for Thomas steel.

Fig. 5: Micrograph of the metal sample from Fig. 3 (rotated by 270°, detail), unetched, bright field. We observe the metal including welding seams outlined by corrosion products and MnS inclusions. The mapped area of Fig. 11 is marked by the rectangle,

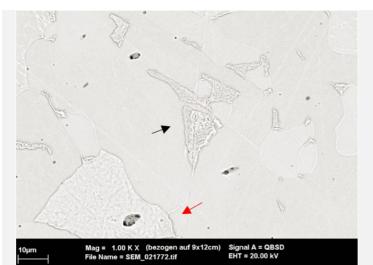
Fig. 7: Micrograph of the metal sample, nital etched, bright field. We observe tertiary cementite (black) on the grain boundaries,

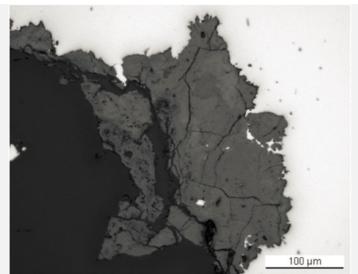
The average thickness of the corrosion products is about 80µm (Figs. 5 and 9). In bright field they appear grey, marbled and heavily cracked (Fig. 9). Under polarised light, the corrosion products appear orange to dark-brown (Fig. 10). At the metal - corrosion products interface they are dark-brown (CP3). The middle part (CP2) is red-orange and the outer part is bright orange (CP1). The elemental mapping of the corrosion layers shows no distinctive stratification, but areas near the metal - corrosion crust interface (CP3) as well as the top surface of the corrosion layer (CP1) seem to have a lower 0 content (Fig. 11). The 0 content indicates the presence of iron hydroxides (Table 3). Soil materials (such as rock fragments and dust) are found in the welding seams near the surface.

Fig. 9: Micrograph showing the metal - corrosion crust interface from Fig. 3 (rotated by 270°, detail), unetched, bright field. We observe in white the metal, in grey the corrosion products and in black the resin,

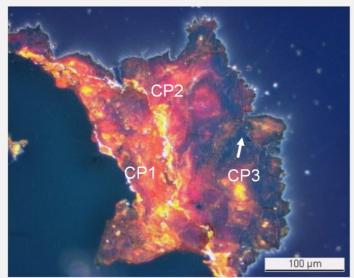
Fig. 10: Micrograph (same as Fig. 9) and corresponding to the stratigraphy of Fig. 4, unetched, polarised light. The corrosion products are dark-brown at the metal - corrosion crust interface and red-orange on the outside,

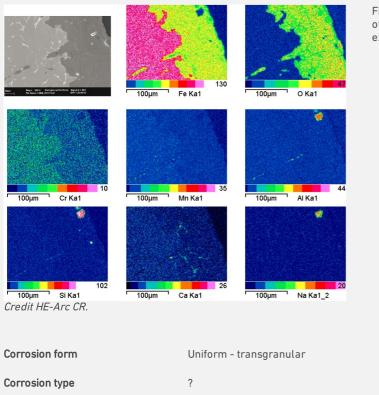
Table 3: Chemical composition (mass %) of the corrosion layer (from Fig. 11). Method of analysis: SEM/EDS, Laboratory of Analytical Chemistry, Empa.

Fig. 11: SEM image, BSE-mode, and elemental chemical distribution of the selected area from Fig. 5 (rotated by 270°, detail). Method of examination: SEM/EDS, Laboratory of Analytical Chemistry, Empa.
