SHOE NAIL 2637 1370.B. - HYPOEUTECTOID STEEL - ROMAN TIMES -**SWITZERLAND**

Artefact name Shoe nail 2637 1370.B.

Authors Christian. Degrigny (HE-Arc CR, Neuchâtel, Neuchâtel, Switzerland) & Valentin. Boissonnas (HE-Arc CR, Neuchâtel,

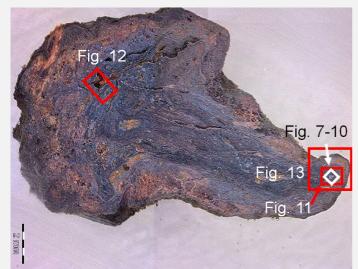
Fig. 4: Micrograph of the cross-section showing the location of figs. $7\ \text{to } 13$

Description of sampleA longitudinal cut through the nail (Fig. 4). Dimensions: L = 16.4mm; W = about 12.0mm.

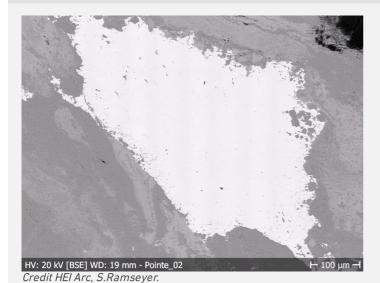
The remaining metal is an hypoeutectoid steel (Fig. 7 and 8), containing Fe, Si and O slags inclusions (possibly fayalite FeO,SiO2), and consisting of less than 1% of the total volume of the highly mineralized nail. After Nital etching, it shows intergranular corrosion on one of its sides (Figs. 9 and 10).

Fig. 7: SEM, BSE-mode picture of remaining metal,

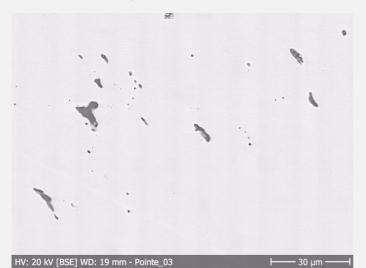
Fig. 8: SEM, BSE-mode picture of inclusions in remaining metal,

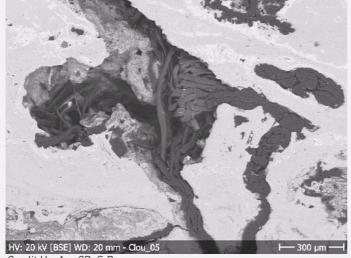
Fig. 12: Micrograph (SEM - BSE-mode) of another void filled with fibers in the head of the nail,

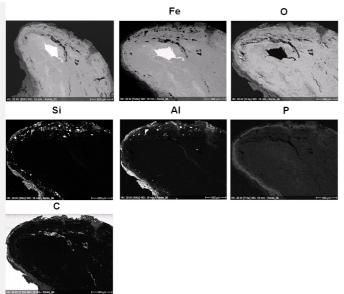
Si, Al, P and K can be considered external markers, helping to determine the limit of the original surface (Fig. 13 and Table 1). The outer layer of corrosion products (CP1-3) ranges from dark grey to orange in bright field and contains less 0 and Fe on its borders than the inner layer (CP4-5, Figs. 4 and 13, Table 1). The SEM pictures show a marbling appearance of the inner corrosion layer (CP5). Cl and S do not seem to be present in the sampled nail.

Fig. 13: Elemental chemical distribution of the selected area from Fig. 4 (90° counter-clockwise rotated). SEM-EDS,
