TOWEL BAR – AL ALLOY – MODERN TIMES – FRANCE

Artefact name	Towel bar
Authors	Christian. Degriigny (HE-Arc CR, Neuchâtel, Neuchâtel, Switzerland)
Url	/artefacts/470/

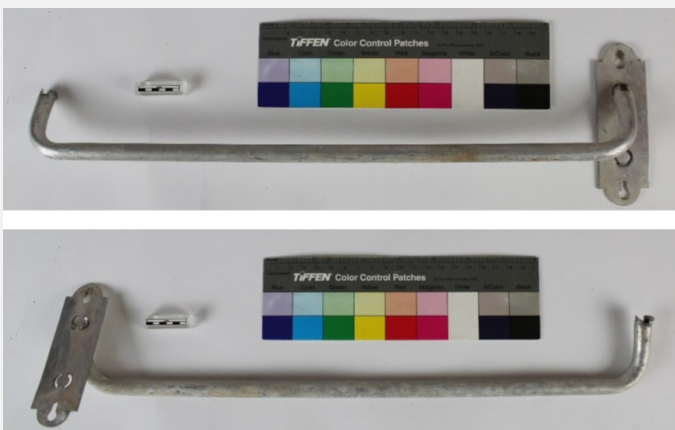
Fig. 1: Front and back sides of a towel bar,

Description of the artefact	Towel bar with traces of use and a broken section (Fig. 1). White deposits have developed on the metal surface. Dimensions: L = 45cm.
Type of artefact	Household implement
Origin	Château de Germolles, Mellecey, Bourgogne, France
Recovering date	Unknown
Chronology category	Modern Times
chronology tpq	1801 A.D. ▼
chronology taq	2000 A.D. ▼
Chronology comment	19th - 20th century
Burial conditions / environment	Indoor atmosphere

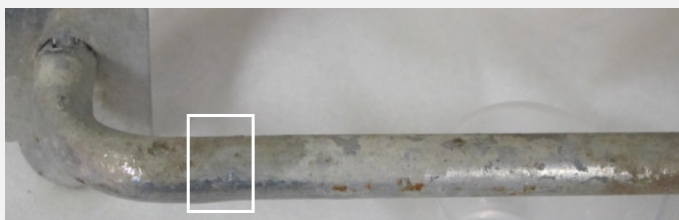
Fig. 2: Detail of the back side of the towel bar showing the location of the sampling area,

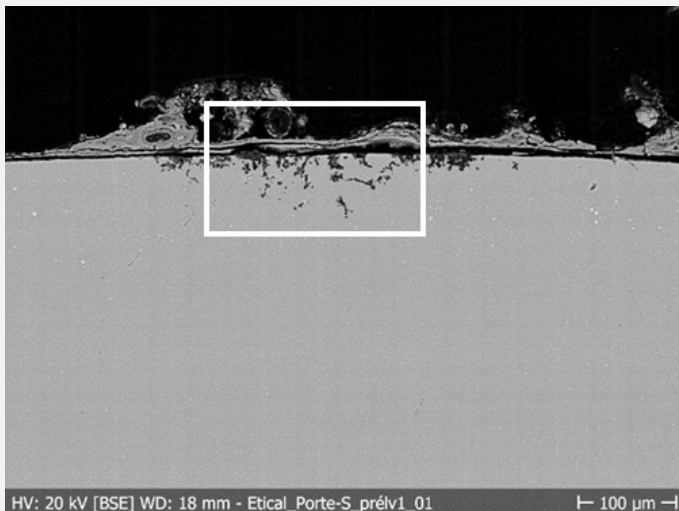
Fig. 3: SEM image of the cross-section showing the location of Fig. 5,

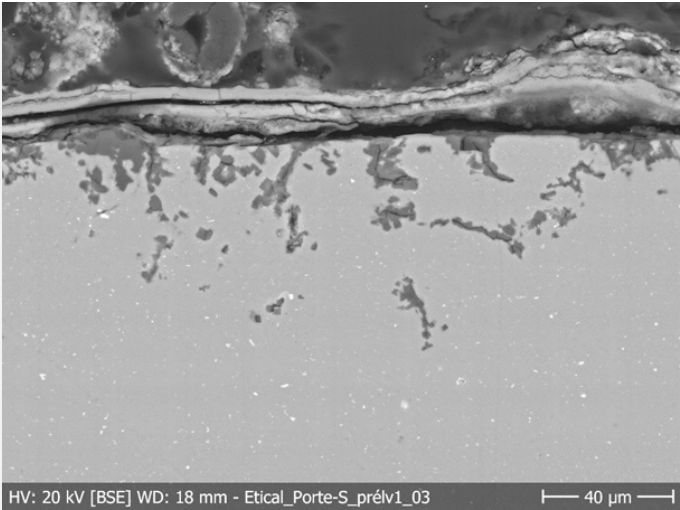
The metal is a relatively pure aluminium alloy with numerous inclusions (Fig. 5). From their chemical composition they can be interpreted as Al_3Fe intermetallic compounds (Fig. 6). Pitting corrosion as well as a start of intergranular corrosion develops locally under the deposits, outlining some of the grains (Fig. 5).

Fig. 5: SEM image of the metal sample from Fig. 3 (detail), BSE-mode. We observe the presence of numerous inclusions,

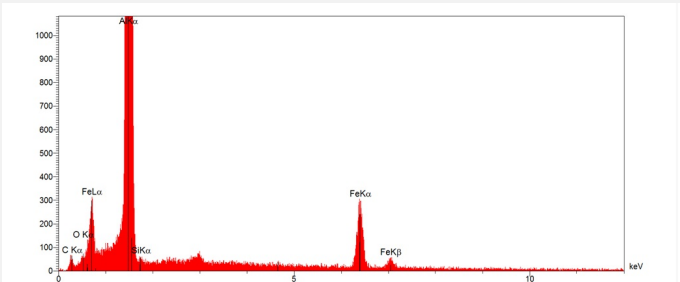
Fig. 6: EDS spectrum of the inclusions of Fig. 5,

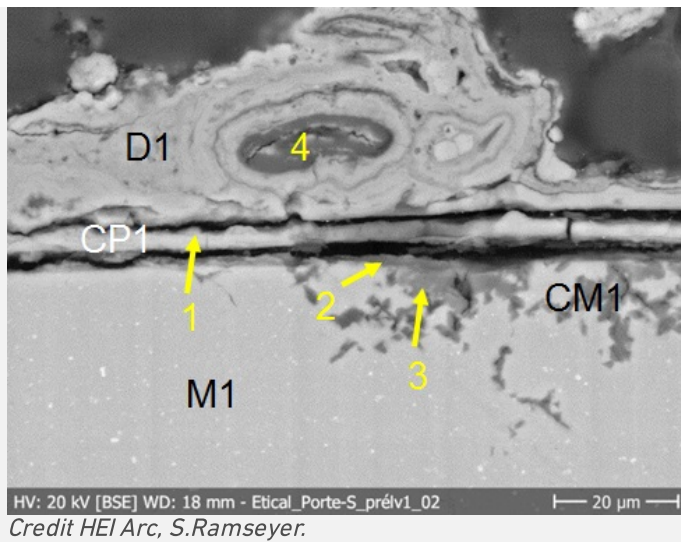
A very thin and loose oxide film has formed on the metal surface (CP1) and is locally covered by white deposits (D1). Intergranular corrosion has developed under the deposits (Fig. 7). Analysis by SEM-EDS indicates that the Al and O-rich oxide layer is contaminated with P and Si (area 1 on Fig. 7 and Fig. 8). These elements are even more present at the interface between CM1 and CP1 with Cl and S (area 2 on Fig. 7 and Fig. 9). The concentration of P and Si decreases in CM1 (area 3 on Fig. 7 and Fig. 10) while the concentration of S and Cl increases (Fig. 11). The deposit is mainly constituted of Ca, O, C and Si (probably CaCO3 and SiO2, area 4 on Fig. 7 and Fig. 12).

Fig. 7: SEM picture with location of EDS analyses of areas 1 to 4), BSE-mode. From bottom to top: the metal (M1) in light grey, the corroded metal (CM1), CP1 and D1,

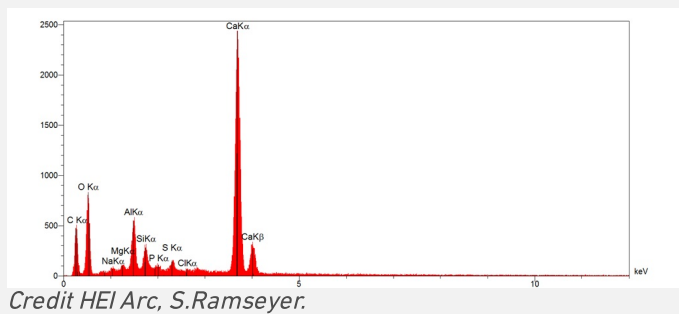
Fig. 8: EDS spectrum of area 1 of Fig. 7,

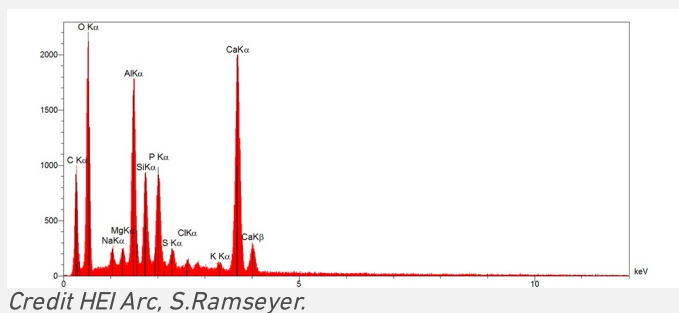
Fig. 9: EDS spectrum of area 2 of Fig. 7,

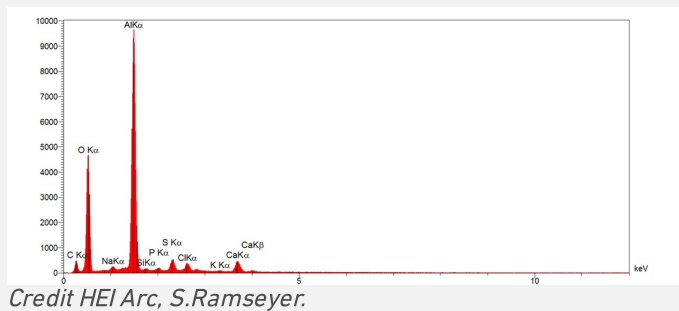
Fig. 10: EDS spectrum of area 3 of Fig. 7,

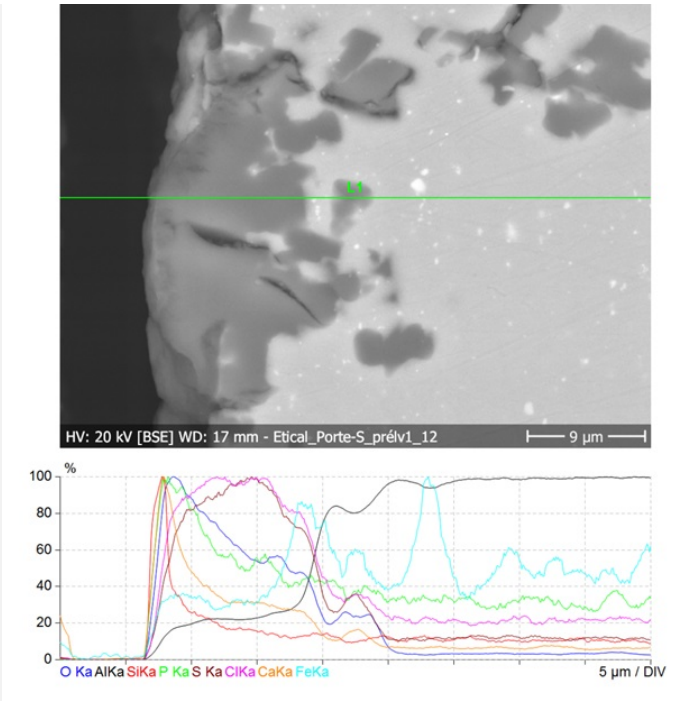
Fig. 11: EDS Linescan from CM1 to M1,

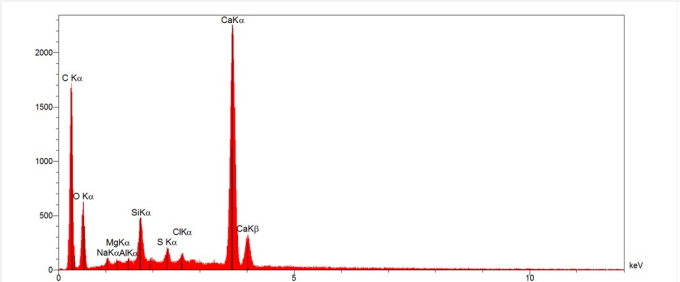
Fig. 12: EDS spectrum of area 4 of Fig. 7,
