TOWEL BAR – AL ALLOY – MODERN TIMES – FRANCE

Artefact name Towel bar
Authors Christian. Degriigny (HE-Arc CR, Neuchâtel, Neuchâtel, Switzerland)
Url /artefacts/470/

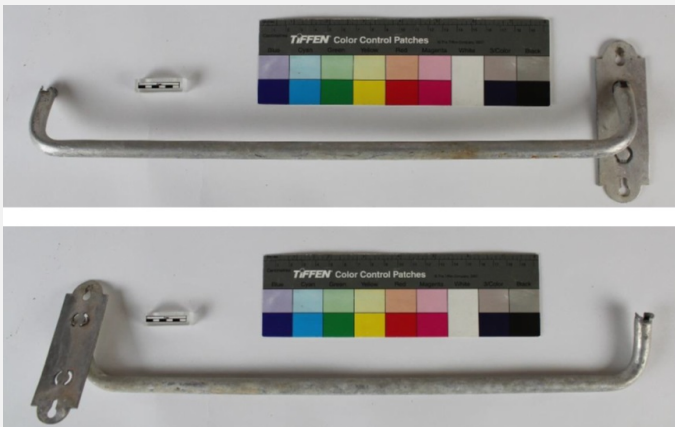
Fig. 1: Front and back sides of a towel bar,

Description of the artefact	Towel bar with traces of use and a broken section (Fig. 1). White deposits have developed on the metal surface. Dimensions: L = 45cm.
Type of artefact	Household implement
Origin	Château de Germolles, Mellecey, Bourgogne, France
Recovering date	Unknown
Chronology category	Modern Times
chronology tpq	<input type="text" value="1801"/> A.D. ▾
chronology taq	<input type="text" value="2000"/> A.D. ▾
Chronology comment	19th - 20th century
Burial conditions / environment	Indoor atmosphere

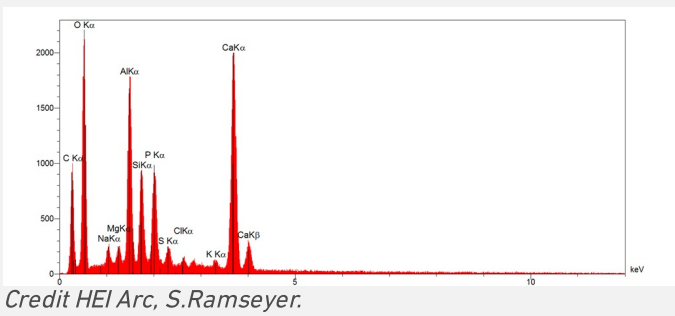
Fig. 9: EDS spectrum of area 2 of Fig. 7,

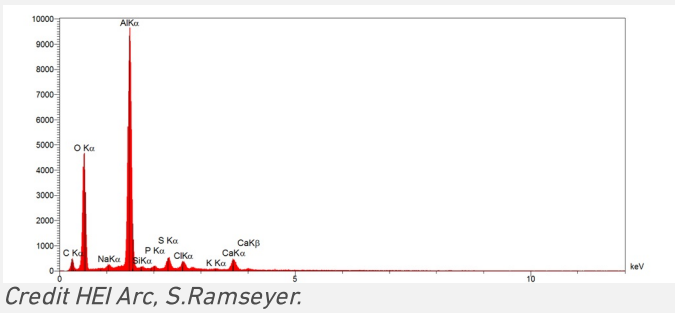
Fig. 10: EDS spectrum of area 3 of Fig. 7,

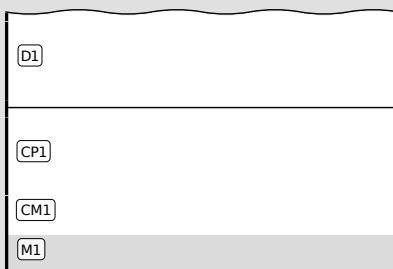
Fig. 4: Stratigraphic representation of the object in cross-section using the MiCorr application. The characteristics of the strata are only accessible by clicking on the drawing that redirects you to the search tool by stratigraphy representation. This representation can be compared to Fig. 9, Credit HE-Arc CR, C.Degrigny.
