TOWEL BAR - AL ALLOY - MODERN TIMES - FRANCE

Artefact name Towel bar

Authors Christian. Degrigny (HE-Arc CR, Neuchâtel, Neuchâtel, Switzerland)

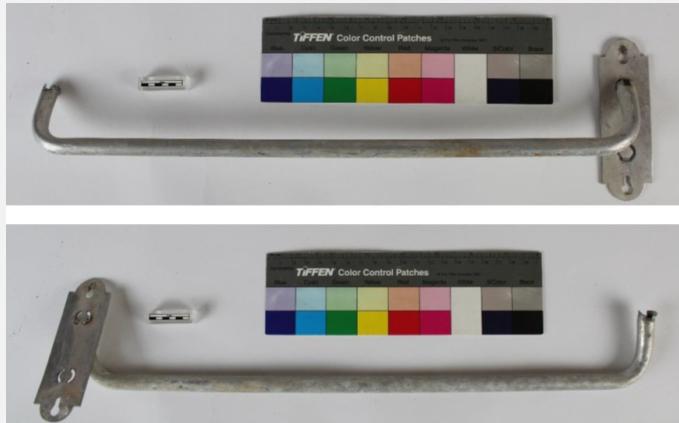
Fig. 1: Front and back sides of a towel bar,

Description of the artefact Towel bar with traces of use and a broken section (Fig. 1). White deposits have developed on the metal surface. Dimensions: L = 45cm.

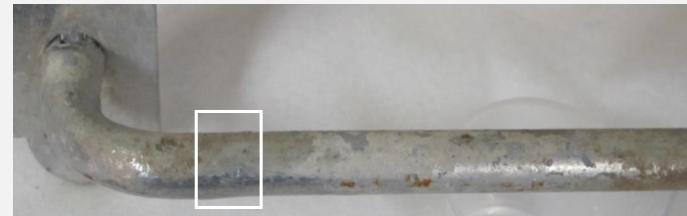
Fig. 2: Detail of the back side of the towel bar showing the location of the sampling area,

Sample cut from the back side of the towel bar (Fig. 2).

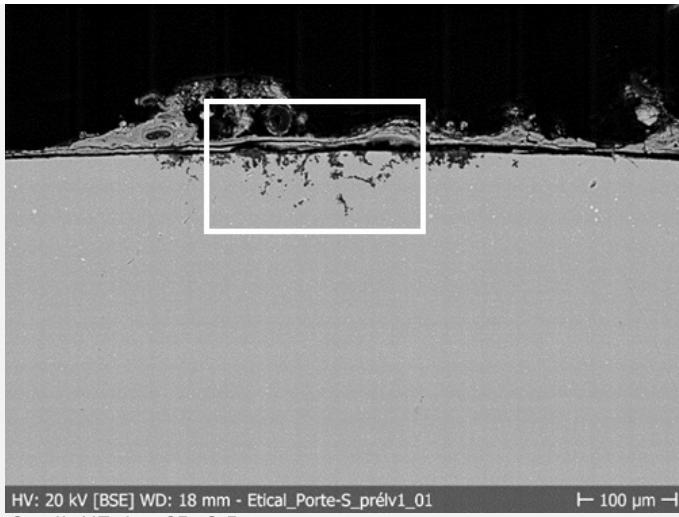
Fig. 3: SEM image of the cross-section showing the location of Fig. 5,

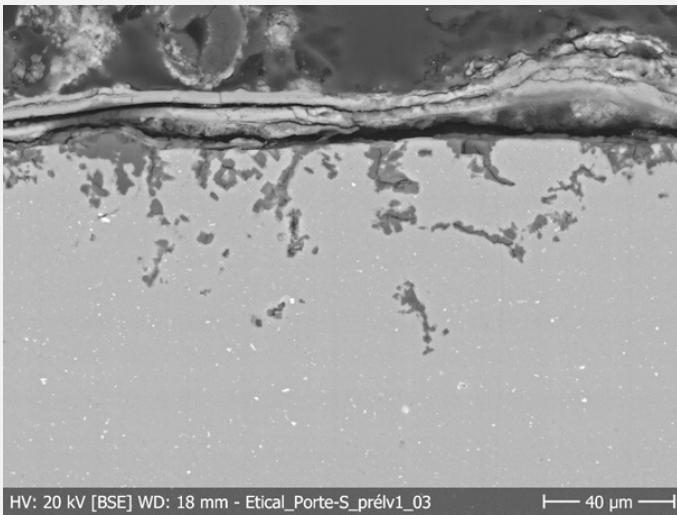
The metal is a relatively pure aluminium alloy with numerous inclusions (Fig. 5). From their chemical composition they can be interpreted as Al₃Fe intermetallic compounds (Fig. 6). Pitting corrosion as well as a start of intergranular

corrosion develops locally under the deposits, outlining some of the grains (Fig. 5).

Fig. 5: SEM image of the metal sample from Fig. 3 (detail), BSE-mode. We observe the presence of numerous inclusions,

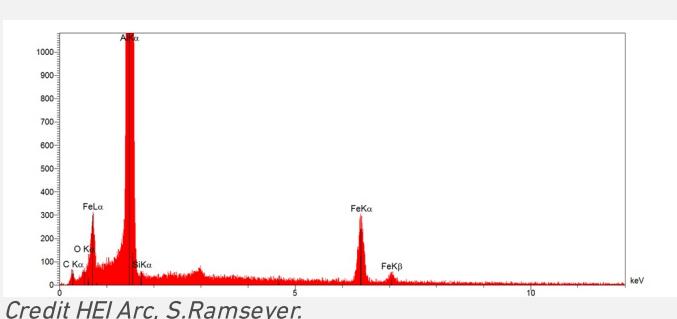
Fig. 6: EDS spectrum of the inclusions of Fig. 5,

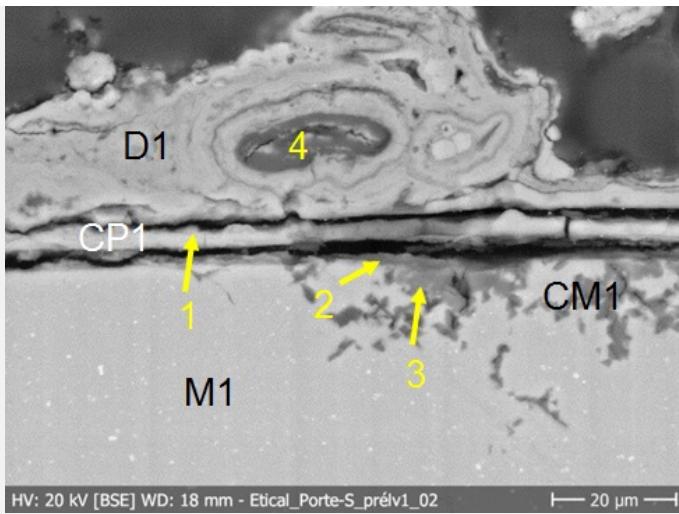
A very thin and loose oxide film has formed on the metal surface (CP1) and is locally covered by white deposits (D1). Intergranular corrosion has developed under the deposits (Fig. 7). Analysis by SEM-EDS indicates that the Al and O-rich oxide layer is contaminated with P and Si (area 1 on Fig. 7 and Fig. 8). These elements are even more present at the interface between CM1 and CP1 with Cl and S (area 2 on Fig. 7 and Fig. 9). The concentration of P and Si decreases in CM1 (area 3 on Fig. 7 and Fig. 10) while the concentration of S and Cl increases (Fig. 11). The deposit is mainly constituted of Ca, O, C and Si (probably CaCO₃ and SiO₂, area 4 on Fig. 7 and Fig. 12).

Fig. 7: SEM picture with location of EDS analyses of areas 1 to 4), BSE-mode. From bottom to top: the metal (M1) in light grey, the corroded metal (CM1), CP1 and D1,
