TOWEL BAR – AL ALLOY – MODERN TIMES – FRANCE

Artefact name Towel bar

Authors Christian. Degriigny (HE-Arc CR, Neuchâtel, Neuchâtel, Switzerland)

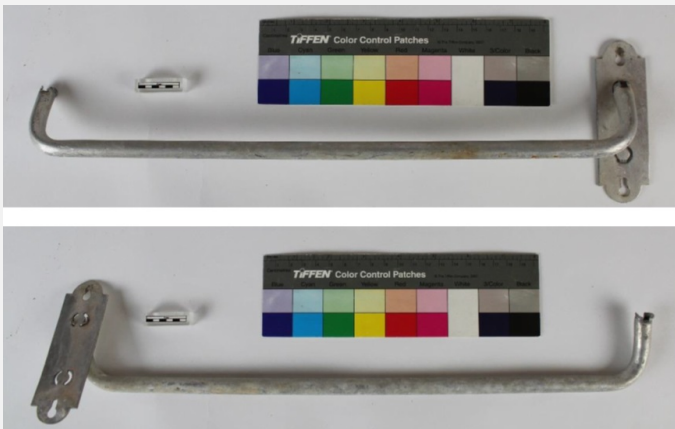
Fig. 1: Front and back sides of a towel bar,

Description of the artefact	Towel bar with traces of use and a broken section (Fig. 1). White deposits have developed on the metal surface. Dimensions: L = 45cm.
Type of artefact	Household implement
Origin	Château de Germolles, Mellecey, Bourgogne, France
Recovering date	Unknown
Chronology category	Modern Times
chronology tpq	<input type="text" value="1801"/> A.D. ▼
chronology taq	<input type="text" value="2000"/> A.D. ▼
Chronology comment	19th - 20th century
Burial conditions / environment	Indoor atmosphere

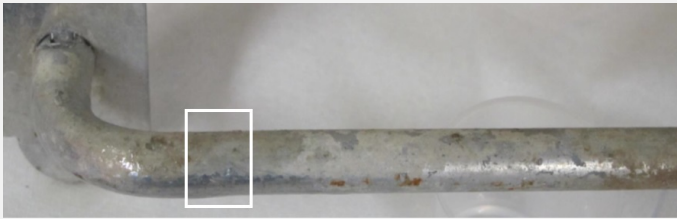
Fig. 2: Detail of the back side of the towel bar showing the location of the sampling area,

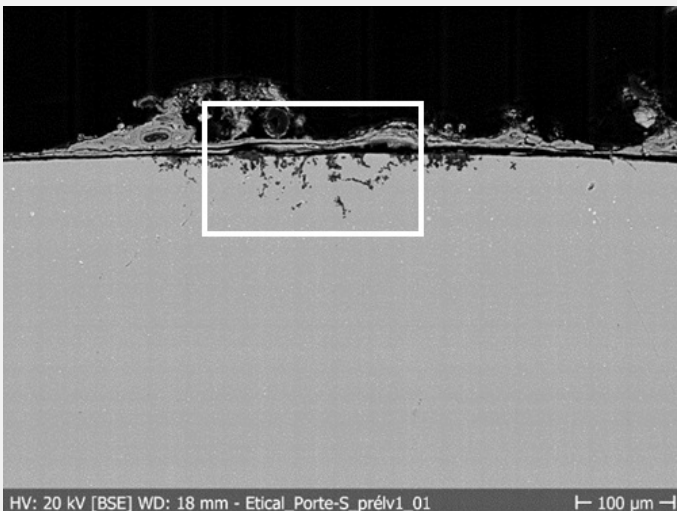
Fig. 3: SEM image of the cross-section showing the location of Fig. 5,

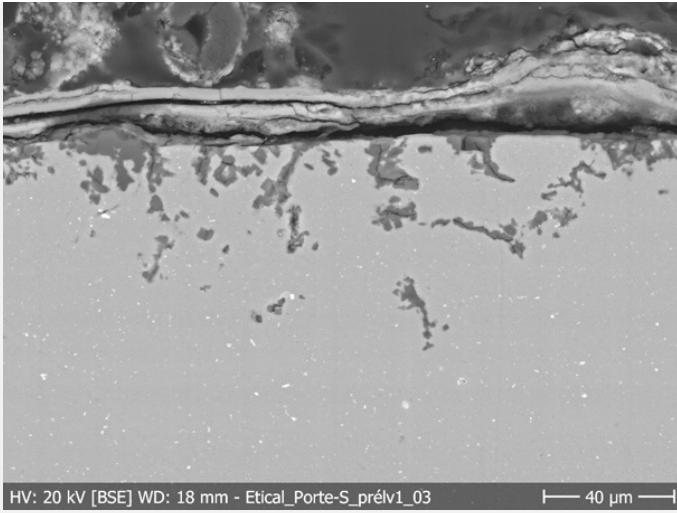
The metal is a relatively pure aluminium alloy with numerous inclusions (Fig. 5). From their chemical composition they can be interpreted as Al₃Fe intermetallic compounds (Fig. 6). Pitting corrosion as well as a start of intergranular corrosion develops locally under the deposits, outlining some of the grains (Fig. 5).

Fig. 5: SEM image of the metal sample from Fig. 3 (detail), BSE-mode. We observe the presence of numerous inclusions,

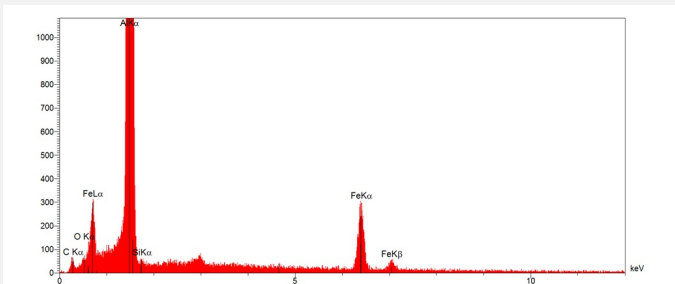
Fig. 6: EDS spectrum of the inclusions of Fig. 5,

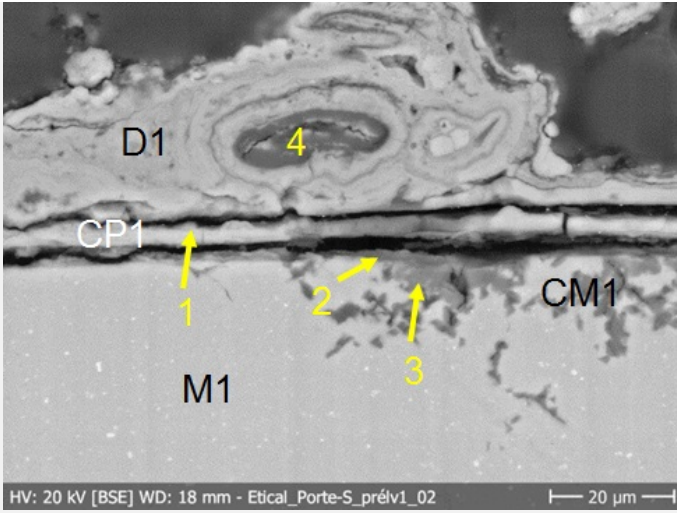
A very thin and loose oxide film has formed on the metal surface (CP1) and is locally covered by white deposits (D1). Intergranular corrosion has developed under the deposits (Fig. 7). Analysis by SEM-EDS indicates that the Al and O-rich oxide layer is contaminated with P and Si (area 1 on Fig. 7 and Fig. 8). These elements are even more present at the interface between CM1 and CP1 with Cl and S (area 2 on Fig. 7 and Fig. 9). The concentration of P and Si decreases in CM1 (area 3 on Fig. 7 and Fig. 10) while the concentration of S and Cl increases (Fig. 11). The deposit is mainly constituted of Ca, O, C and Si (probably CaCO₃ and SiO₂, area 4 on Fig. 7 and Fig. 12).

Fig. 7: SEM picture with location of EDS analyses of areas 1 to 4), BSE-mode. From bottom to top: the metal (M1) in light grey, the corroded metal (CM1), CP1 and D1,

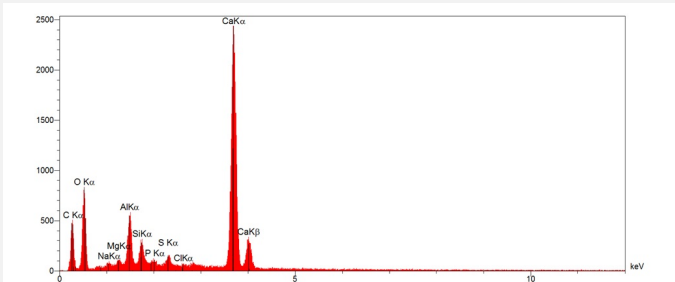
Fig. 8: EDS spectrum of area 1 of Fig. 7,

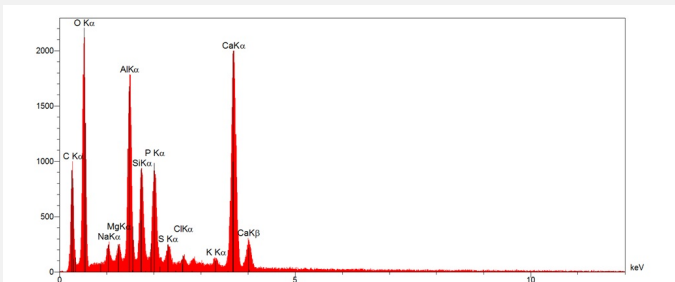
Fig. 9: EDS spectrum of area 2 of Fig. 7,

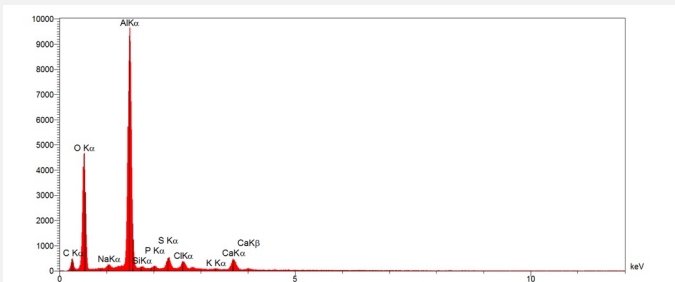
Fig. 10: EDS spectrum of area 3 of Fig. 7,

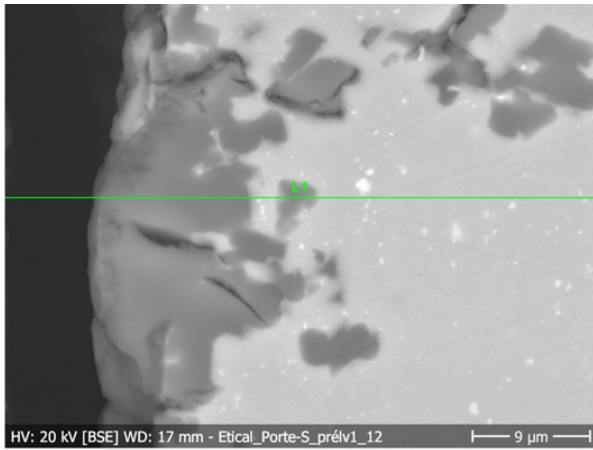
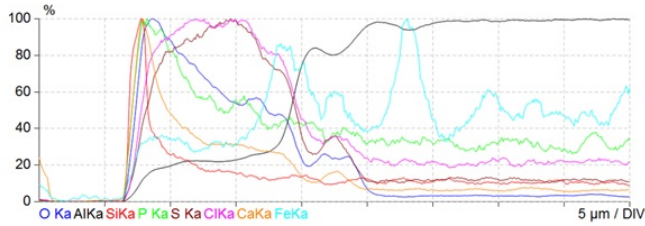
Fig. 11: EDS Linescan from CM1 to M1,

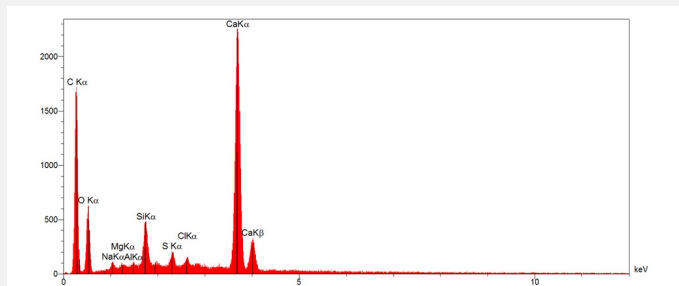
Fig. 12: EDS spectrum of area 4 of Fig. 7,

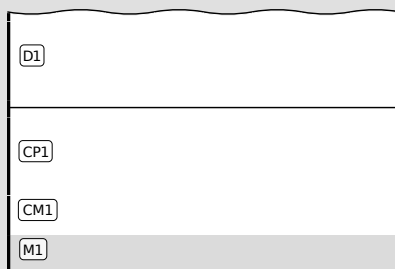
Fig. 4: Stratigraphic representation of the object in cross-section using the MiCorr application. The characteristics of the strata are only accessible by clicking on the drawing that redirects you to the search tool by stratigraphy representation. This representation can be compared to Fig. 9, Credit HE-Arc CR, C.Degrigny.
