# ROOF GUTTER ELEMENT – ZN ALLOY – MODERN TIMES – FRANCE

<b>Artefact name</b>	Roof gutter element
<b>Authors</b>	Christian. Degrigny (HE-Arc CR, Neuchâtel, Neuchâtel, Switzerland) & Mathea. Hovind (University of Oslo, Department of archaeology, conservation and history (IAKH-UiO), Oslo, Oslo, Norway)
<b>Url</b>	/artefacts/495/

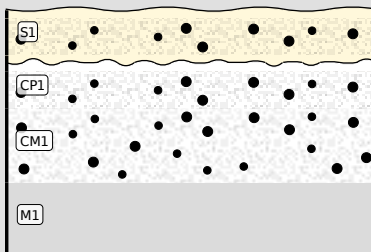
Fig. 5: Stratigraphic representation of the sample taken from the roof gutter (surface "b") in cross-section using the MiCorr application. The characteristics of the strata are only accessible by clicking on the drawing that redirects you to the search tool by stratigraphy representation. This representation can be compared to Figs. 11 and 12, Credit UiO-IAKH, M.Hovind.
