ROOF GUTTER ELEMENT – ZN ALLOY – MODERN TIMES – FRANCE

Artefact name Roof gutter element

Authors Christian. Degrigny (HE-Arc CR, Neuchâtel, Neuchâtel, Switzerland) & Mathea. Hovind (University of Oslo, Department of archaeology, conservation and history (IAKH-UiO), Oslo, Oslo, Norway)

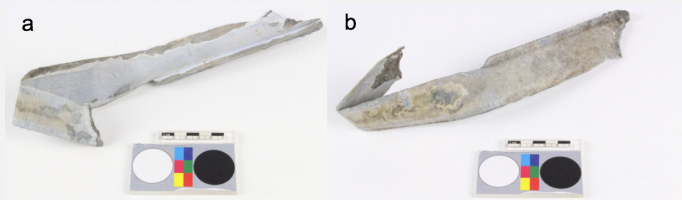
Fig. 1: Roof gutter element having different appearances on each of its surfaces: "a" on the left and "b" on the right,

| Description of the artefact | A roof gutter element with remains of lead solder (Fig. 1). Its surfaces are covered by a white, strongly adherent oxide layer. Surface "b" is slightly darker in colour than surface "a" due to the presence of soil particles. Dimensions: L = 265mm; W = 47mm; T = 1mm; WT = 93g. |

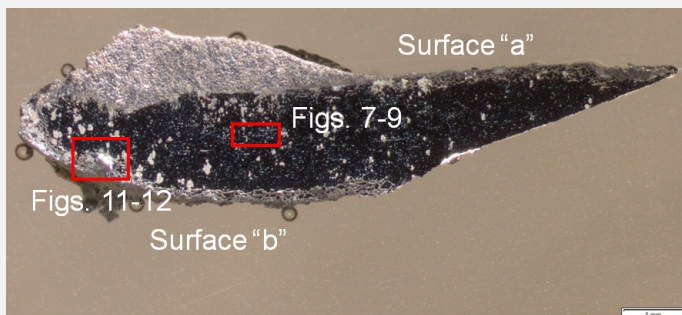
Fig. 4: Micrograph of the sample taken from the roof gutter showing the locations of Figs. 7-9 and 11-12. The uppermost area (in white) is remains of solder, while the zinc metal appears dark grey to black (the white patches are due to secondary oxidation of the sample),

A cross-section (Fig. 4) was cut out where the metal is at an angle of approximately 90° to the flat surface. Its upper edge corresponds to surface "a" and contains remains of solder, while the lower edge corresponds to surface "b".

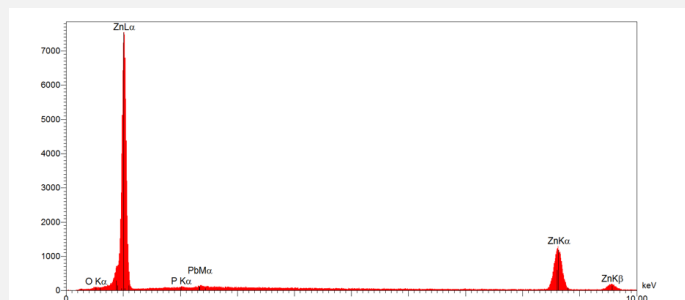
The roof gutter element is composed of Zn with P and Pb at lower concentrations (Fig. 6). The latter is probably originating from the solder that was applied to adjoin several metal sheets for the roof gutter.

Fig. 6: Chemical composition of the metal. Method of analysis: SEM-EDS. Lab. of Electronic Microscopy and Microanalysis, Néode, HEI Arc,

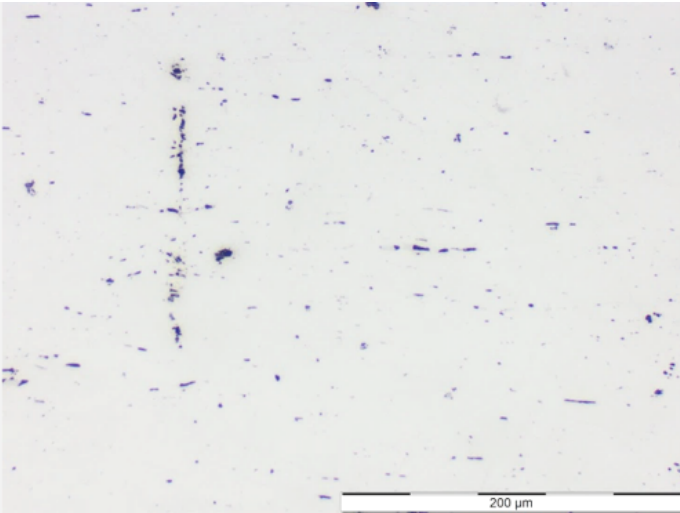
The metal appears white to light grey under bright field (Fig. 7). Under polarized light however (Fig. 8), the microstructure of the metal is visible as small polygonal grains appearing in various shades of brown, a coloured effect due to the anisotropic properties of the metal (Scott 1991: 49). In the SEM-image, white elongated inclusions are visible (Fig. 9) consisting mainly of Zn and Pb with some O (Fig. 10).

Fig. 7: Micrograph of the metal sample from Fig. 4 (detail). Unetched, bright field,

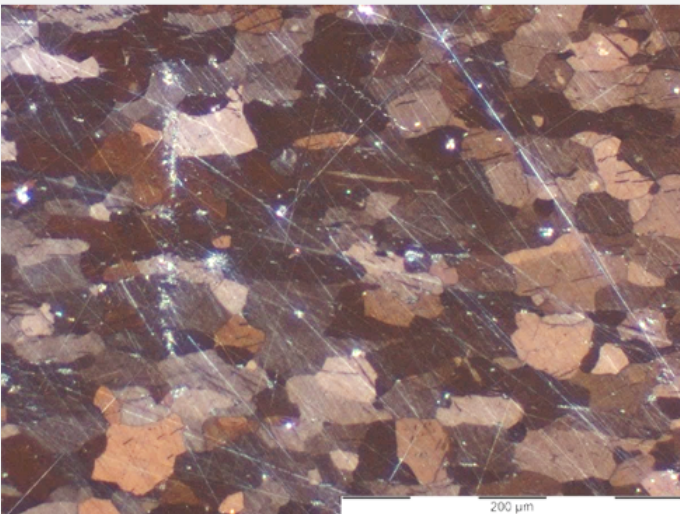
Fig. 8: Micrograph similar to Fig. 7, but under polarized light. The microstructure of the metal shows the presence of small and polygonal grains in shape,

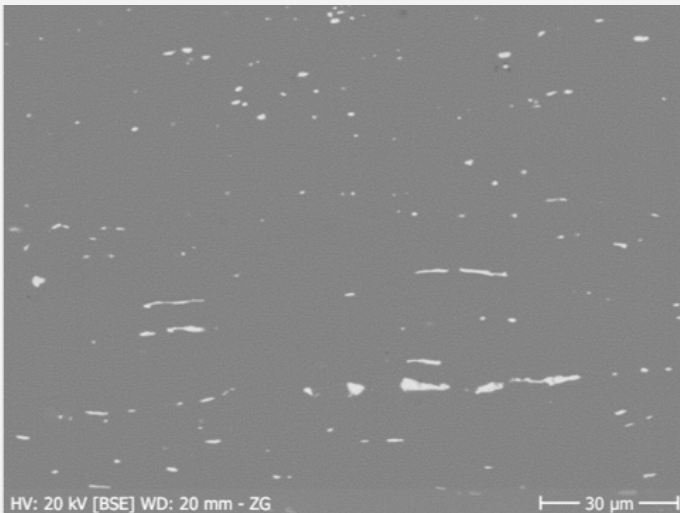
Fig. 9: SEM-image (BSE-mode) of the metal sample from Fig. 4 (detail) showing the white elongated inclusions,

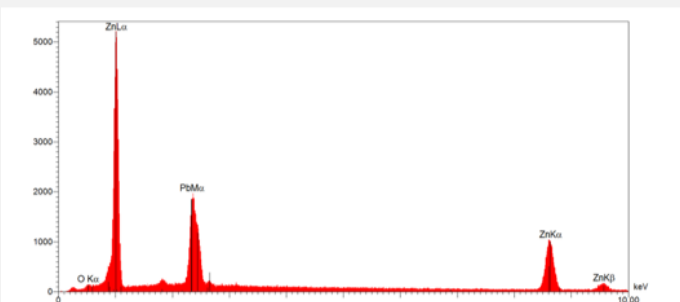
Fig. 10: SEM-EDS spectrum showing the composition of the elongated inclusions from Fig. 9. Method of analysis: SEM-EDS. Lab. of Electronic Microscopy and Microanalysis, Néode, HEI Arc,

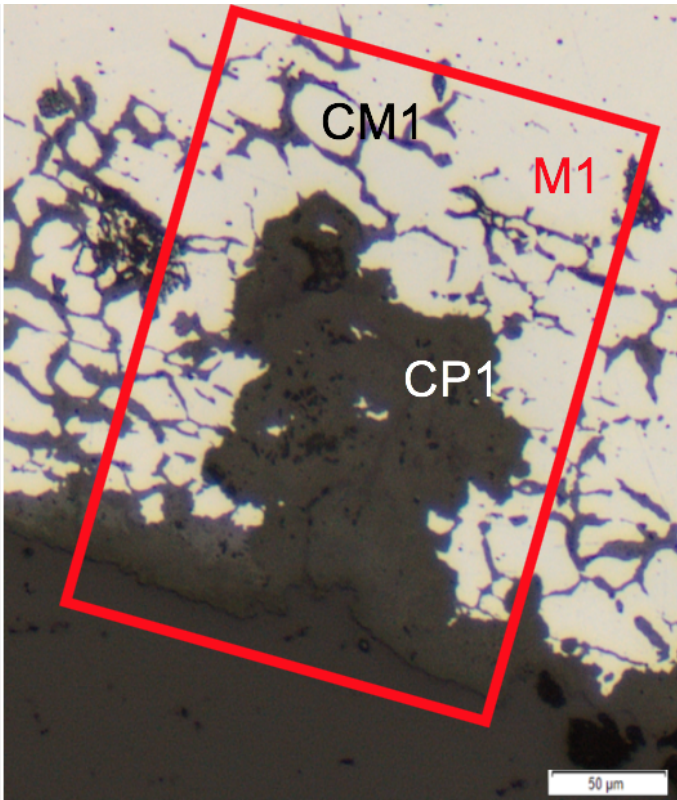
The metal is suffering from intergranular corrosion visible as a white corrosion product (CP1) located within crevices and along the grain boundaries (Figs. 11 and 12). Both the porous and powdery corrosion product (CP1) and the corroded metal (CM1) appear dark grey in bright field (Fig. 11) and white-grey under polarized light (Fig. 12). They both consist of Zn and O (Table 1). The external corrosion product (CP1) contains some S (and not Pb as suggested by Table 1 and Fig. 14) which is probably due to atmospheric pollution. The structural composition of the corrosion product was determined by crystallographic analysis (XRD) to consist of a mixture of zincite (ZnO) and pure zinc (Zn) (Table 2, Fig 13). Mapping of the corroded area by SEM-EDS displays a similar composition but shows additionally the presence of Cl in some of the veins of the corroded metal (Fig. 14). S1 (soil material) is found on the very top of CP1.

| Layer | Elements mass % | C | O | Zn | Pb | S | Al | Si | Fe | Cu | Sn |
|---|---|---|---|---|---|---|---|---|---|---|---|
| CP1, white corrosion product | | 7 | 33 | 51 | 3 | 5 | - | 0.3 | 0.1 | 0.1 | 0.4 |
| CM1, intergranular corrosion | | 6 | 22 | 68 | 3 | 0.1 | 0.1 | 0.1 | 0.1 | 0.1 | 0.5 |

Fig. 11: Micrograph of the metal sample from Fig. 4 (detail). Unetched, bright field. The corrosion product (CP1) is located at the surface of the metal and in its crevices. Intergranular corrosion (CM1) is visible as thin grey lines in between the metal grains (M1). The area selected for elemental chemical distribution (Fig. 14) is marked by a red rectangle,

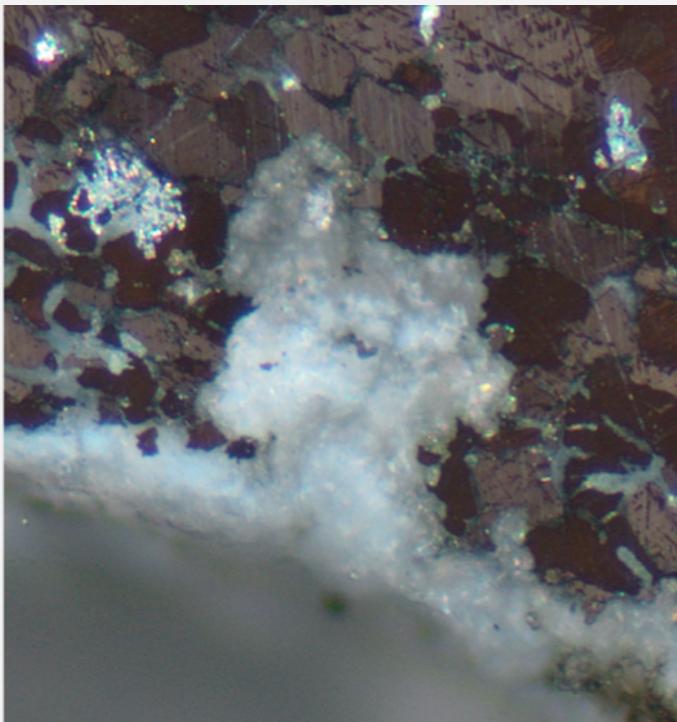
Fig. 12: Micrograph similar to Fig. 11 but under polarized light, the corrosion product (CP1) and the corroded metal (CM1) appear white,

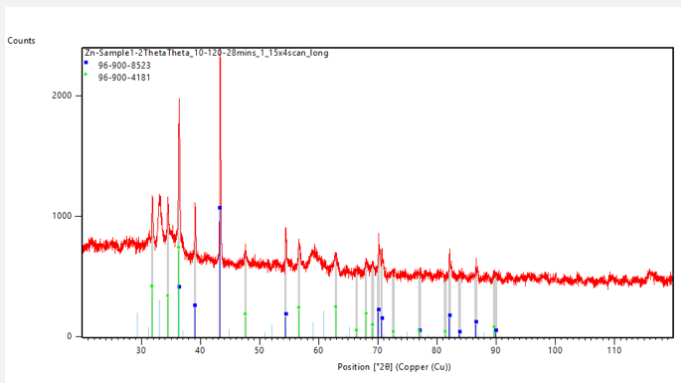
| Stratum | Components* |
|---|---|
| CP1 | Zincite (ZnO), Zinc (Zn) |

Fig. 13: XRD-spectrum for the analysis of powder sample 1. Ref. 96-900-8523 (in blue) corresponds to pure zinc and 96-900-4181 (in green) to zincite (ZnO),

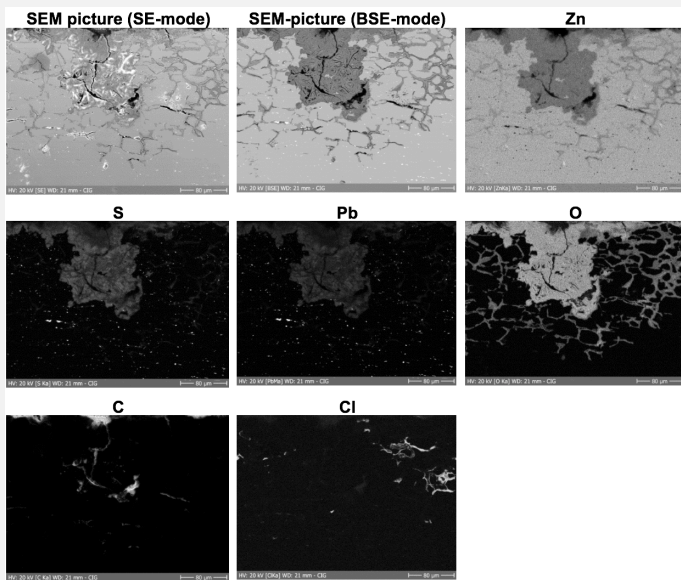
Fig. 14: SEM image and elemental chemical distribution of a selected area of Fig. 11 (rotated almost 180° and reversed). Method of analysis: SEM-EDS. Lab. of Electronic Microscopy and Microanalysis, Néode, HEI Arc,

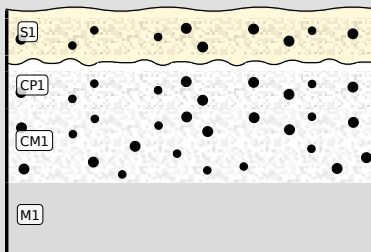
Fig. 5: Stratigraphic representation of the sample taken from the roof gutter (surface "b") in cross-section using the MiCorr application. The characteristics of the strata are only accessible by clicking on the drawing that redirects you to the search tool by stratigraphy representation. This representation can be compared to Figs. 11 and 12, Credit UiO-IAKH, M.Hovind.
