# ROOF GUTTER ELEMENT – ZN ALLOY – MODERN TIMES – FRANCE

| Artefact name | Roof gutter element |
| Authors | Christian. Degrigny (HE-Arc CR, Neuchâtel, Neuchâtel, Switzerland) & Mathea. Hovind (University of Oslo, Department of archaeology, conservation and history (IAKH-UiO), Oslo, Oslo, Norway) |

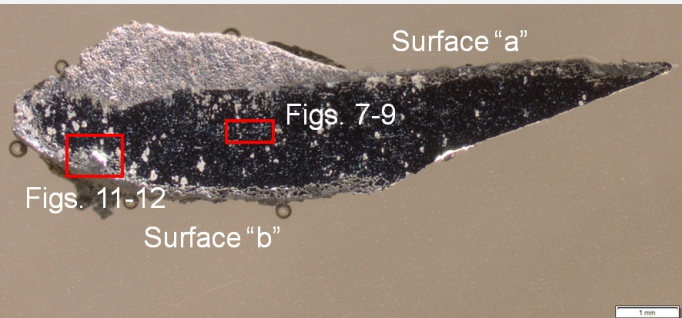
Fig. 4: Micrograph of the sample taken from the roof gutter showing the locations of Figs. 7-9 and 11-12. The uppermost area (in white) is remains of solder, while the zinc metal appears dark grey to black (the white patches are due to secondary oxidation of the sample),

A cross-section (Fig. 4) was cut out where the metal is at an angle of approximately 90° to the flat surface. Its upper edge corresponds to surface "a" and contains remains of solder, while the lower edge corresponds to surface "b".

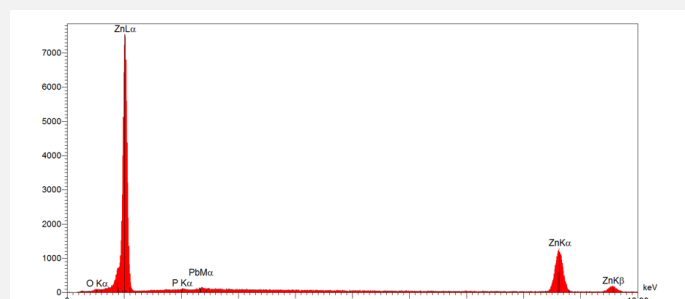
The roof gutter element is composed of Zn with P and Pb at lower concentrations (Fig. 6). The latter is probably originating from the solder that was applied to adjoin several metal sheets for the roof gutter.

Fig. 6: Chemical composition of the metal. Method of analysis: SEM-EDS. Lab. of Electronic Microscopy and Microanalysis, Néode, HEI Arc,

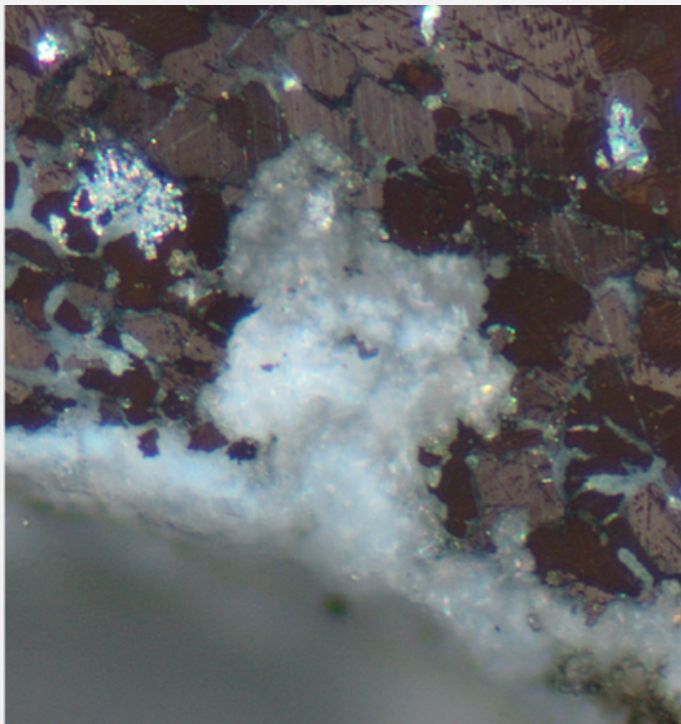
Fig. 12: Micrograph similar to Fig. 11 but under polarized light, the corrosion product (CP1) and the corroded metal (CM1) appear white,

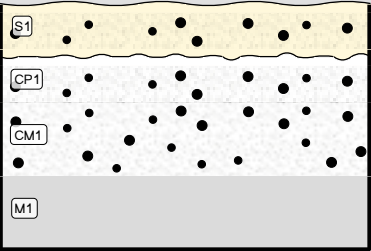
Fig. 5: Stratigraphic representation of the sample taken from the roof gutter (surface "b") in cross-section using the MiCorr application. The characteristics of the strata are only accessible by clicking on the drawing that redirects you to the search tool by stratigraphy representation. This representation can be compared to Figs. 11 and 12, Credit UiO-IAKH, M.Hovind.
