DOMED CAP NUT – ZN AL SN CU ALLOY – MODERN TIMES – FRANCE

Artefact name Domed cap nut

Authors Christian. Degrigny (HE-Arc CR, Neuchâtel, Neuchâtel, Switzerland) & Mathea. Hovind (University of Oslo, Department of archaeology, conservation and history (IAKH-UiO), Oslo, Oslo, Norway)

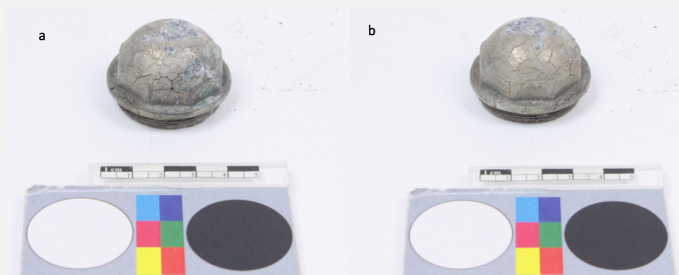
Fig. 1: Octogonal domed cap nut. Profile "a" and "b", to the left and right, respectively,

Description of the artefact	A domed cap nut made of a cast alloy with a metallic plating (Fig. 1). Its shape is octagonal and the inside is hollow. The plating is heavily cracked, leading to surface flaking. The metal appears to be consumed by some kind of internal corrosion. Dimensions: L (∅) = 40mm; H = 28mm; T = 5mm; WT = 49g.
Type of artefact	Cap
Origin	Château de Germolles, Mellecey, Bourgogne, France
Recovering date	Date unknown
Chronology category	Modern Times
chronology tpq	<input type="text" value="1900"/> A.D. ▼
chronology taq	<input type="text" value="2000"/> A.D. ▼
Chronology comment	19th - 20th century
Burial conditions / environment	Outdoor atmosphere
Artefact location	Haute Ecole Arc Conservation-Restauration

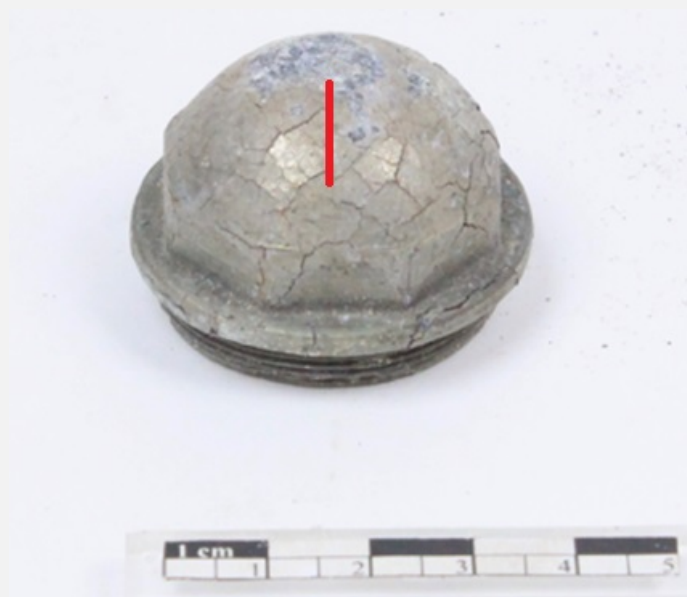
Fig. 2: Zone of the artefact submitted to visual observation and location of sampling area (a cross-section of the metal marked by the red line),

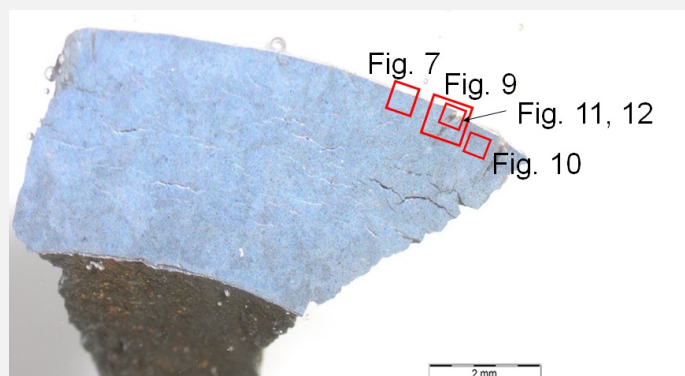
Fig. 4: Micrograph of the cross-section of the sample taken from the domed cap nut showing the locations of Figs. 7 and 9-12,

The sample is a cross section of the metal, representative of the domed cap nut. It shows external cracks extending from the metal surface and into its structure in addition to internal cracks, visible as thin lines along its longitudinal axis (Fig. 4).

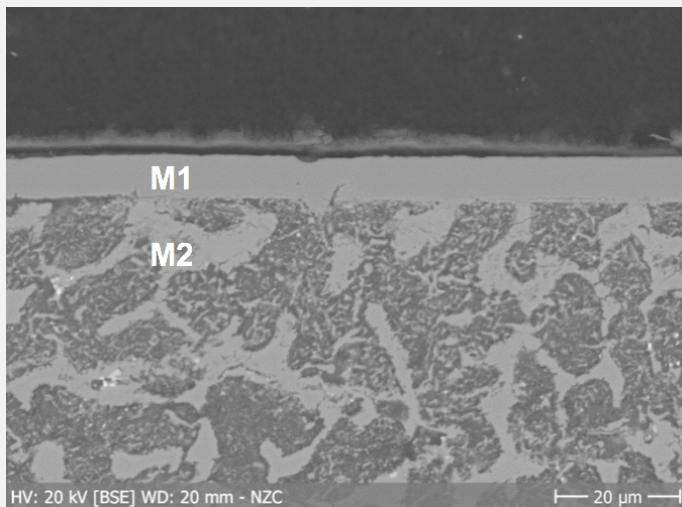
The metal of the domed cap nut (M2) consists of a Zn/Al/Pb/Cu/Sn alloy (Table 1) externally covered by a nickel-based plating (M1) (Figs. 7 and 8) containing some cobalt (Co). The bulk metal (M2) has a dendritic microstructure appearing light grey in bright field, while the interdendritic phase appears white (Fig. 9). The latter is Zn-rich, while the dendritic phase consists of approximately equal amounts of Zn and Al (Table 2, Fig. 11). Observation in SEM (BSE-mode) reveals the presence of Pb-nodules, visible as white irregular spots with a scattered distribution, in addition to opaque grey patches which are rich in Al and Fe (Fig. 10).

Fig. 7: SEM-image (BSE-mode) of a selected area from Fig. 4 (detail), showing the metal plating (M1) and the bulk metal (M2),

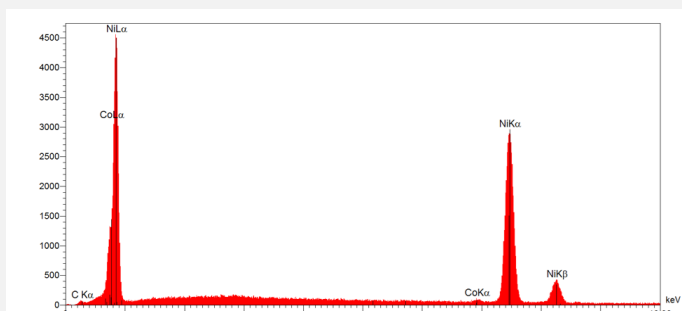
Fig. 8: EDS-spectrum showing the chemical composition of the metal plating (M1). Method of analysis: SEM-EDS. Lab. of Electronic Microscopy and and Microanalysis, Néode, HEI Arc,

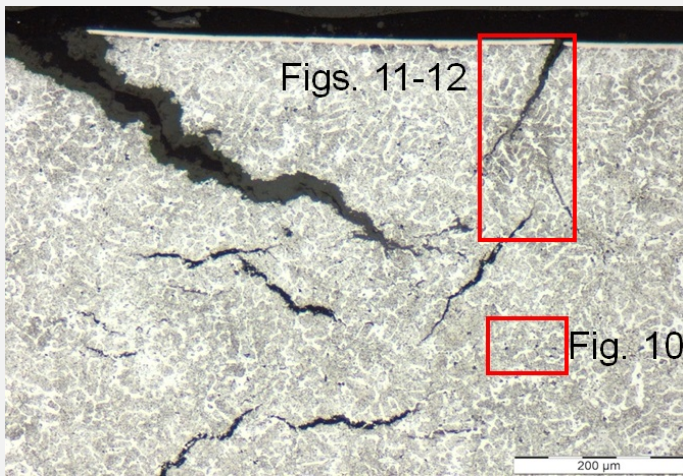
Fig. 9: Micrograph of the metal sample from Fig. 4 (detail), unetched, bright field. The dendrites appear light to dark grey while the interdendritic phase appears white. The metal is characterized by surface cracks as well as internal cracks. The lower red rectangle corresponds to Fig. 10 while the areas selected for elemental chemical distributions (Figs. 11 and 12) are marked by the upper red rectangle,

The dendritic phase is heavily oxidized compared to the interdendritic phase (Table 2 and Fig. 12). The corrosion has developed throughout the entire metal body, generating cracks (Fig. 9). The cracks are Zn and O-rich (Fig. 12) and could be composed of zinc carbonate. It could be a case of zinc pest, an intergranular corrosion phenomenon known to cause disintegration in poor quality alloys (Selwyn 2004, Zhang 2011).

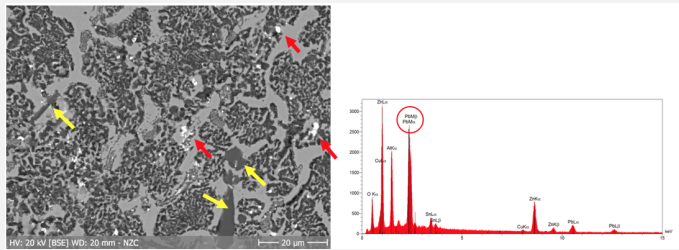
Fig. 10: SEM-image in BSE-mode (left) and EDS-spectrum (right), showing the appearance and the chemical composition of the Pb inclusions (red arrows). The inclusions appear white, the dendrites appear dark grey/black and the interdendritic phase appears grey. Grey opaque patches (yellow arrows) are Fe- and Al-rich phases,

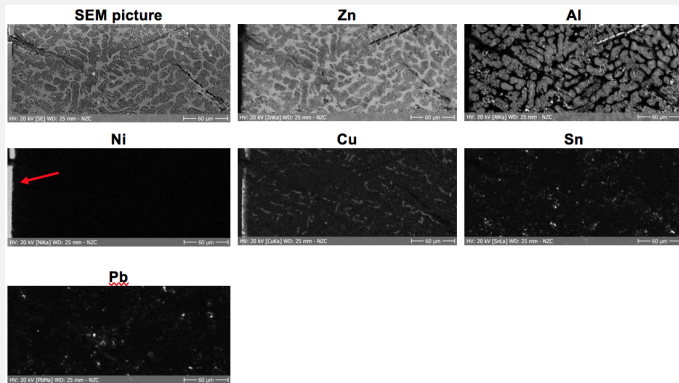
Fig. 11: SEM image and elemental chemical distribution of the selected area from Fig. 9 (rotated 270° and inverted). Method of analysis: SEM-EDS. Lab. of Electronic Microscopy and Microanalysis, Néode, HEI Arc,

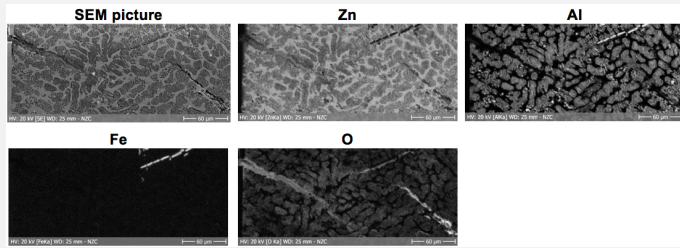
Fig. 12: SEM image and elemental chemical distribution of the selected area from Fig. 9 (rotated 270° and inversed). Method of analysis: SEM-EDS. Lab. of Electronic Microscopy and Microanalysis, Néode, HEI Arc,

Corrosion form Internal cracking
Corrosion type zinc pest

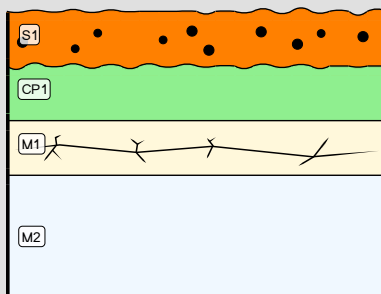
Fig. 5: Stratigraphic representation of the sample taken from the domed cap nut in cross-section using the MiCorr application. The characteristics of the strata are only accessible by clicking on the drawing that redirects you to the search tool by stratigraphy representation. Stratigraphy representative of an area with intact metal plating (M1). S1 represents Fe-polluted soil while CP1 is a green translucent corrosion product, Credit UiO-IAKH, M.Hovind.

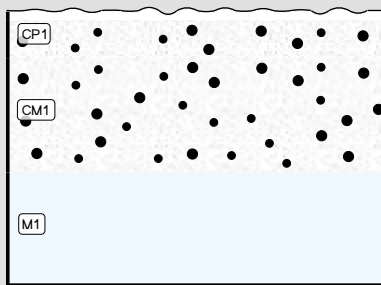
Fig. 6: Stratigraphic representation of the sample taken from the domed cap nut in cross-section using the MiCorr application. The characteristics of the strata are only accessible by clicking on the drawing that redirects you to the search tool by stratigraphy representation. Area where the metal plating is missing. CP1 corresponds to CP2 in Fig. 3, CM1 represents the corroded metal phase, while M1 corresponds to the bulk metal (M2 in Fig. 3 and Fig. 5), Credit UiO-IAKH, M.Hovind.
