# DOMED CAP NUT – ZN AL SN CU ALLOY – MODERN TIMES – FRANCE

Artefact name	Domed cap nut
Authors	Christian. Degriigny (HE-Arc CR, Neuchâtel, Neuchâtel, Switzerland) & Mathea. Hovind (University of Oslo, Department of archaeology, conservation and history (IAKH-UiO), Oslo, Oslo, Norway)
Url	/artefacts/497/

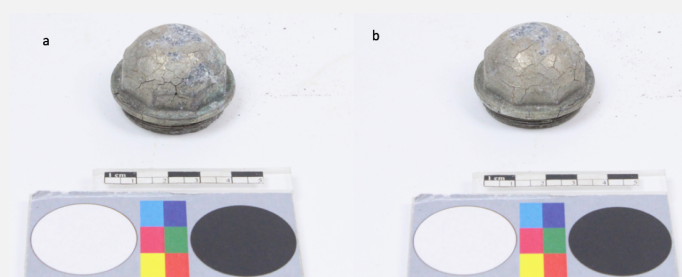
Fig. 1: Octogonal domed cap nut. Profile "a" and "b", to the left and right, respectively,

Description of the artefact	A domed cap nut made of a cast alloy with a metallic plating (Fig. 1). Its shape is octagonal and the inside is hollow. The plating is heavily cracked, leading to surface flaking. The metal appears to be consumed by some kind of internal corrosion. Dimensions: L (ø) = 40mm; H = 28mm; T = 5mm; WT = 49g.
Type of artefact	Cap
Origin	Château de Germolles (14th century), Mellecey, Bourgogne, France
Recovering date	Date unknown
Chronology category	Modern Times
chronology tpq	1900 A.D. ▼
chronology taq	2000 A.D. ▼
Chronology comment	19th - 20th century
Burial conditions / environment	Outdoor atmosphere
Artefact location	Haute Ecole Arc Conservation-Restauration
Owner	Château de Germolles, Mellecey, Bourgogne

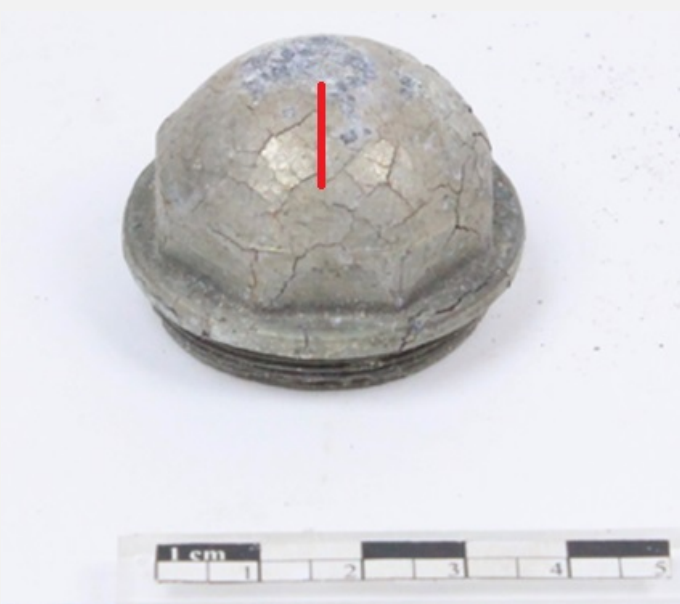
Fig. 2: Zone of the artefact submitted to visual observation and location of sampling area (a cross-section of the metal marked by the red line),

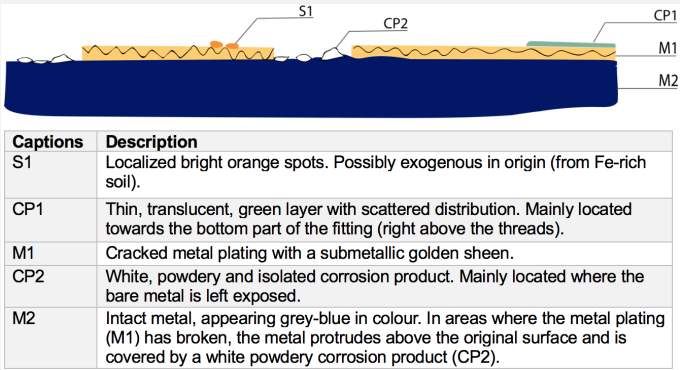
Captions	Description
S1	Localized bright orange spots. Possibly exogenous in origin (from Fe-rich soil).
CP1	Thin, translucent, green layer with scattered distribution. Mainly located towards the bottom part of the fitting (right above the threads).
M1	Cracked metal plating with a submetallic golden sheen.
CP2	White, powdery and isolated corrosion product. Mainly located where the bare metal is left exposed.
M2	Intact metal, appearing grey-blue in colour. In areas where the metal plating (M1) has broken, the metal protrudes above the original surface and is covered by a white powdery corrosion product (CP2).

Fig. 3: Preliminary stratigraphy corresponding to the overall surface of the artefact. CP = Corrosion Product, S = Soil, M = Metal,

The external corrosion products and deposits (Fig. 3) were documented but not analyzed as they were considered to be mainly exogenous in origin and not the main reason behind the deterioration of the object. The orange deposit (S1) is probably soil from Fe-rich environment, while the thin green layer (CP1) is most likely consisting of an oxide of Ni from

the nickel plating (M1). The white corrosion product (CP2) can either be a salt from the environment, corrosion products of Zn/Al or Zinc carbonate.

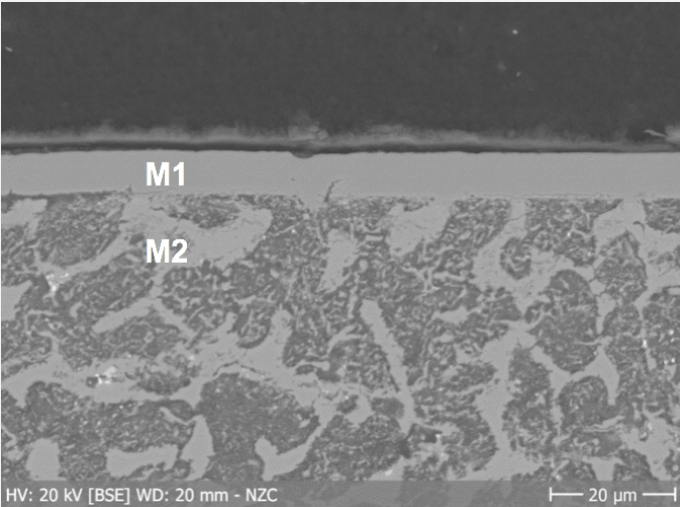
The metal of the domed cap nut (M2) consists of a Zn/Al/Pb/Cu/Sn alloy (Table 1) externally covered by a nickel-based plating (M1) (Figs. 7 and 8) containing some cobalt (Co). The bulk metal (M2) has a dendritic microstructure appearing light grey in bright field, while the interdendritic phase appears white (Fig. 9). The latter is Zn-rich, while the dendritic phase consists of approximately equal amounts of Zn and Al (Table 2, Fig. 11). Observation in SEM (BSE-mode) reveals the presence of Pb-nodules, visible as white irregular spots with a scattered distribution, in addition to opaque grey patches which are rich in Al and Fe (Fig. 10).

Fig. 7: SEM-image (BSE-mode) of a selected area from Fig. 4 (detail), showing the metal plating (M1) and the bulk metal (M2),

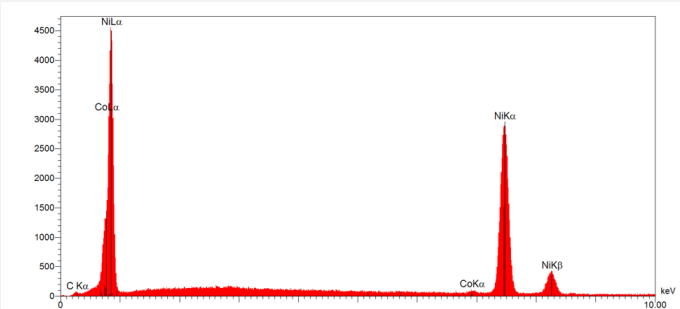
Fig. 8: EDS-spectrum showing the chemical composition of the metal plating (M1). Method of analysis: SEM-EDS. Lab. of Electronic Microscopy and and Microanalysis, Néode, HEI Arc,

The domed cap nut is nickel plated (6-7 micrometers).

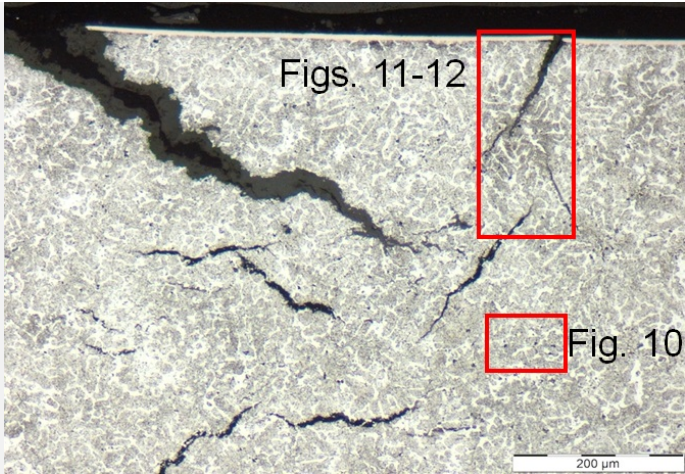
Fig. 9: Micrograph of the metal sample from Fig. 4 (detail), unetched, bright field. The dendrites appear light to dark grey while the interdendritic phase appears white. The metal is characterized by surface cracks as well as internal cracks. The lower red rectangle corresponds to Fig. 10 while the areas

selected for elemental chemical distributions (Figs. 11 and 12) are marked by the upper red rectangle,

The dendritic phase is heavily oxidized compared to the interdentritic phase (Table 2 and Fig. 12). The corrosion has developed throughout the entire metal body, generating cracks (Fig. 9). The cracks are Zn and O-rich (Fig. 12) and could be composed of zinc carbonate. It could be a case of zinc pest, an intergranular corrosion phenomenon known to cause disintegration in poor quality alloys (Selwyn 2004, Zhang 2011).

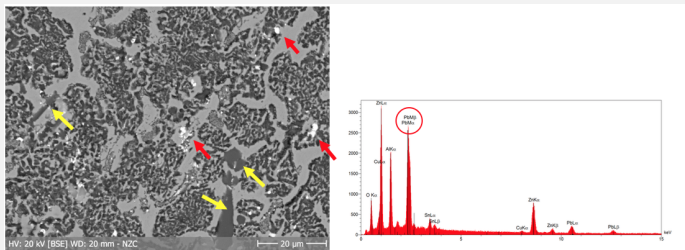
Fig. 10: SEM-image in BSE-mode (left) and EDS-spectrum (right), showing the appearance and the chemical composition of the Pb inclusions (red arrows). The inclusions appear white, the dendrites appear dark grey/black and the interdentritic phase appears grey. Grey opaque patches (yellow arrows) are Fe- and Al-rich phases,

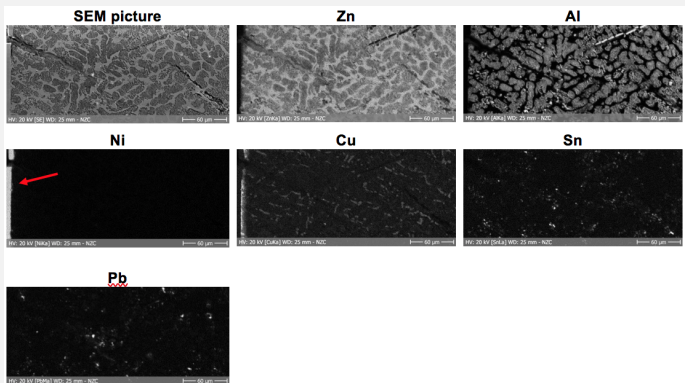
Fig. 11: SEM image and elemental chemical distribution of the selected area from Fig. 9 (rotated 270° and inversed). Method of analysis: SEM-EDS. Lab. of Electronic Microscopy and Microanalysis, Néode, HEI Arc,

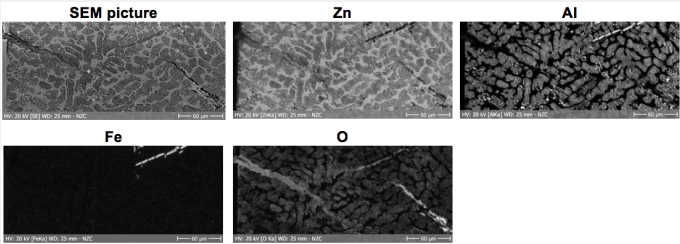
Fig. 12: SEM image and elemental chemical distribution of the selected area from Fig. 9 (rotated 270° and inversed). Method of analysis: SEM-EDS. Lab. of Electronic Microscopy and Microanalysis, Néode, HEI Arc,

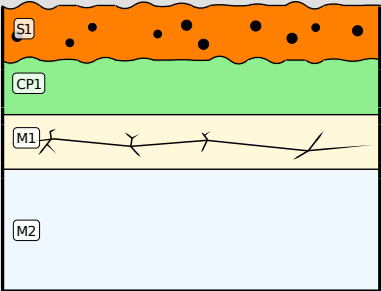
Fig. 5: Stratigraphic representation of the sample taken from the domed cap nut in cross-section using the MiCorr application. The characteristics of the strata are only accessible by clicking on the drawing that redirects you to the search tool by stratigraphy representation. Stratigraphy representative of an area with intact metal plating (M1). S1 represents Fe-polluted soil while CP1 is a green translucent corrosion product, Credit UiO-IAKH, M.Hovind.

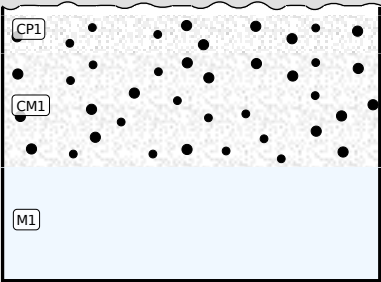
Fig. 6: Stratigraphic representation of the sample taken from the domed cap nut in cross-section using the MiCorr application. The characteristics of the strata are only accessible by clicking on the drawing that redirects you to the search tool by stratigraphy representation. Area where the metal plating is missing. CP1 corresponds to CP2 in Fig. 3, CM1 represents the corroded metal phase, while M1 corresponds to the bulk metal (M2 in Fig. 3 and Fig. 5), Credit UiO-IAKH, M.Hovind.
