## DOMED CAP NUT – ZN AL SN CU ALLOY – MODERN TIMES – FRANCE

<b>Artefact name</b>	Domed cap nut
<b>Authors</b>	Christian. Degriigny (HE-Arc CR, Neuchâtel, Neuchâtel, Switzerland) & Mathea. Hovind (University of Oslo, Department of archaeology, conservation and history (IAKH-UiO), Oslo, Oslo, Norway)
<b>Url</b>	/artefacts/497/

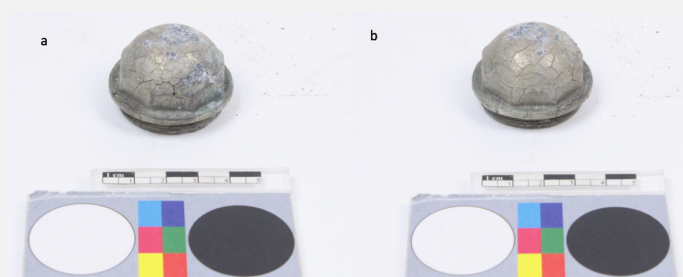
Fig. 1: Octogonal domed cap nut. Profile "a" and "b", to the left and right, respectively,

<b>Description of the artefact</b>	A domed cap nut made of a cast alloy with a metallic plating (Fig. 1). Its shape is octagonal and the inside is hollow. The plating is heavily cracked, leading to surface flaking. The metal appears to be consumed by some kind of internal corrosion. Dimensions: L ( $\varnothing$ ) = 40mm; H = 28mm; T = 5mm; WT = 49g.
<b>Type of artefact</b>	Cap
<b>Origin</b>	Château de Germolles (14th century), Mellecey, Bourgogne, France
<b>Recovering date</b>	Date unknown
<b>Chronology category</b>	Modern Times
<b>chronology tpq</b>	<input type="text" value="1900"/> A.D. ∨
<b>chronology taq</b>	<input type="text" value="2000"/> A.D. ∨
<b>Chronology comment</b>	19th - 20th century
<b>Burial conditions / environment</b>	Outdoor atmosphere
<b>Artefact location</b>	Haute Ecole Arc Conservation-Restauration
<b>Owner</b>	Château de Germolles, Mellecey, Bourgogne

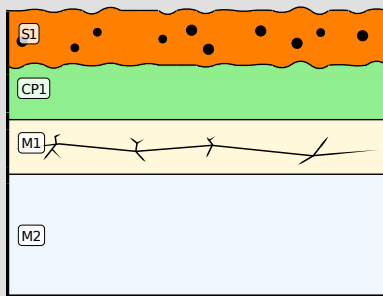
Fig. 5: Stratigraphic representation of the sample taken from the domed cap nut in cross-section using the MiCorr application. The characteristics of the strata are only accessible by clicking on the drawing that redirects you to the search tool by stratigraphy representation. Stratigraphy representative of an area with intact metal plating (M1). S1 represents Fe-polluted soil while CP1 is a green translucent corrosion product, Credit UiO-IAKH, M.Hovind.

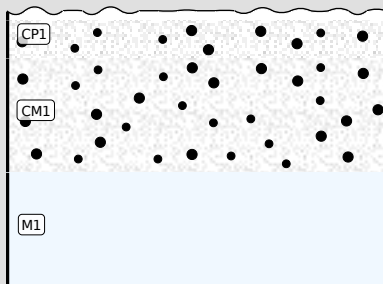
Fig. 6: Stratigraphic representation of the sample taken from the domed cap nut in cross-section using the MiCorr application. The characteristics of the strata are only accessible by clicking on the drawing that redirects you to the search tool by stratigraphy representation. Area where the metal plating is missing. CP1 corresponds to CP2 in Fig. 3, CM1 represents the corroded metal phase, while M1 corresponds to the bulk metal (M2 in Fig. 3 and Fig. 5), Credit UiO-IAKH, M.Hovind.
