RAIN GUTTER FRAGMENT – GREY CAST IRON – MODERN TIMES – FRANCE

Artefact name	Rain gutter fragment
Authors	Christian. Degriigny (HE-Arc CR, Neuchâtel, Neuchâtel, Switzerland) & Mathea. Hovind (University of Oslo, Department of archaeology, conservation and history (IAKH-UiO), Oslo, Oslo, Norway)
Url	/artefacts/498/

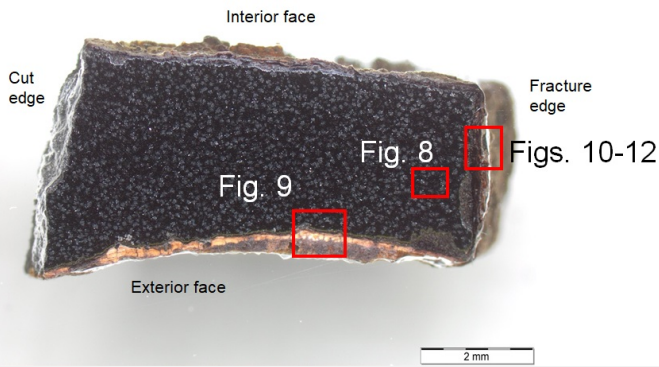
Fig. 4: Micrograph of the sample taken from the rain gutter fragment showing its orientation relative to the artefact and the

locations of Figs. 8-12,

Description of sample	The sample consists of a rectangular section (Fig. 4) which was cut out from the fractured edge of the gutter fragment. It is representative of three surfaces: the exterior and interior surface, as well as the fracture edge. Dimensions: L = 7mm; Wmax. = 5mm; Tmax. = 4mm (approx.).
Alloy	Grey cast iron
Technology	Cast
Lab number of sample	CIG2018 (Cast Iron Gutter, sampled in 2018)
Sample location	Haute Ecole Arc Conservation-Restauration
Responsible institution	Haute Ecole Arc Conservation-Restauration
Date and aim of sampling	March 2018, study of corrosion stratigraphy and chemical analyses

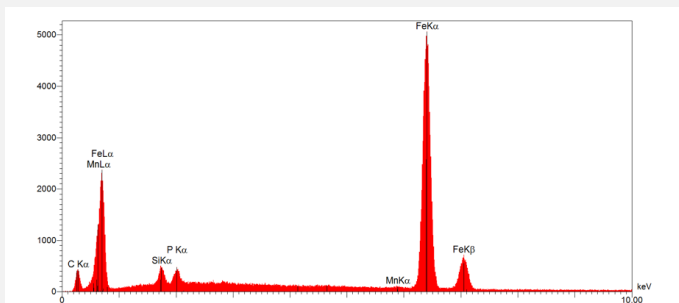
The metal is a P-rich grey cast iron with Si and Mn (Fig. 7). Its microstructure is characterized by evenly distributed graphite flakes in a matrix composed of dendrites and an interdendritic eutectic phase (Fig. 8). What appears to be irregular graphite flakes / porosity is in fact deformed graphite flakes; graphite is soft and prone to destruction by smearing and/or preferential removal during polishing (Scott 1991).

Fig. 7: EDS-spectrum showing the chemical composition of the metal. Method of analysis: SEM-EDS. Lab. of Electronic Microscopy and Microanalysis, Néode, HEI Arc,

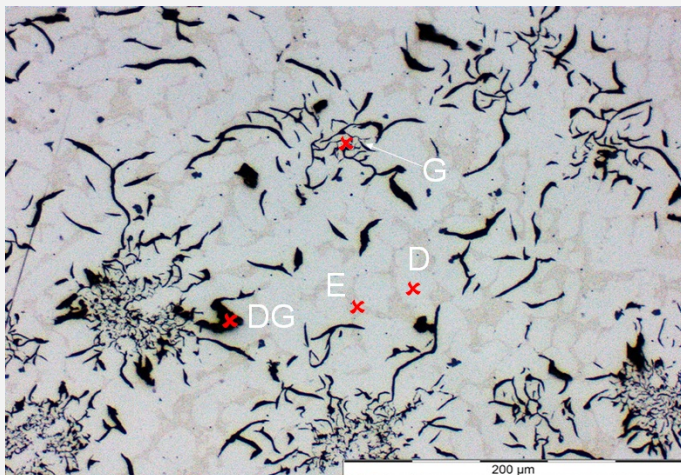
The dendrites appear light grey under polarized light, while the eutectic phase appear light brown (Fig. 8). The eutectic phase is rich in Fe and P and contains small amounts of C and Si, whereas the dendritic phase contains much less P (Table 1).

Fig. 8: Micrograph of the metal sample from Fig. 4 (detail). Unetched, bright field. Graphite flakes (G) in black, the dendrites (D) in light grey and the eutectoid phase (E) in light brown. Deformed graphite (DG) flakes are visible as irregular black inclusions,

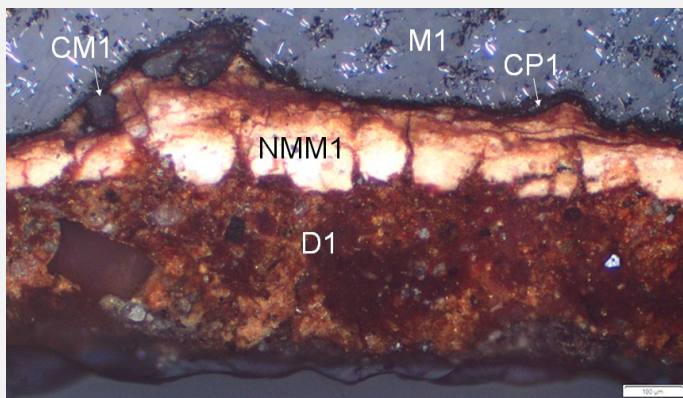
The exterior face (Figs. 2, 4 and 9) consists of a white / light yellow cracked layer (NMM1 in Fig. 5) superimposed by a layer of deposit mixed with orange-red corrosion products (D1 in Fig. 5). Punctual analysis by SEM-EDS (Table 2) revealed that the white / light yellow layer is rich in Ba, O, S, Fe, C and Zn. It has a chemical composition similar to Lithopone (BaSO₄,ZnS), a preparatory paint layer. Fe is probably a contamination from the superimposed porous deposit / corrosion product D1 (Table 2). The latter (D1) is Fe- and O-rich and contains Si, Al and some Ca, in addition to a range of elements (K, P, Na, Cl, S and Ti) present in minor amounts (Table 2). A thin layer of corrosion products (CP1) is located just beneath the paint layer, appearing dark grey under polarized light (Fig. 9). This layer is followed by a corroded metal phase (CM1). Their exact composition was not analyzed but is likely to correspond to the corroded metal phase of the fracture edge, described below.

Fig. 9: Micrograph of the metal sample from Fig. 4 (detail), unetched, polarized light, 5x. The stratigraphy of the exterior surface, from top to bottom: the metal (M1) in grey, a layer of corroded metal (CM1) followed by a thin layer of CP1, and a white cracked layer (NMM1) superimposed by a porous dark-red deposit (D1),

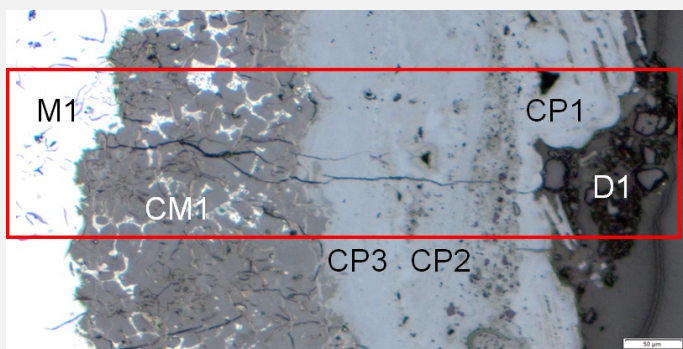
The interior face (Figs. 2 and 4) shows similar characteristics but does not include a white layer similar to NMM1. The fracture edge however (Figs. 2, 4 and 10), shows a more complex stratigraphy consisting of a dense product layer which can be further divided into two individual strata (CP3 and CP2), superimposed by a porous corrosion crust appearing orange under polarized light (CP1) (Fig. 11). The corroded metal (CM1) is located just beneath CP3 and contains remnants of the P-rich eutectic phase (Figs. 10-12). The M/CP ratio (metal to corrosion products) is rather high, implying extensive internal corrosion. Furthermore, a simple crack is traversing the corrosion layers – indicating a fragilization of the structure. As for the composition of the corrosion products CP1, CP2 and CP3, they all contain Fe and O (Fig. 12). A marbling effect within CP2 and CP3 indicates a variation in the concentration of Fe and O (particularly visible in bright field - Fig. 10). The white deposit (D1 in Fig. 6) might originate from exposure to calcareous water (Table 2). The presence of exogenous elements such as Si, Ca, Al, Na and O (Table 2) was confirmed by elemental mapping (Fig. 12).

Fig. 10: Micrograph of the metal sample from Fig. 4 (detail), unetched, bright field. From left to right: intact metal (M1) in white, followed by preferentially corroded metal (CM1) and dense product layers (CP3 and CP2) in various shades of grey. CP1 is slightly porous and covered by grain-like particles (D1). The area selected for elemental chemical distribution (Fig. 12) is marked by a red rectangle. A simple crack is traversing the corrosion layers,

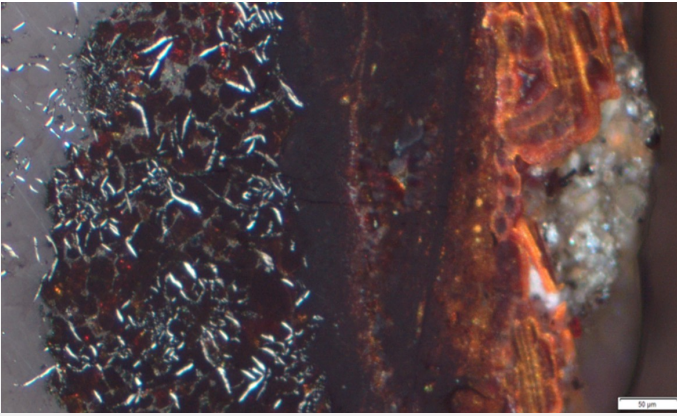
Fig. 11: Micrograph similar to Fig. 10 but under polarized light. The external deposit (D1) appears grey-white, CP1 in bright orange, while CP2 and CP3 appear dark red to brown. The corroded metal (CM1) contains remnants of graphite flakes (in white) and the P-rich eutectic (in grey),

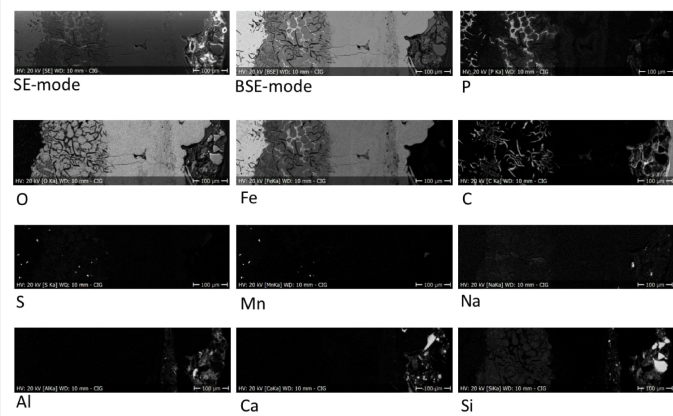
Fig. 12: SEM image and elemental chemical distribution of the selected area from Fig. 10. Method of analysis: SEM-EDS. Lab. of Electronic Microscopy and Microanalysis, Néode, HEI Arc,

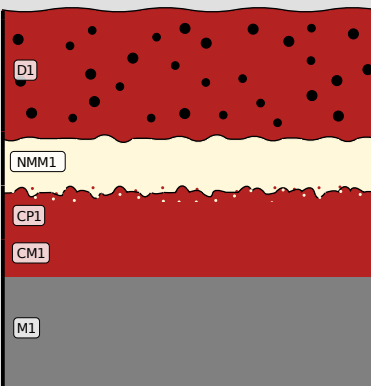
Fig. 5: Stratigraphic representation of the sample taken from the rain gutter fragment in cross-section using the MiCorr application. The characteristics of the strata are only accessible by clicking on the drawing that redirects you to the search tool by stratigraphy representation. This representation can be compared to Fig. 9. CP1 corresponds to CP2 in Fig. 3, Credit UiO-IAKH, M.Hovind.

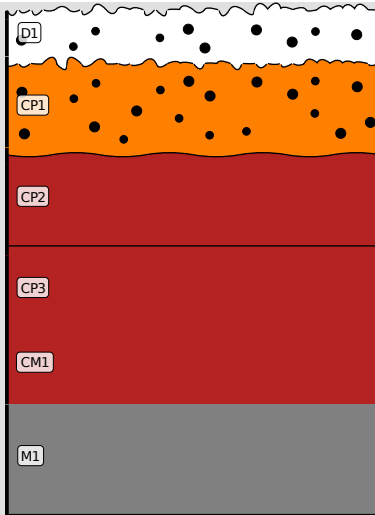
Fig. 6: Stratigraphic representation of the sample taken from the rain gutter fragment in cross-section using the MiCorr application. The characteristics of the strata are only accessible by clicking on the drawing that redirects you to the search tool by stratigraphy representation. This representation can be compared to Fig. 11. D1 corresponds to D3 in Fig. 3, Credit UiO-IAKH, M.Hovind.

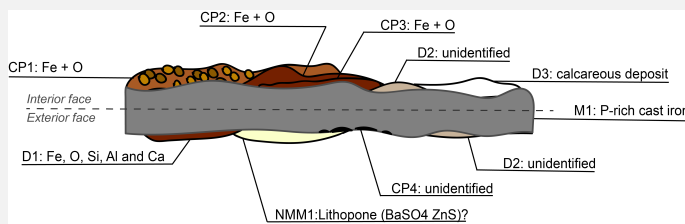
Fig. 13: Improved stratigraphic representation of the rain gutter fragment with results of SEM-EDS analysis and visual microscopic observation,

The rain gutter fragment is a grey cast iron with a microstructure consisting of graphite flakes and a P-rich eutectic phase. The exterior surface contains a preparatory paint layer, located beneath a layer of corrosion products mixed with soil. It seems likely that the cast iron gutter has been covered with a protective paint layer (e.g. Lithopone) to slow down the rate of atmospheric corrosion. The presence of Lithopone reinforces the suggested dating of the artefact (20th century) as this pigment was developed and used from the 1880s and onwards (Lithopone 2007). However, it seems that the protective layer has none or only very limited effect as (pitting) corrosion is present also in these areas.

The corrosion layers consist mainly of Fe and O, indicating atmospheric corrosion with presence of only a very small amount of contaminants/pollution. The scattered white deposit is possibly originating from exposure to calcareous water as it is localized mainly on the interior face of the fragment, where rain water would hit the metal before entering the ground.
