RAIN GUTTER FRAGMENT – GREY CAST IRON – MODERN TIMES – FRANCE

Artefact name Rain gutter fragment

Authors Christian. Degrigny (HE-Arc CR, Neuchâtel, Neuchâtel, Switzerland) & Mathea. Hovind (University of Oslo, Department of archaeology, conservation and history (IAKH-UiO), Oslo, Oslo, Norway)

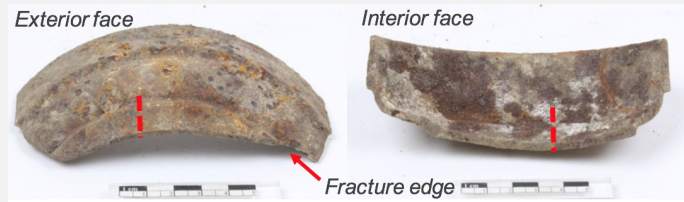
Fig. 2: The exterior and interior faces before sampling. The dotted line represents the sample location (a cross-section of the metal). The fracture edge corresponds to the edge that was formerly attached to the remaining artefact,

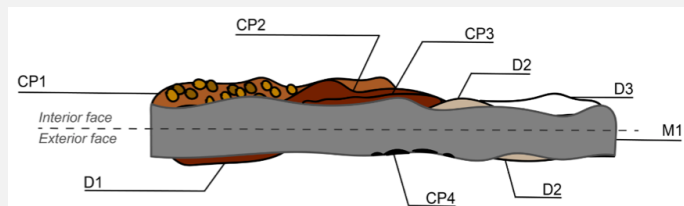
Captions	Description
D1	Scattered, orange to dark red encrustations. Probably corrosion products mixed with soil.
D2	Grey-brown and matte deposit, somewhat powdery - possibly corrosion product mixed with soil. This layer is located both on the interior and exterior surface of the artefact.
D3	Localized, white and strongly adherent deposit.
CP1	Bright orange to dark red corrosion product. Uneven surface with pustules.
CP2	Red-brown corrosion crust. Brittle, but adherent. Flakes off in bits when force is applied perpendicular to the surface with a scalpel.
CP3	Similar to CP2 but appears to be an individual layer.
CP4	Isolated corrosion blisters. Circular and black in colour. Mainly located on the exterior surface.
M1	Intact metal with a dark grey metallic sheen.

Fig. 3: Preliminary stratigraphy corresponding to the overall surface of the artefact. The interior surface is shown above the stippled line and the exterior surface below. D = Deposit, CP = Corrosion products, M = Metal,

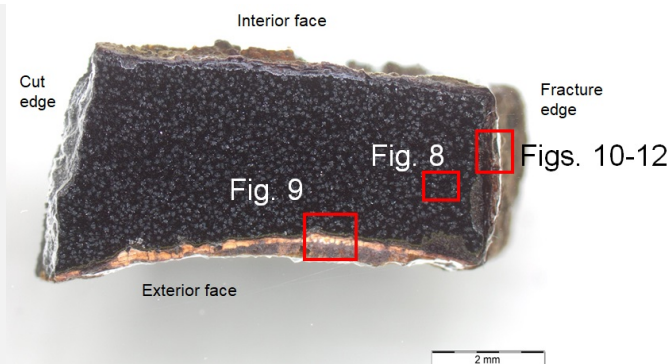
Fig. 4: Micrograph of the sample taken from the rain gutter fragment showing its orientation relative to the artefact and the locations of Figs. 8-12,

Description of sample	The sample consists of a rectangular section (Fig. 4) which was cut out from the fractured edge of the gutter fragment. It is representative of three surfaces: the exterior and interior surface, as well as the fracture edge. Dimensions: L = 7mm; Wmax. = 5mm; Tmax. = 4mm (approx.).
Alloy	Grey cast iron
Technology	Cast
Lab number of sample	CIG2018 (Cast Iron Gutter, sampled in 2018)
Sample location	Haute Ecole Arc Conservation-Restauration
Responsible institution	Haute Ecole Arc Conservation-Restauration
Date and aim of sampling	March 2018, study of corrosion stratigraphy and chemical analyses

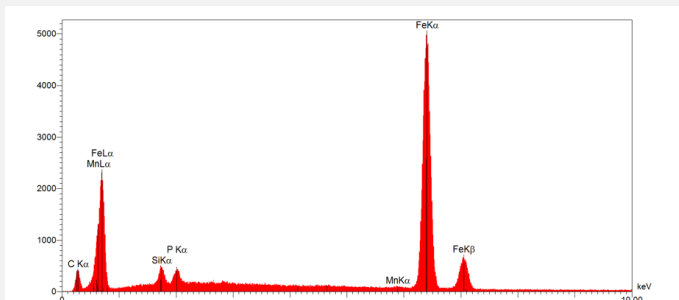
The metal is a P-rich grey cast iron with Si and Mn (Fig. 7). Its microstructure is characterized by evenly distributed graphite flakes in a matrix composed of dendrites and an interdendritic eutectic phase (Fig. 8). What appears to be irregular graphite flakes / porosity is in fact deformed graphite flakes; graphite is soft and prone to destruction by smearing and/or preferential removal during polishing (Scott 1991).

Fig. 7: EDS-spectrum showing the chemical composition of the metal. Method of analysis: SEM-EDS. Lab. of Electronic Microscopy and Microanalysis, Néode, HEI Arc,

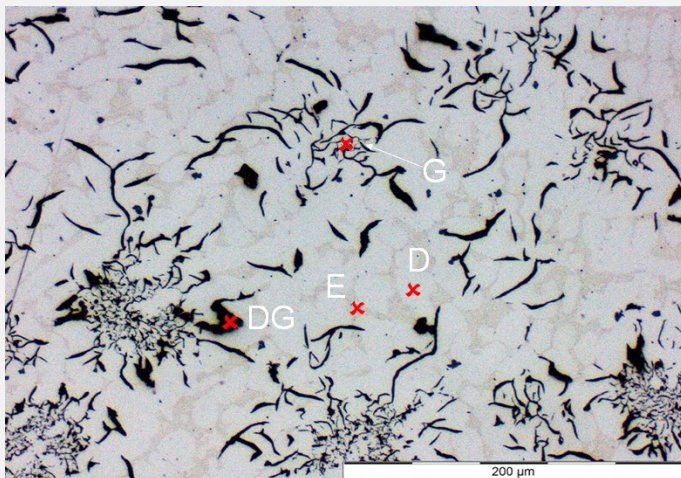
The dendrites appear light grey under polarized light, while the eutectic phase appear light brown (Fig. 8). The eutectic phase is rich in Fe and P and contains small amounts of C and Si, whereas the dendritic phase contains much less P (Table 1).

Fig. 8: Micrograph of the metal sample from Fig. 4 (detail). Unetched, bright field. Graphite flakes (G) in black, the dendrites (D) in light grey and the eutectoid phase (E) in light brown. Deformed graphite (DG) flakes are visible as irregular black inclusions,

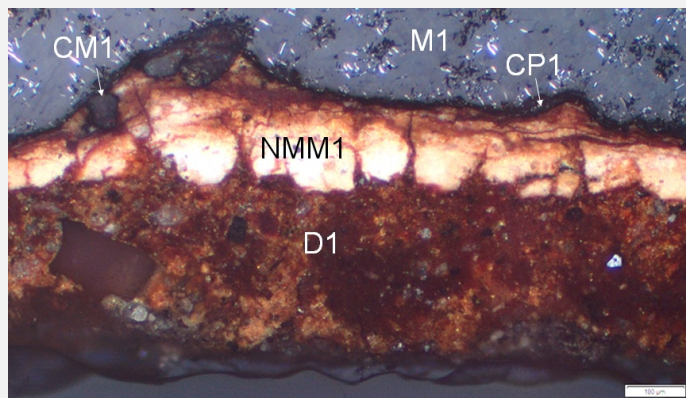
The exterior face (Figs. 2, 4 and 9) consists of a white / light yellow cracked layer (NMM1 in Fig. 5) superimposed by a layer of deposit mixed with orange-red corrosion products (D1 in Fig. 5). Punctual analysis by SEM-EDS (Table 2) revealed that the white / light yellow layer is rich in Ba, O, S, Fe, C and Zn. It has a chemical composition similar to Lithopone (BaSO₄,ZnS), a preparatory paint layer. Fe is probably a contamination from the superimposed porous deposit / corrosion product D1 (Table 2). The latter (D1) is Fe- and O-rich and contains Si, Al and some Ca, in addition to a range of elements (K, P, Na, Cl, S and Ti) present in minor amounts (Table 2). A thin layer of corrosion products (CP1) is located just beneath the paint layer, appearing dark grey under polarized light (Fig. 9). This layer is followed by a corroded metal phase (CM1). Their exact composition was not analyzed but is likely to correspond to the corroded metal phase of the fracture edge, described below.

Fig. 9: Micrograph of the metal sample from Fig. 4 (detail), unetched, polarized light, 5x. The stratigraphy of the exterior surface, from top to bottom: the metal (M1) in grey, a layer of corroded metal (CM1) followed by a thin layer of CP1, and a white cracked layer (NMM1) superimposed by a porous dark-red deposit (D1),

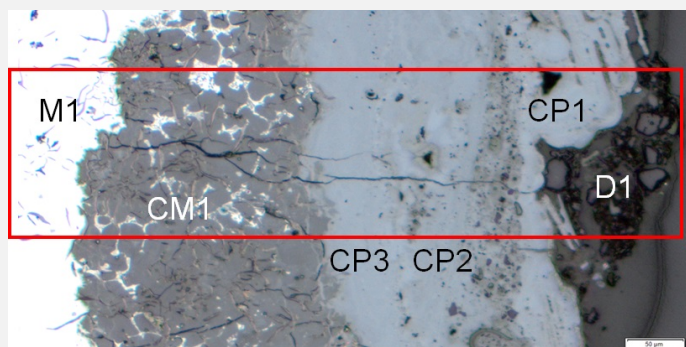
The interior face (Figs. 2 and 4) shows similar characteristics but does not include a white layer similar to NMM1. The fracture edge however (Figs. 2, 4 and 10), shows a more complex stratigraphy consisting of a dense product layer which can be further divided into two individual strata (CP3 and CP2), superimposed by a porous corrosion crust appearing orange under polarized light (CP1) (Fig. 11). The corroded metal (CM1) is located just beneath CP3 and contains remnants of the P-rich eutectic phase (Figs. 10-12). The M/CP ratio (metal to corrosion products) is rather high, implying extensive internal corrosion. Furthermore, a simple crack is traversing the corrosion layers – indicating a fragilization of the structure. As for the composition of the corrosion products CP1, CP2 and CP3, they all contain Fe and O (Fig. 12). A marbling effect within CP2 and CP3 indicates a variation in the concentration of Fe and O (particularly visible in bright field - Fig. 10). The white deposit (D1 in Fig. 6) might originate from exposure to calcareous water (Table 2). The presence of exogenous elements such as Si, Ca, Al, Na and O (Table 2) was confirmed by elemental mapping (Fig. 12).

Fig. 10: Micrograph of the metal sample from Fig. 4 (detail), unetched, bright field. From left to right: intact metal (M1) in white, followed by preferentially corroded metal (CM1) and dense product layers (CP3 and CP2) in various shades of grey. CP1 is slightly porous and covered by grain-like particles (D1). The area selected for elemental chemical distribution (Fig. 12) is marked by a red rectangle. A simple crack is traversing the corrosion layers,

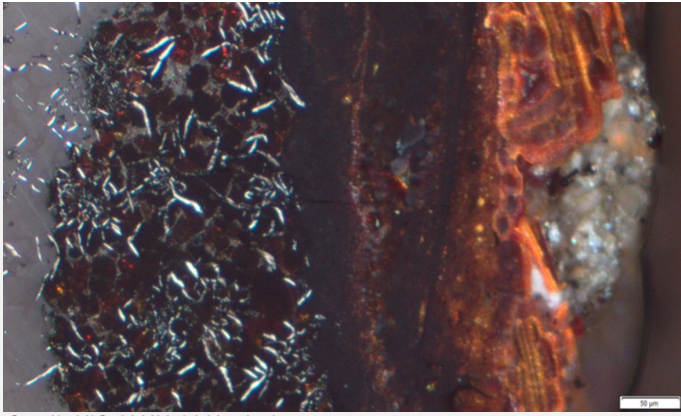
Fig. 11: Micrograph similar to Fig. 10 but under polarized light. The external deposit (D1) appears grey-white, CP1 in bright orange, while CP2 and CP3 appear dark red to brown. The corroded metal (CM1) contains remnants of graphite flakes (in white) and the P-rich eutectic (in grey),

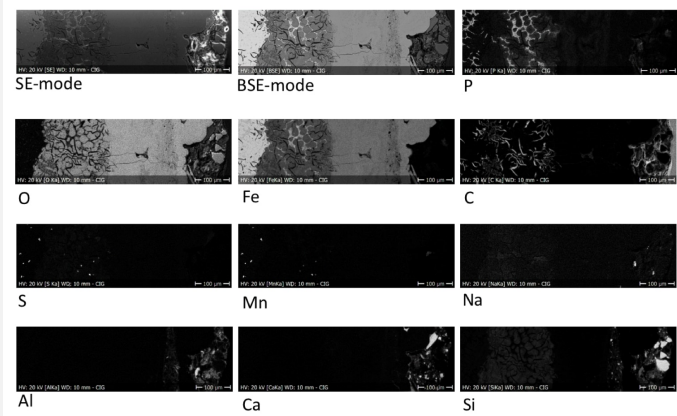
Fig. 12: SEM image and elemental chemical distribution of the selected area from Fig. 10. Method of analysis: SEM-EDS. Lab. of Electronic Microscopy and Microanalysis, Néode, HEI Arc,

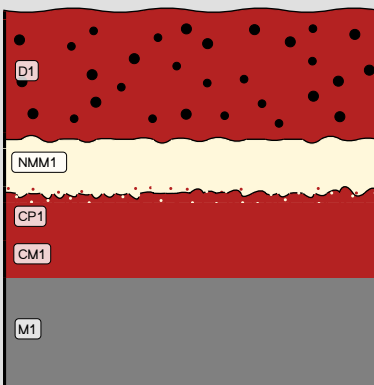
Fig. 5: Stratigraphic representation of the sample taken from the rain gutter fragment in cross-section using the MiCorr application. The characteristics of the strata are only accessible by clicking on the drawing that redirects you to the search tool by stratigraphy representation. This representation can be compared to Fig. 9. CP1 corresponds to CP2 in Fig. 3, Credit UiO-IAKH, M.Hovind.

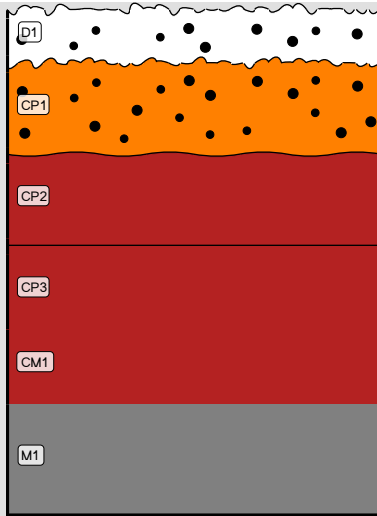
Fig. 6: Stratigraphic representation of the sample taken from the rain gutter fragment in cross-section using the MiCorr application. The characteristics of the strata are only accessible by clicking on the drawing that redirects you to the search tool by stratigraphy representation. This representation can be compared to Fig. 11. D1 corresponds to D3 in Fig. 3, Credit UiO-IAKH, M.Hovind.

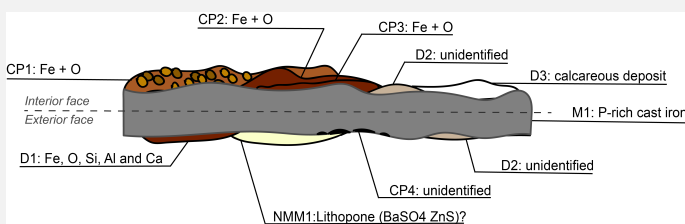
Fig. 13: Improved stratigraphic representation of the rain gutter fragment with results of SEM-EDS analysis and visual microscopic observation,

The rain gutter fragment is a grey cast iron with a microstructure consisting of graphite flakes and a P-rich eutectic phase. The exterior surface contains a preparatory paint layer, located beneath a layer of corrosion products mixed with soil. It seems likely that the cast iron gutter has been covered with a protective paint layer (e.g. Lithopone) to slow down the rate of atmospheric corrosion. The presence of Lithopone reinforces the suggested dating of the artefact (20th century) as this pigment was developed and used from the 1880s and onwards (Lithopone 2007). However, it seems that the protective layer has none or only very limited effect as (pitting) corrosion is present also in these areas.

The corrosion layers consist mainly of Fe and O, indicating atmospheric corrosion with presence of only a very small amount of contaminants/pollution. The scattered white deposit is possibly originating from exposure to calcareous water as it is localized mainly on the interior face of the fragment, where rain water would hit the metal before entering the ground.
