RAIN GUTTER FRAGMENT – GREY CAST IRON – MODERN TIMES – FRANCE

Artefact name Rain gutter fragment

Authors Christian. Degriigny (HE-Arc CR, Neuchâtel, Neuchâtel, Switzerland) & Mathea. Hovind (University of Oslo, Department of archaeology, conservation and history (IAKH-UiO), Oslo, Oslo, Norway)

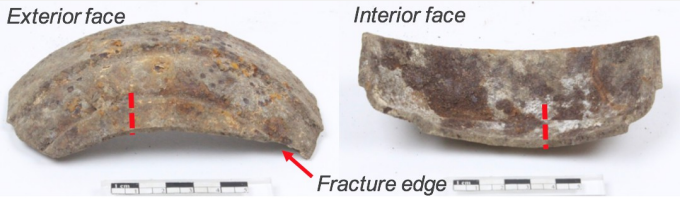
Fig. 2: The exterior and interior faces before sampling. The dotted line represents the sample location (a cross-section of the metal). The fracture edge corresponds to the edge that was formerly attached to the remaining artefact,

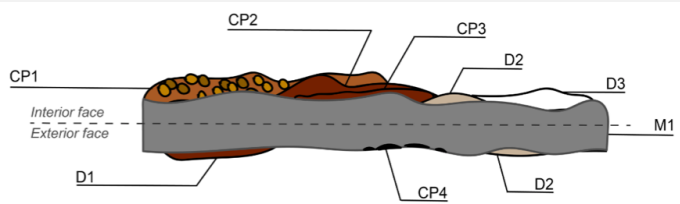
Fig. 3: Preliminary stratigraphy corresponding to the overall surface of the artefact. The interior surface is shown above the stippled line and the exterior surface below. D = Deposit, CP = Corrosion products, M = Metal,

Captions	Description
D1	Scattered, orange to dark red encrustations. Probably corrosion products mixed with soil.
D2	Grey-brown and matte deposit, somewhat powdery - possibly corrosion product mixed with soil. This layer is located both on the interior and exterior surface of the artefact.
D3	Localized, white and strongly adherent deposit.
CP1	Bright orange to dark red corrosion product. Uneven surface with pustules.
CP2	Red-brown corrosion crust. Brittle, but adherent. Flakes off in bits when force is applied perpendicular to the surface with a scalpel.
CP3	Similar to CP2 but appears to be an individual layer.
CP4	Isolated corrosion blisters. Circular and black in colour. Mainly located on the exterior surface.
M1	Intact metal with a dark grey metallic sheen.

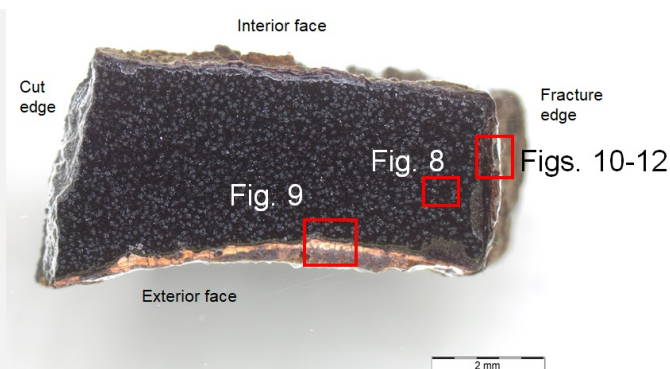
Fig. 4: Micrograph of the sample taken from the rain gutter fragment showing its orientation relative to the artefact and the

locations of Figs. 8-12,

The sample consists of a rectangular section (Fig. 4) which was cut out from the fractured edge of the gutter fragment. It is representative of three surfaces: the exterior and interior surface, as well as the fracture edge. Dimensions: L = 7mm; Wmax. = 5mm; Tmax. = 4mm (approx.).

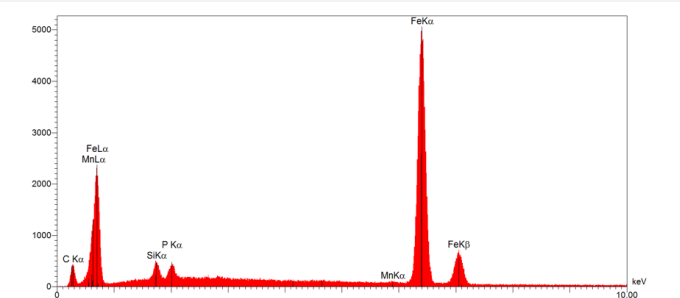
The metal is a P-rich grey cast iron with Si and Mn (Fig. 7). Its microstructure is characterized by evenly distributed graphite flakes in a matrix composed of dendrites and an interdendritic eutectic phase (Fig. 8). What appears to be irregular graphite flakes / porosity is in fact deformed graphite flakes; graphite is soft and prone to destruction by smearing and/or preferential removal during polishing (Scott 1991).

Fig. 7: EDS-spectrum showing the chemical composition of the metal. Method of analysis: SEM-EDS. Lab. of Electronic Microscopy and Microanalysis, Néode, HEI Arc,

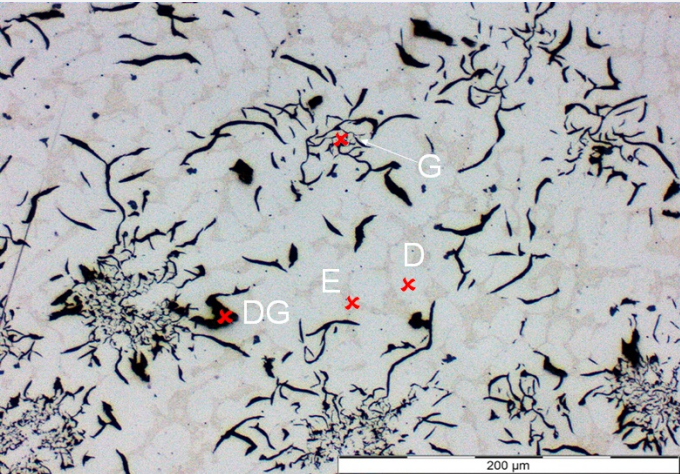
The dendrites appear light grey under polarized light, while the eutectic phase appear light brown (Fig. 8). The eutectic phase is rich in Fe and P and contains small amounts of C and Si, whereas the dendritic phase contains much less P (Table 1).

Fig. 8: Micrograph of the metal sample from Fig. 4 (detail). Unetched, bright field. Graphite flakes (G) in black, the dendrites (D) in light grey and the eutectoid phase (E) in light brown. Deformed graphite (DG) flakes are visible as irregular black inclusions,

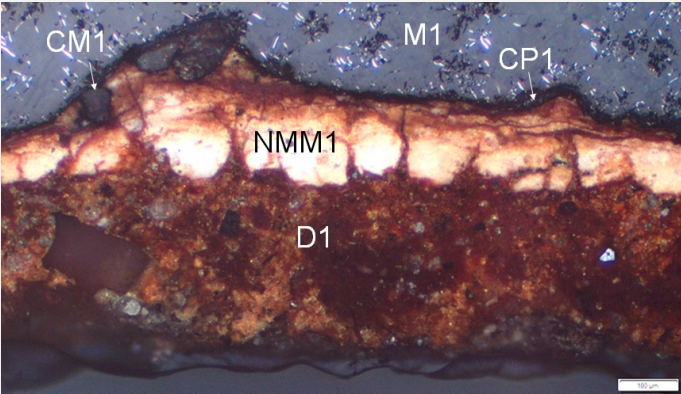
The exterior face (Figs. 2, 4 and 9) consists of a white / light yellow cracked layer (NMM1 in Fig. 5) superimposed by a layer of deposit mixed with orange-red corrosion products (D1 in Fig. 5). Punctual analysis by SEM-EDS (Table 2) revealed that the white / light yellow layer is rich in Ba, O, S, Fe, C and Zn. It has a chemical composition similar to Lithopone (BaSO₄,ZnS), a preparatory paint layer. Fe is probably a contamination from the superimposed porous deposit / corrosion product D1 (Table 2). The latter (D1) is Fe- and O-rich and contains Si, Al and some Ca, in addition to a range of elements (K, P, Na, Cl, S and Ti) present in minor amounts (Table 2). A thin layer of corrosion products (CP1) is located just beneath the paint layer, appearing dark grey under polarized light (Fig. 9). This layer is followed by a corroded metal phase (CM1). Their exact composition was not analyzed but is likely to correspond to the corroded metal phase of the fracture edge, described below.

Fig. 9: Micrograph of the metal sample from Fig. 4 (detail), unetched, polarized light, 5x. The stratigraphy of the exterior surface, from top to bottom: the metal (M1) in grey, a layer of corroded metal (CM1) followed by a thin layer of CP1, and a white cracked layer (NMM1) superimposed by a porous dark-red deposit (D1),

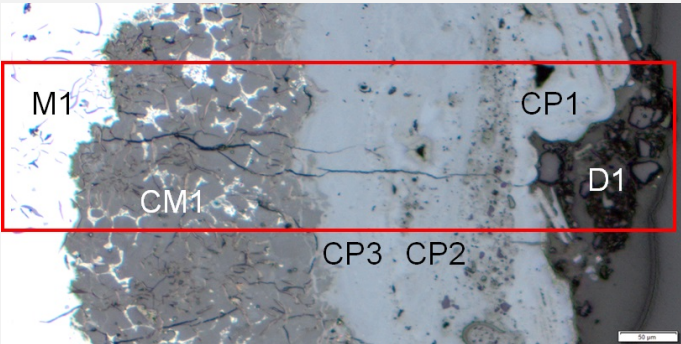
The interior face (Figs. 2 and 4) shows similar characteristics but does not include a white layer similar to NMM1. The fracture edge however (Figs. 2, 4 and 10), shows a more complex stratigraphy consisting of a dense product layer which can be further divided into two individual strata (CP3 and CP2), superimposed by a porous corrosion crust appearing orange under polarized light (CP1) (Fig. 11). The corroded metal (CM1) is located just beneath CP3 and contains remnants of the P-rich eutectic phase (Figs. 10-12). The M/CP ratio (metal to corrosion products) is rather high, implying extensive internal corrosion. Furthermore, a simple crack is traversing the corrosion layers – indicating a fragilization of the structure. As for the composition of the corrosion products CP1, CP2 and CP3, they all contain Fe and O (Fig. 12). A marbling effect within CP2 and CP3 indicates a variation in the concentration of Fe and O (particularly visible in bright field - Fig. 10). The white deposit (D1 in Fig. 6) might originate from exposure to calcareous water (Table 2). The presence of exogenous elements such as Si, Ca, Al, Na and O (Table 2) was confirmed by elemental mapping (Fig. 12).

Fig. 10: Micrograph of the metal sample from Fig. 4 (detail), unetched, bright field. From left to right: intact metal (M1) in white, followed by preferentially corroded metal (CM1) and dense product layers (CP3 and CP2) in various shades of grey. CP1 is slightly porous and covered by grain-like particles (D1). The area selected for elemental chemical distribution (Fig. 12) is marked by a red rectangle. A simple crack is traversing the corrosion layers,

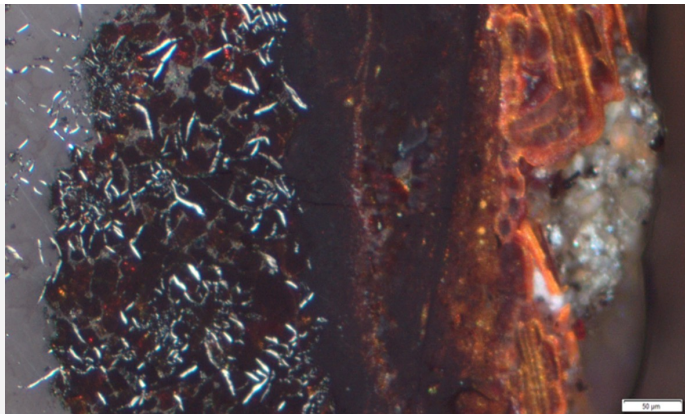
Fig. 11: Micrograph similar to Fig. 10 but under polarized light. The external deposit (D1) appears grey-white, CP1 in bright orange, while CP2 and CP3 appear dark red to brown. The corroded metal (CM1) contains remnants of graphite flakes (in white) and the P-rich eutectic (in grey),

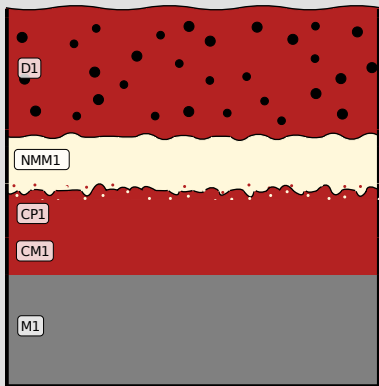
Fig. 5: Stratigraphic representation of the sample taken from the rain gutter fragment in cross-section using the MiCorr application. The characteristics of the strata are only accessible by clicking on the drawing that redirects you to the search tool by stratigraphy representation. This representation can be compared to Fig. 9. CP1 corresponds to CP2 in Fig. 3, Credit UiO-IAKH, M.Hovind.

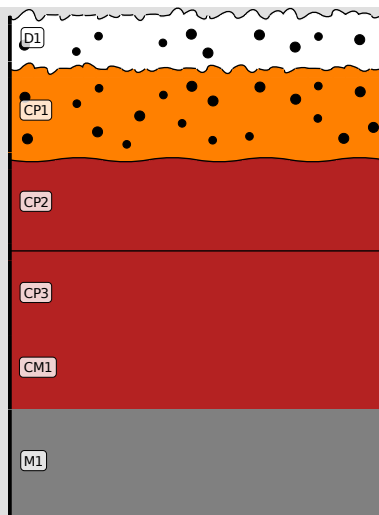
Fig. 6: Stratigraphic representation of the sample taken from the rain gutter fragment in cross-section using the MiCorr application. The characteristics of the strata are only accessible by clicking on the drawing that redirects you to the search tool by stratigraphy representation. This representation can be compared to Fig. 11. D1 corresponds to D3 in Fig. 3, Credit UiO-IAKH, M.Hovind.

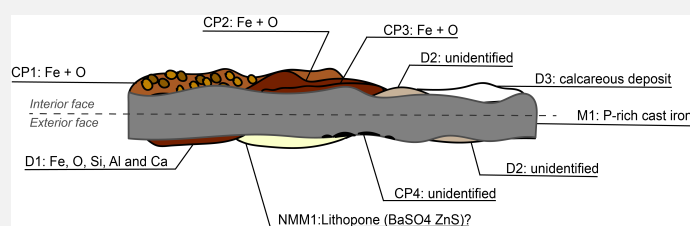
Fig. 13: Improved stratigraphic representation of the rain gutter fragment with results of SEM-EDS analysis and visual microscopic observation,

The rain gutter fragment is a grey cast iron with a microstructure consisting of graphite flakes and a P-rich eutectic phase. The exterior surface contains a preparatory paint layer, located beneath a layer of corrosion products mixed with soil. It seems likely that the cast iron gutter has been covered with a protective paint layer (e.g. Lithopone) to slow down the rate of atmospheric corrosion. The presence of Lithopone reinforces the suggested dating of the artefact (20th century) as this pigment was developed and used from the 1880s and onwards (Lithopone 2007). However, it seems that the protective layer has none or only very limited effect as (pitting) corrosion is present also in these areas.

The corrosion layers consist mainly of Fe and O, indicating atmospheric corrosion with presence of only a very small amount of contaminants/pollution. The scattered white deposit is possibly originating from exposure to calcareous water as it is localized mainly on the interior face of the fragment, where rain water would hit the metal before entering the ground.
