FUNERAL MASK IVC 11595 – CU/AG, WITH SURFACE ENRICHMENT (AG)

Artefact name Funeral mask Ivc 11595

Authors Christian. Degriigny (HE-Arc CR, Neuchâtel, Neuchâtel, Switzerland) & Naima. Gutknecht (HE-Arc CR, Neuchâtel, Neuchâtel, Switzerland) & Valentin. Boissonnas (HE-Arc CR, Neuchâtel, Neuchâtel, Switzerland)

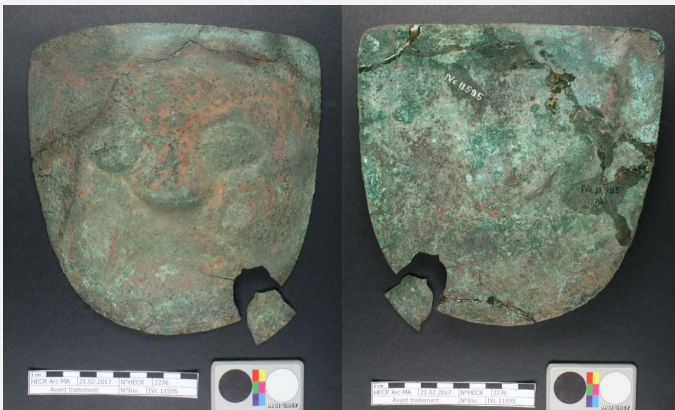
Fig. 1: Funeral mask, front and back face to the left and right respectively,

Description of the artefact Peruvian funeral mask (Fig. 1). There are remains of red pigment and of a mineralised textile on both sides of the object. It is heavily corroded in green and red corrosion layers. It is deformed and broken. Dimensions: Length = 180mm; Width = 170mm; Height = 20 mm; WT = 158,6g.

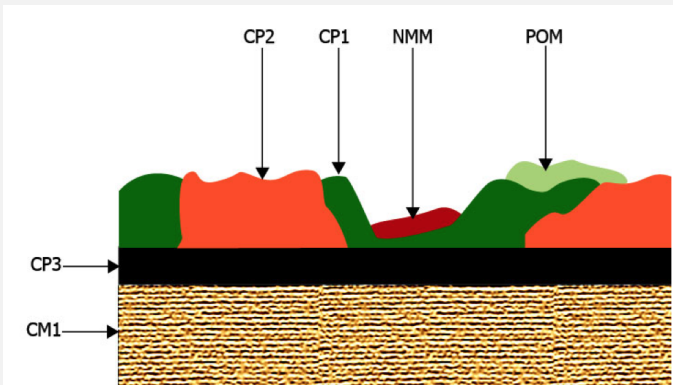
The schematic representation below gives an overview of the corrosion layers encountered on the object from visual macroscopic observation. The first stratigraphy (Fig. 3a) is for the front, while the second (Fig. 3b) represents the back.

Fig. 3a: Stratigraphic representation of the front face of the funeral mask in cross-section by macroscopic observation,

Fig. 3b: Stratigraphic representation of the back face of the funeral mask in cross-section by macroscopic observation,

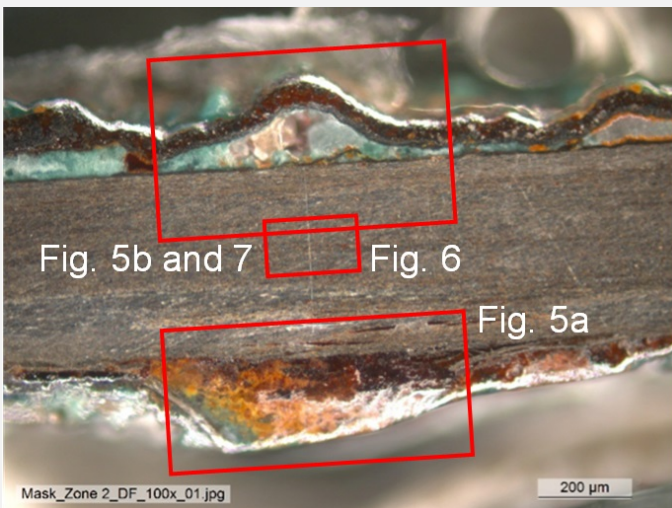
Fig. 4: Micrograph of the cross-section of the sample temporarily taken from the detached fragment of Fig. 2 showing the locations of Figs. 5a (corresponding to the front of the funeral mask), Fig. 5b (back of the funeral mask), Figs. 6 and 7,

A polished section was made from an already detached fragment that was temporarily embedded in resin (Fig. 2). On Fig. 4 the upper part of the sample corresponds to the front face of the funeral mask while the lower part corresponds to its back face. Both sides have developed subsequent layers of corrosion. In areas, these have buckled and become detached.

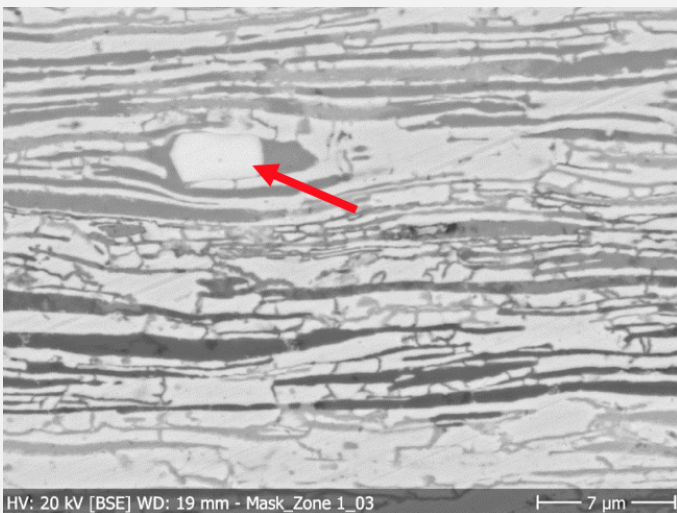
The XRF analysis is a surface analysis that was done without any removal of the copper corrosion products. The proportions are given for the oxide on the surface. The SEM/EDS analysis shows that there are Cu-rich phases alternating with Ag-rich phases. There are inclusions of Pb and As (Fig. 6). Cl has been detected throughout the entire corroded metal, most likely in the form of Cu and Ag corrosion products.

Fig. 6: SEM image (BSE-mode) of the metal sample from Fig. 4 (detail), the elongated grains are the result of repeated hammering. Absence of strain lines indicates that the metal is annealed. The darker areas are Cu-rich phases and the lighter areas are Ag-rich phases. The arrow shows an As- and Pb inclusion,

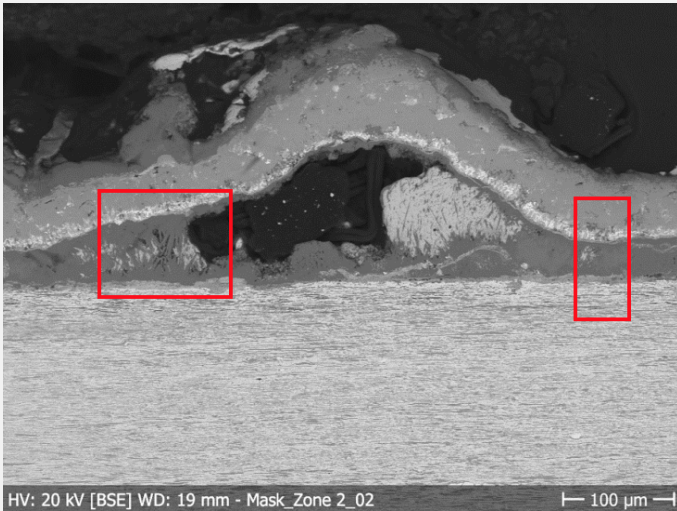
A layer of mercury can be seen with EDS (Figs. 7 and 8). Mercury was not used by the pre-Columbians in metallic form (Scott 2000 and McEwan 2000) but was common as a pigment in form of mercury sulfide (cinnabar).

Fig. 7: SEM image (BSE-mode) of the metal sample from Fig. 4 with detail (Fig. 8) indicated by the left red rectangle. The selected area for elemental chemical distribution (Fig. 9) is marked by the right red rectangle,

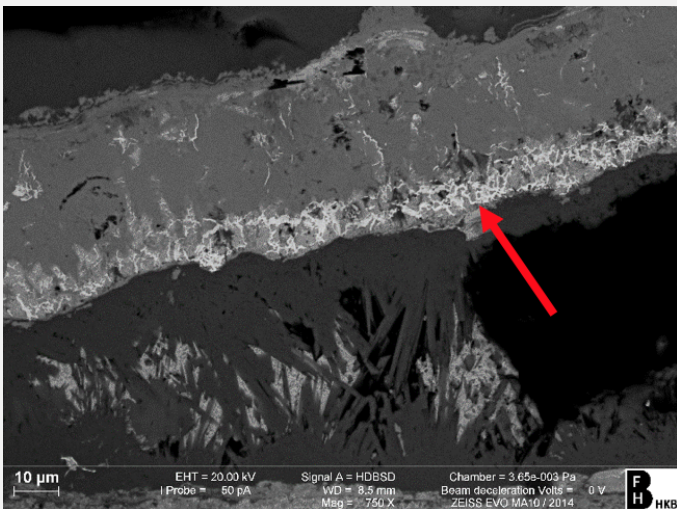
Fig. 8: SEM image of a partially refilled structural void with a silver-, copper- and mercury-rich layer (red arrow),

through an electrochemical process in the presence of chlorides (Keune 2005). The released sulfur recombined with the silver to form black silver sulphide. Above that layer a porous mercury- and silver rich stratum has formed (see Hg & Ag on cartography Fig. 9). It remains unclear if the limitos is located in the silver enriched surface or within this silver-mercury compound (Fig. 8).

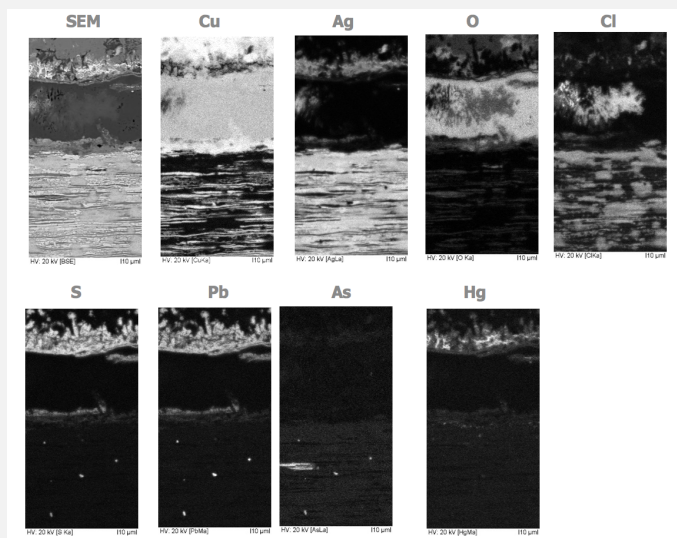
The remaining metal shows a preferential corrosion of copper and a presence of chlorides (Fig. 9, Table 1). There is a preferential corrosion of copper that has fragilized the structure of the sheet metal. The silver enriched surface is entirely covered with copper corrosion products. The outer green layer (CP1) is a copper carbonate (Fig. 12, Table 1), while the red layers (CP2 in Fig. 5a ; CP4 and CP5 in Fig. 5b) are consisting of a copper oxide, most likely cuprite (Fig. 10). Below the cuprite and above the silver enriched surface on the front face a thin black layer is present (appears grey under polarized light). SEM-EDS analysis shows that in that stratum the mercury of the pigment (Fig. 14) has been transformed into a mercury-silver compound (Figs. 8 and 11a and b) which according to Raman spectrometry (Fig. 15) is not cinnabar anymore. In areas this silver- and mercury-rich surface has been pulled off by raising the corrosion layers, leaving structural voids that were subsequently filled by secondary corrosion products, most likely copper carbonates (Figs. 7 and 8). The silver sulphide (HgS, cinnabar, Fig. 14), present as a red pigment on the silver surface, could have been reduced

Fig. 9: SEM image (BSE-mode) and elemental chemical distribution of the selected area on Fig. 7. Method of examination: SEM/EDS,

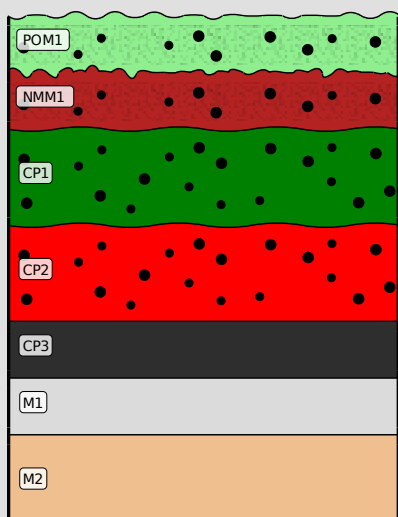
Fig. 5a: Stratigraphic representation of the cross-section from Figs. 3a or 4 (front of the object) using the MiCorr application. The characteristics of the strata are only accessible by clicking on the drawing that redirects you to the search tool by stratigraphy representation, Credit HE-Arc CR, N. Gutknecht.

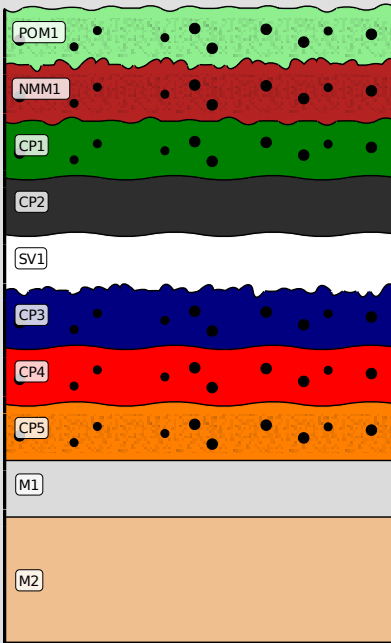
Fig. 5b: Stratigraphic representation of the cross-section from Figs. 3b and 4 (back of the object) using the MiCorr application. CP2 is CP3 while CP3 is CP2 and CP3 is CP4 in Fig. 3b. The characteristics of the strata are only accessible by clicking on the drawing that redirects you to the search tool by stratigraphy representation, Credit HE-Arc CR, N. Gutknecht.

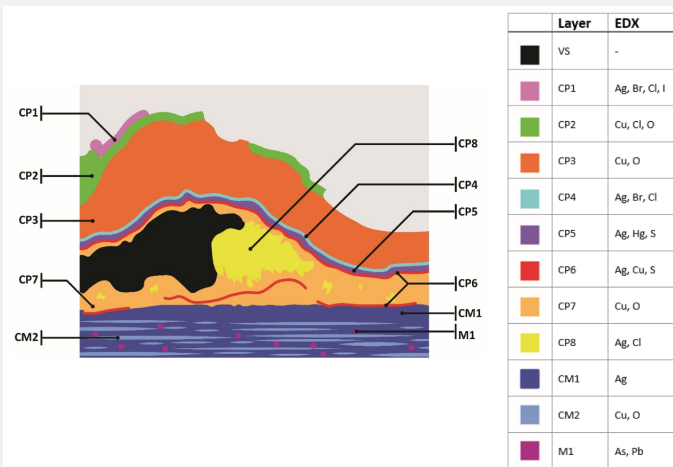
Fig. 16: Improved stratigraphic representation of the funeral mask (Fig. 7) based on the results from the SEM-EDS analyses,

The artefact is a repeatedly hammered, annealed and pickled Cu-Ag tumbaga. The cuprite and hydroxycarbonate layers and the presence of chlorides are typical for the corrosion of tumbaga alloys in an archaeological context. Cinnabar has been identified as pigment applied to the surface before burial. Over the centuries, it was partially incorporated into the growing copper corrosion layers.

Close to the enriched silver surface and below the cuprite layer a silver- and mercury-rich stratum has formed. Only one publication mentions the reaction of cinnabar with a gold-enriched tumbaga surface but does not go into details about the possible mechanism involved (Masuda 1997).

The presence of a silver-sulphur compound below this silver-mercury stratum could indicate that the cinnabar was reduced by electrochemical processes to mercury, releasing sulphur that reacted with the silver enriched surface.
