# FUNERAL MASK IVC 11595 – CU/AG, WITH SURFACE ENRICHMENT (AG)

**Artefact name** Funeral mask IVC 11595

**Authors** Christian. Degrigny (HE-Arc CR, Neuchâtel, Neuchâtel, Switzerland) & Naima. Gutknecht (HE-Arc CR, Neuchâtel, Neuchâtel, Switzerland) & Valentin. Boissonnas (HE-Arc CR, Neuchâtel, Neuchâtel, Switzerland)

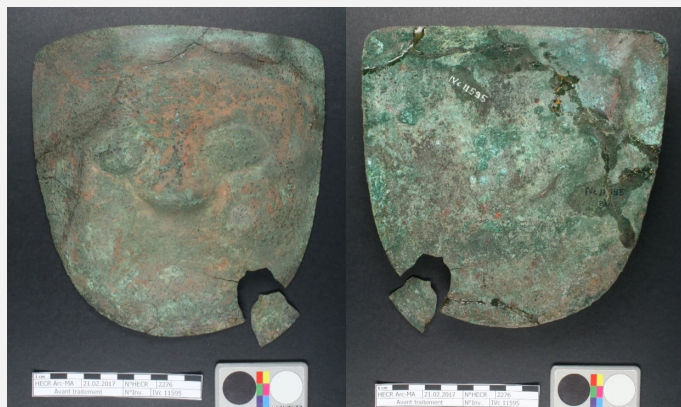
Fig. 1: Funeral mask, front and back face to the left and right respectively,

**Description of the artefact** Peruvian funeral mask (Fig. 1). There are remains of red pigment and of a mineralised textile on both sides of the object. It is heavily corroded in green and red corrosion layers. It is deformed and broken. Dimensions: Length = 180mm; Width = 170mm; Height = 20 mm; WT = 158,6g.

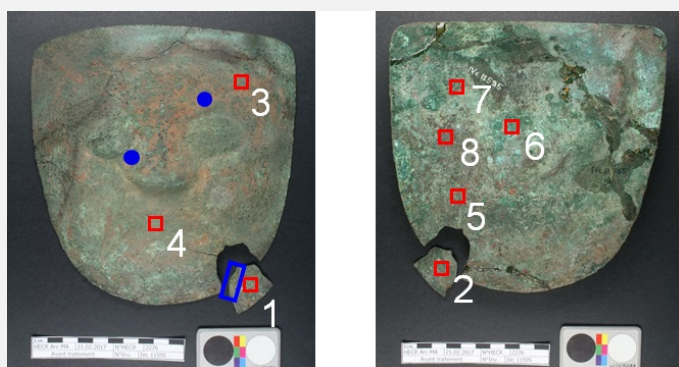
Fig. 2: Front (left) and back (right) faces showing the location of XRF analyses (red squares), sampling areas for SEM-EDS (blue points) and sampling area for examination on cross-section (blue rectangle),

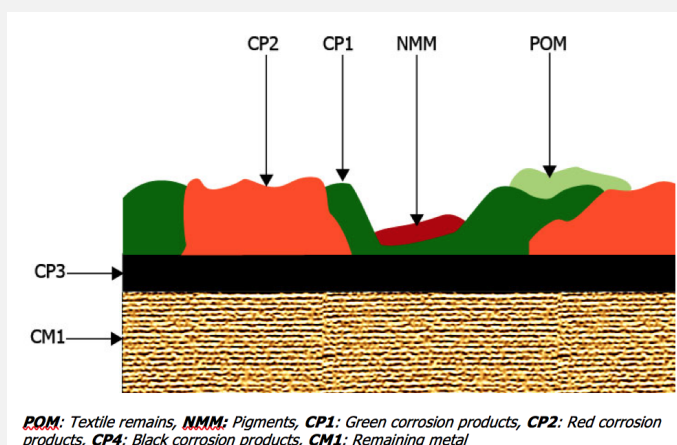
Fig. 3a: Stratigraphic representation of the front face of the funeral mask in cross-section by macroscopic observation,

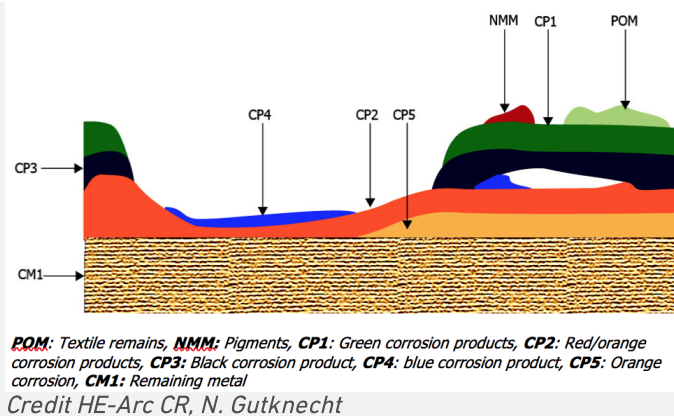
Fig. 3b: Stratigraphic representation of the back face of the funeral mask in cross-section by macroscopic observation,

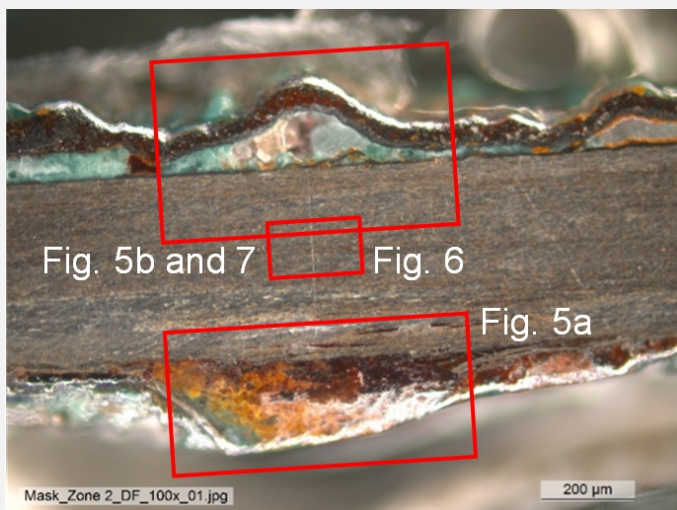
Fig. 4: Micrograph of the cross-section of the sample temporarily taken from the detached fragment of Fig. 2 showing the locations of Figs. 5a (corresponding to the front of the funeral mask), Fig. 5b (back of the funeral mask), Figs. 6 and 7,

A polished section was made from an already detached fragment that was temporarily embedded in resin (Fig. 2). On Fig. 4 the upper part of the sample corresponds to the front face of the funeral mask while the lower part corresponds to its back face. Both sides have developed subsequent layers of corrosion. In areas, these have buckled and become detached.

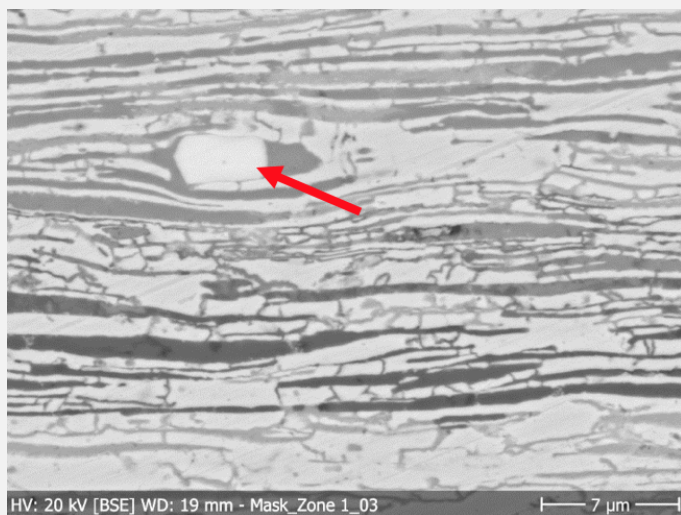
The XRF analysis is a surface analysis that was done without any removal of the copper corrosion products. The proportions are given for the oxide on the surface. The SEM/EDS analysis shows that there are Cu-rich phases alternating with Ag-rich phases. There are inclusions of Pb and As (Fig. 6). Cl has been detected throughout the entire corroded metal, most likely in the form of Cu and Ag corrosion products.

Fig. 6: SEM image (BSE-mode) of the metal sample from Fig. 4 (detail), the elongated grains are the result of repeated hammering. Absence of strain lines indicates that the metal is annealed. The darker areas are Cu-rich phases and the lighter areas are Ag-rich phases. The arrow shows an As- and Pb inclusion,

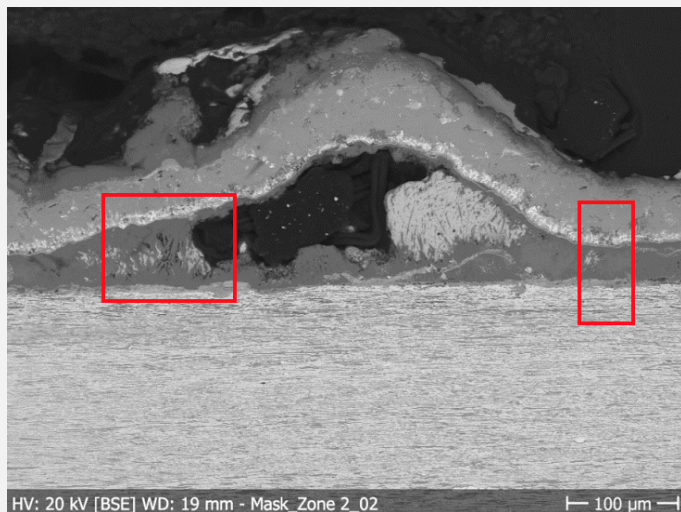
A layer of mercury can be seen with EDS (Figs. 7 and 8). Mercury was not used by the pre-Columbians in metallic form (Scott 2000 and McEwan 2000) but was common as a pigment in form of mercury sulfide (cinnabar).

Fig. 7: SEM image (BSE-mode) of the metal sample from Fig. 4 with detail (Fig. 8) indicated by the left red rectangle. The selected area for elemental chemical distribution (Fig. 9) is marked by the right red rectangle,

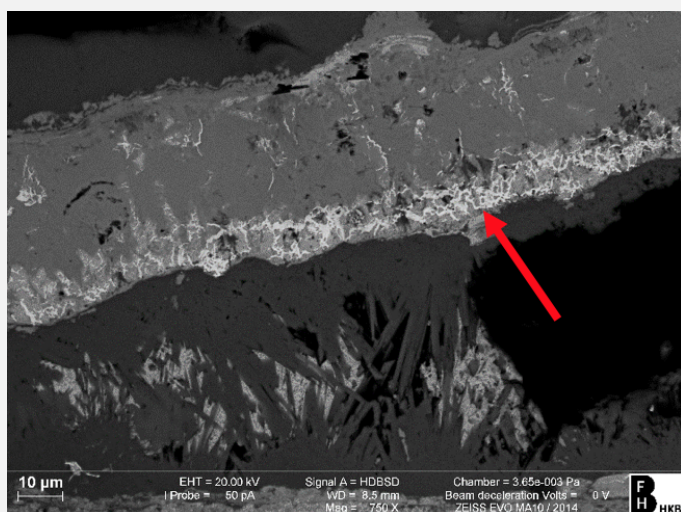
Fig. 8: SEM image of a partially refilled structural void with a silver-, copper- and mercury-rich layer (red arrow),

through an electrochemical process in the presence of chlorides (Keune 2005). The released sulfur recombined with the silver to form black silver sulphide. Above that layer a porous mercury- and silver rich stratum has formed (see Hg & Ag on cartography Fig. 9). It remains unclear if the limitos is located in the silver enriched surface or within this silver-mercury compound (Fig. 8).

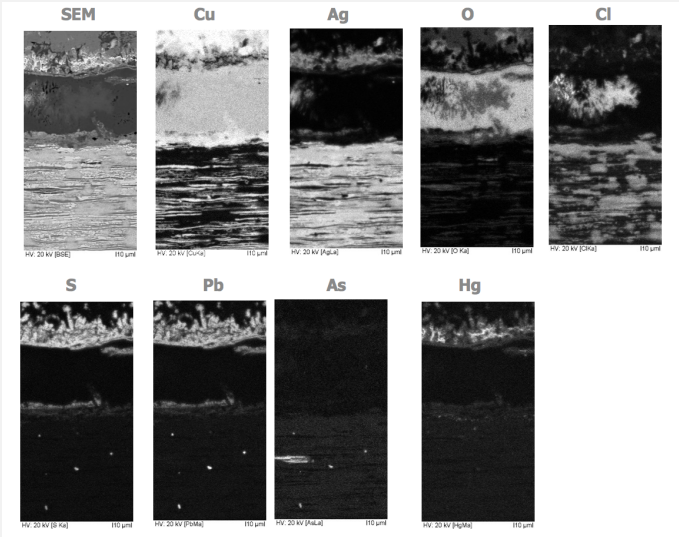
The remaining metal shows a preferential corrosion of copper and a presence of chlorides (Fig. 9, Table 1). There is a preferential corrosion of copper that has fragilized the structure of the sheet metal. The silver enriched surface is entirely covered with copper corrosion products. The outer green layer (CP1) is a copper carbonate (Fig. 12, Table 1), while the red layers (CP2 in Fig. 5a ; CP4 and CP5 in Fig. 5b) are consisting of a copper oxide, most likely cuprite (Fig. 10). Below the cuprite and above the silver enriched surface on the front face a thin black layer is present (appears grey under polarized light). SEM-EDS analysis shows that in that stratum the mercury of the pigment (Fig. 14) has been transformed into a mercury-silver compound (Figs. 8 and 11a and b) which according to Raman spectrometry (Fig. 15) is not cinnabar anymore. In areas this silver- and mercury-rich surface has been pulled off by raising the corrosion layers, leaving structural voids that were subsequently filled by secondary corrosion products, most likely copper carbonates (Figs. 7 and 8). The silver sulphide (HgS, cinnabar, Fig. 14), present as a red pigment on the silver surface, could have been reduced

Fig. 9: SEM image (BSE-mode) and elemental chemical distribution of the selected area on Fig. 7. Method of examination: SEM/EDS,

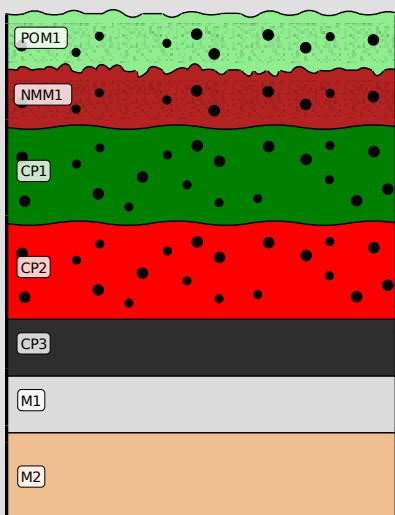
Fig. 5a: Stratigraphic representation of the cross-section from Figs. 3a or 4 (front of the object) using the MiCorr application. The characteristics of the strata are only accessible by clicking on the drawing that redirects you to the search tool by stratigraphy representation, Credit HE-Arc CR, N. Gutknecht.

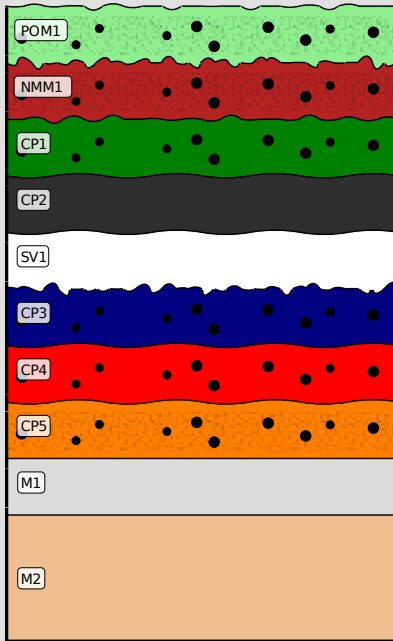
Fig. 5b: Stratigraphic representation of the cross-section from Figs. 3b and 4 (back of the object) using the MiCorr application. CP2 is CP3 while CP3 is CP2 and CP3 is CP4 in Fig. 3b. The characteristics of the strata are only accessible by clicking on the drawing that redirects you to the search tool by stratigraphy representation, Credit HE-Arc CR, N. Gutknecht.

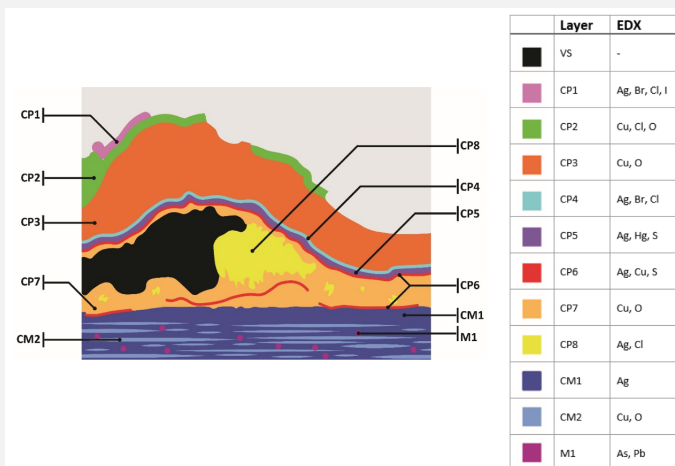
The schematic representation of corrosion layers of Fig. 7 integrating additional information based on the analyses carried out is given in Fig. 16.

Fig. 16: Improved stratigraphic representation of the funeral mask (Fig. 7) based on the results from the SEM-EDS analyses,
