FUNERAL MASK IVC 11595 – CU/AG, WITH SURFACE ENRICHMENT (AG)

Artefact name Funeral mask IVC 11595

Authors Christian. Degriy (HE-Arc CR, Neuchâtel, Neuchâtel, Switzerland) & Naima. Gutknecht (HE-Arc CR, Neuchâtel, Neuchâtel, Switzerland) & Valentin. Boissonnas (HE-Arc CR, Neuchâtel, Neuchâtel, Switzerland)

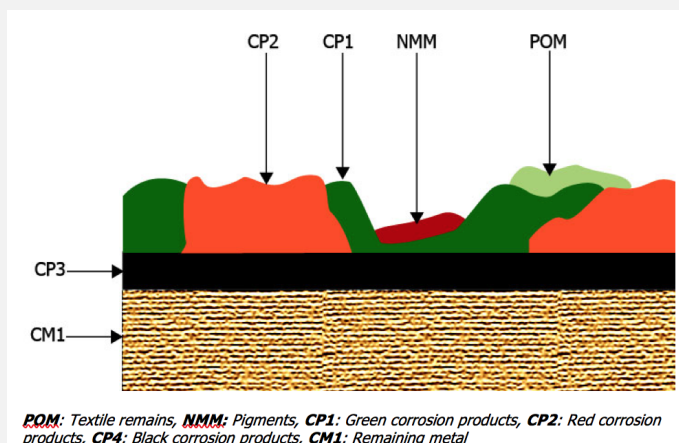
Fig. 3a: Stratigraphic representation of the front face of the funeral mask in cross-section by macroscopic observation,

POM: Textile remains, **NMM:** Pigments, **CP1:** Green corrosion products, **CP2:** Red corrosion products, **CP4:** Black corrosion products, **CM1:** Remaining metal

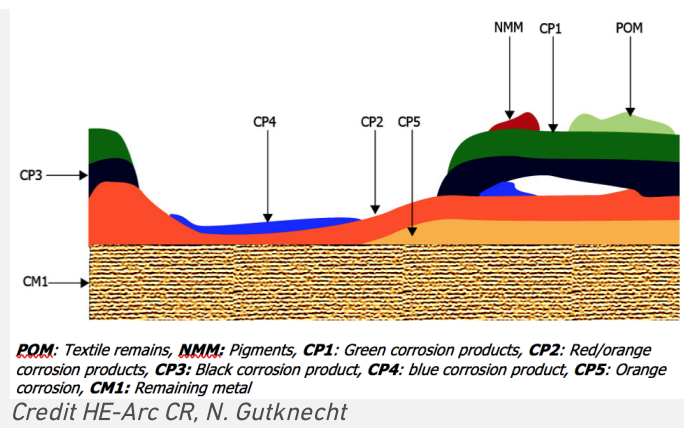
Fig. 3b: Stratigraphic representation of the back face of the funeral mask in cross-section by macroscopic observation,

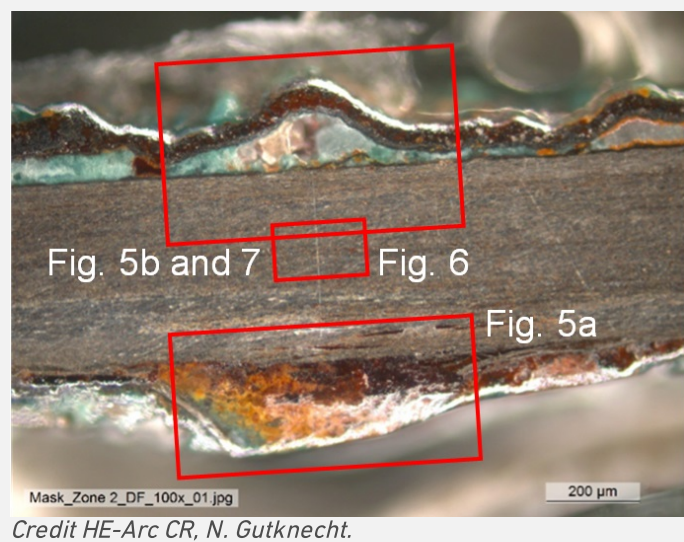
Fig. 4: Micrograph of the cross-section of the sample temporarily taken from the detached fragment of Fig. 2 showing the locations of Figs. 5a (corresponding to the front of the funeral mask), Fig. 5b (back of the funeral mask), Figs. 6 and 7,

A polished section was made from an already detached fragment that was temporarily embedded in resin (Fig. 2). On Fig. 4 the upper part of the sample corresponds to the front face of the funeral mask while the lower part corresponds to its back face. Both sides have developed subsequent layers of corrosion. In areas, these have buckled and become detached.

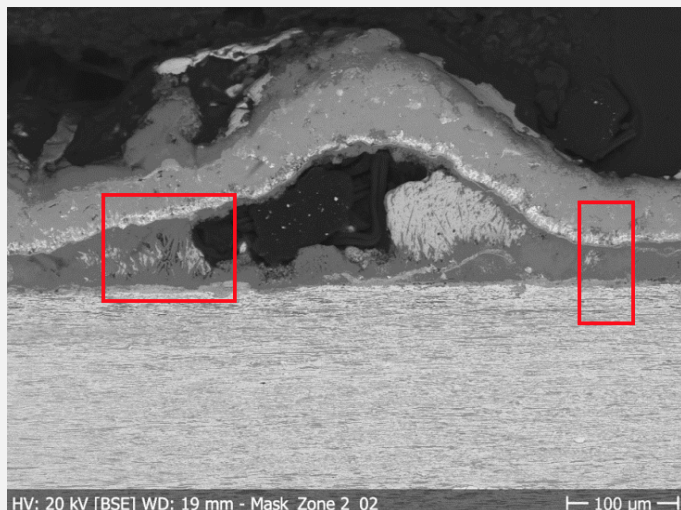
A layer of mercury can be seen with EDS (Figs. 7 and 8). Mercury was not used by the pre-Columbians in metallic form (Scott 2000 and McEwan 2000) but was common as a pigment in form of mercury sulfide (cinnabar).

Fig. 7: SEM image (BSE-mode) of the metal sample from Fig. 4 with detail (Fig. 8) indicated by the left red rectangle. The selected area for elemental chemical distribution (Fig. 9) is marked by the right red rectangle,

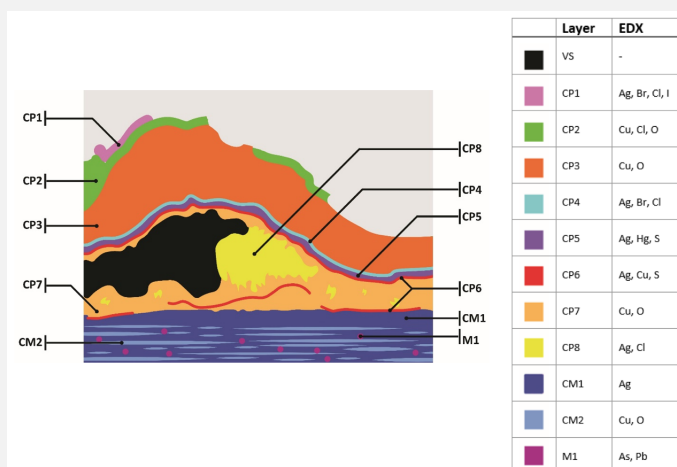
The schematic representation of corrosion layers of Fig. 7 integrating additional information based on the analyses carried out is given in Fig. 16.

Fig. 16: Improved stratigraphic representation of the funeral mask (Fig. 7) based on the results from the SEM-EDS analyses,
