VOTIVE FIGURE OF A BAT IVB4168 – GILDED BRASS – MODERN TIMES

Artefact name Votive figure of a bat IVb4168

Authors Christian. Degriigny (HE-Arc CR, Neuchâtel, Neuchâtel, Switzerland) & Naima. Gutknecht (HE-Arc CR, Neuchâtel, Neuchâtel, Switzerland) & Valentin. Boissonnas (HE-Arc CR, Neuchâtel, Neuchâtel, Switzerland)

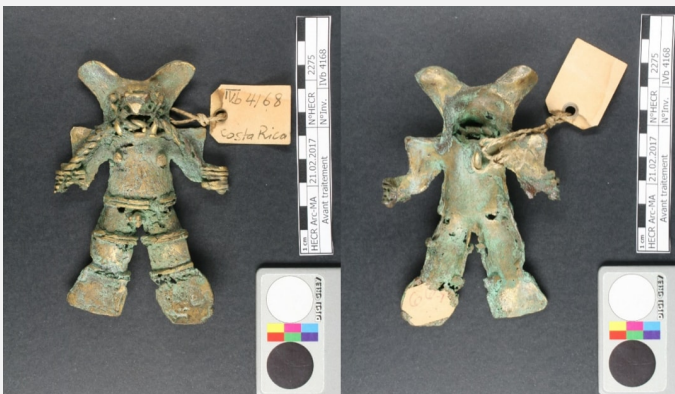
Fig. 1: Votive figure of a bat, front (left) and back (right) view,

The metal seems to have been heavily attacked (acid dissolution). There are several perforations on the lower part of the object, and where the gold layer is absent the surface is unevenly pitted by corrosion (Figs. 1, 2 and 7). The submetallic core is not visible from the surface.

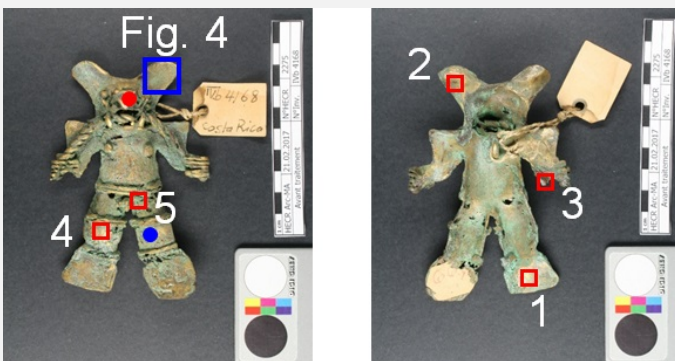
Fig. 2: Bat figure, front (left) and back (right) view with location of XRF analyses (red squares), FTIR analysis with sampling (blue point) and SEM-EDS analysis (red point),

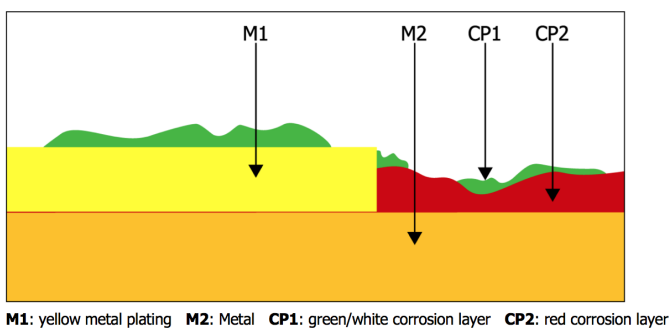
M1: yellow metal plating M2: Metal CP1: green/white corrosion layer CP2: red corrosion layer
Credit HE-Arc CR, N.Gutknecht.

Fig. 3: Stratigraphic representation of the bat in cross-section by macroscopic observation,

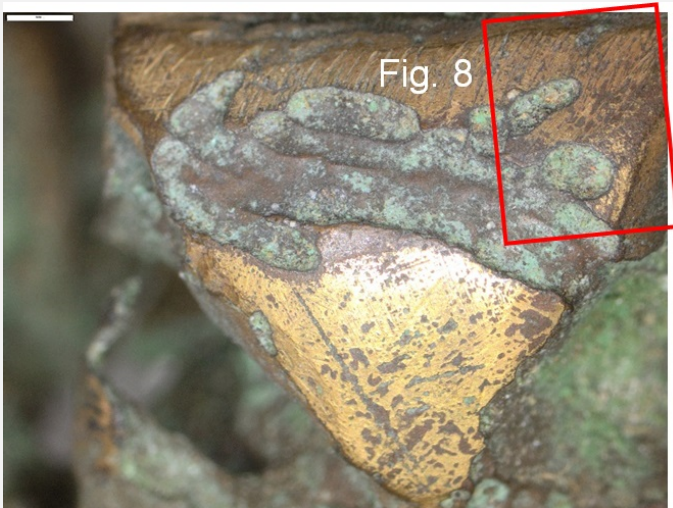
There are two corrosion products (Figs. 7 and 8). The red one (CP2) has a submetallic brightness and is opaque, non-magnetic, compact, hard and adherent. It is very thin (less than a few microns thick) and only appears where the gold layer has been lost. The EDX spectrum (Fig. 9) shows that it is a Cu- and O rich product, probably cuprite (Cu_2O). The light green to white corrosion product (CP1) has a waxy consistency and is thin, translucent, non-magnetic, powdery and very soft. It is very loosely bound. It is distributed on the whole object (front and back) as disparate clumps. It is mainly located on the cavities and irregularities of the surface. FTIR analyses (ATR mode) of both green and white areas of CP1 have similar spectra and were identified as copper nitrate (Fig. 10).

Fig. 7: Binocular image of the nose of the bat showing detail of Fig. 8,

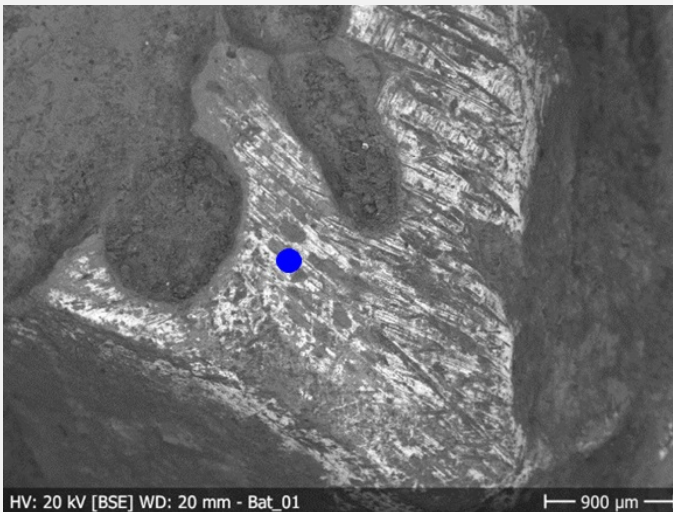
Figs. 8: SEM images of the metal on the nose of the bat. The blue point represents the area for the EDS point analysis (Fig. 9),

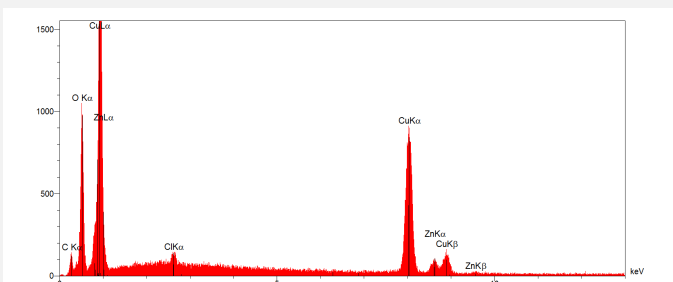
Fig. 9: EDS analysis of the red corrosion product. Method of analysis: SEM-EDS, Lab of Electronic Microscopy and Microanalysis, Néode, HEI Arc,

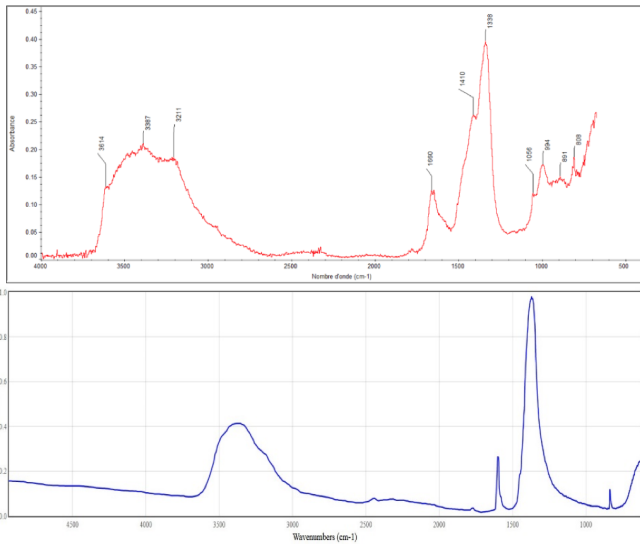
Fig. 10: FTIR spectrum (ATR mode) of the white corrosion product (top), and of synthesized copper nitrate ($\text{Cu}(\text{NO}_3)_2 \cdot 3\text{H}_2\text{O}$) (bottom),

FTIR analysis of the green/white corrosion product suggests that it is a copper nitrate, a highly water soluble corrosion product that cannot be found in an archaeological context. However, it has been recorded on artificially patinated copper alloys (Scott 2000; Craddock 2009).
